OVERVIEW & EXECUTIVE SUMMARY

Venue Solutions Group (VSG)[®] was engaged by Gensler Sports on behalf of Hamilton County and the Cincinnati Bengals to provide a comprehensive facility condition assessment of Paul Brown Stadium that benchmarks the current condition of the facility. As part of the assessment, VSG, in partnership with their consultant team, has developed a 20-year capital expense matrix to assist the owner in establishing priorities for major repairs, potential upgrades and maintaining the facility in a professional manner. The ability to plan and maintain the stadium as it transitions from years 18 to 30 is crucial in extending the life of the facility as well as its relevance in the competitive and ever evolving regional and national marketplace. In addition to the facility assessment, VSG has also provided information related to the practice field, bowl cleaning and event-day trash removal.

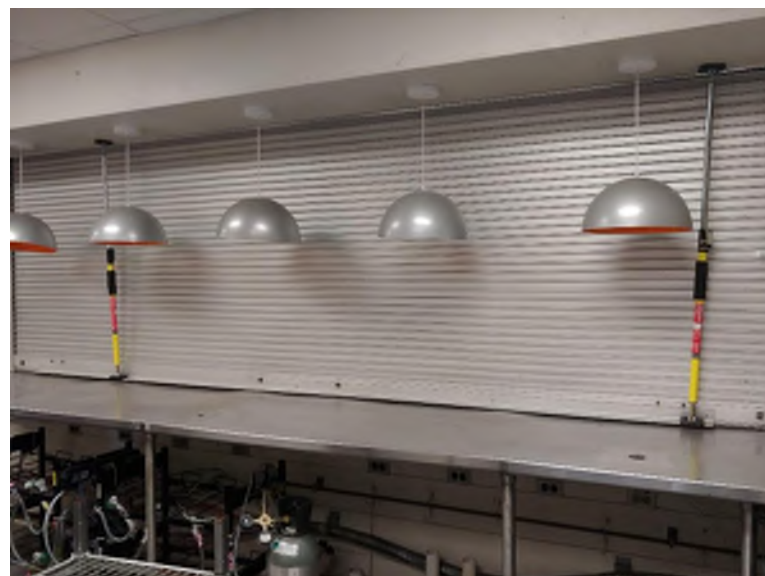
Food service management noted that in a few of the recently renovated concession areas, particularly in the 400 level north plaza, the wind will blow some of the pendant light fixtures. These fixtures are low enough to be a hazard to staff and guests.

Concession with pendant lights

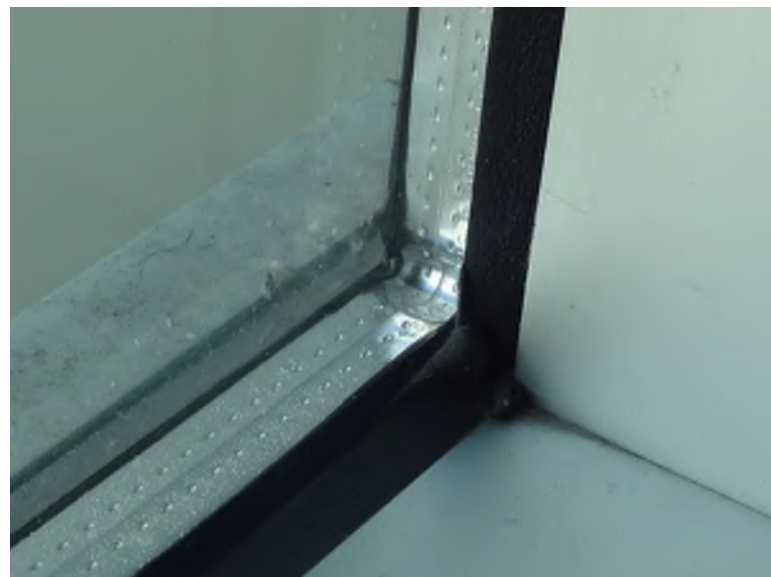
The glazing gaskets are one of the first curtain wall components to deteriorate through normal aging. Over time, EPDM glazing gaskets begin to deteriorate, shrink and develop surfaces crazing due to UV degradation and other atmospheric exposure. Shrinkage and crazing of the outside gaskets can cause seal loss which can allow water penetration into the system. Gasket shrinkage at the mitered corners can create gaps which can allow water penetration.

Curtain wall glazing gasket

The glazing gaskets should be inspected every five years to actively monitor the condition of the gaskets. Eventually, the outer gaskets, on the most weather prone exposure areas, will deteriorate to the point where they are no longer watertight.

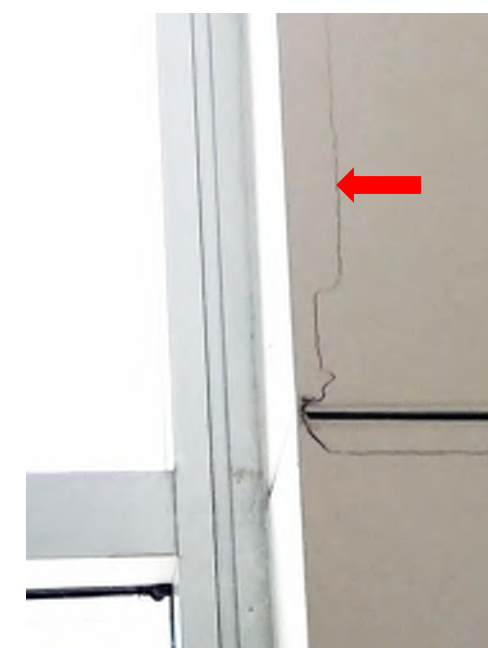
Along the side area of the large east and west curtain wall, some cracking was observed in the adjacent gypsum board walls.

Cracking in gyp board next to curtainwall

Cracking in adjacent gypsum walls could be due to midspan lateral deflection (wind loads) of the curtain wall, or from thermal expansion of the aluminum framing in the curtain walls. The curtain wall system is designed to deflect and expand at a higher rate than the adjacent gypsum board areas.

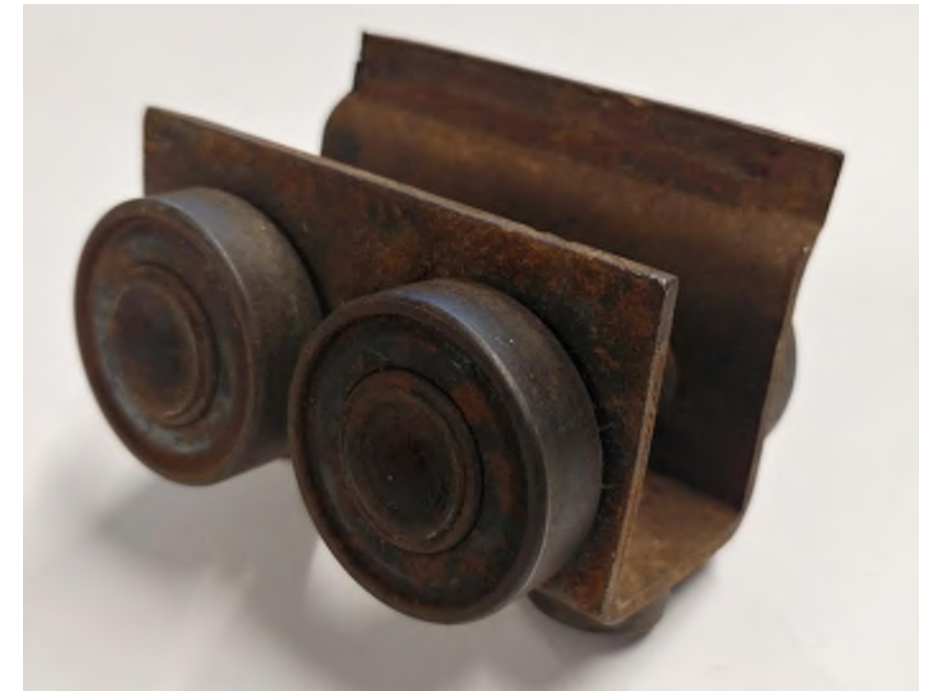
These components of the insulated glass units are reaching the end of their service life. To prevent future failure and loss of visibility, it is time to begin annual inspections and periodic maintenance of the glazing seals. Alternately, PBS could consider replacement with a new design and installation of suite operable glazing.

Typical trolley for sliding glass wall panel

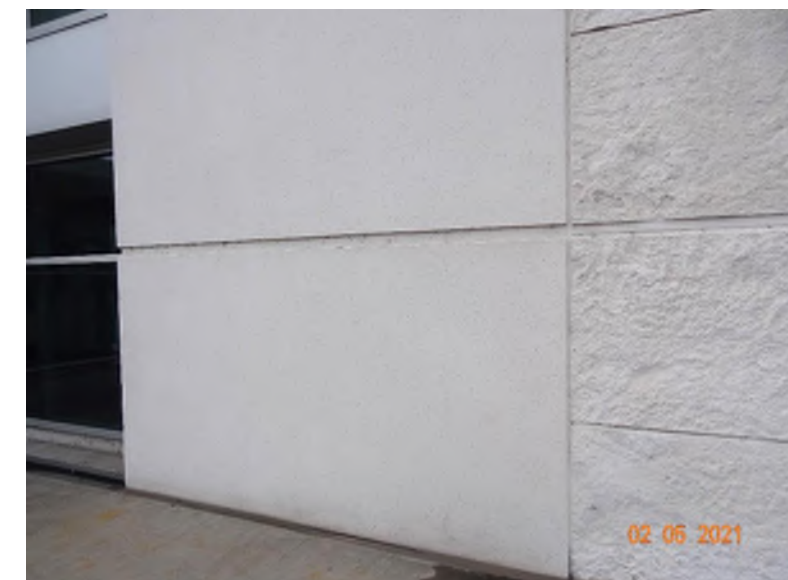
There are several precast concrete wall panels around the stadium that form part of the exterior wall system. Overall, the concrete appeared to be in good condition with no noticed cracking, rust spots (from internal reinforcing) or deterioration. The white concrete appeared to be clean and bright.

Precast concrete wall panels – Administration building

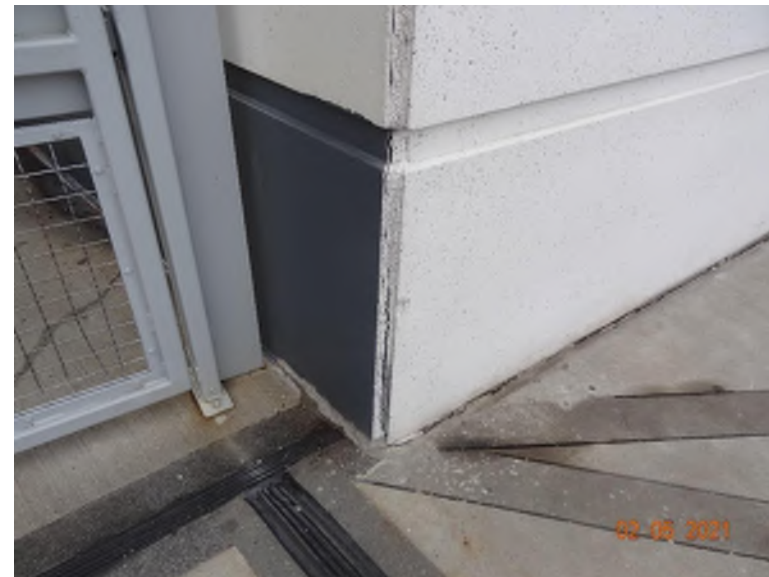
Joint sealants between the concrete panels are aged, weathered and showing early signs of failure. All joint sealants between precast concrete panels should be replaced. There is a plan to recaulk all joints between the panels on the Administration Building in 2021.

Precast concrete wall panels – sealant failure

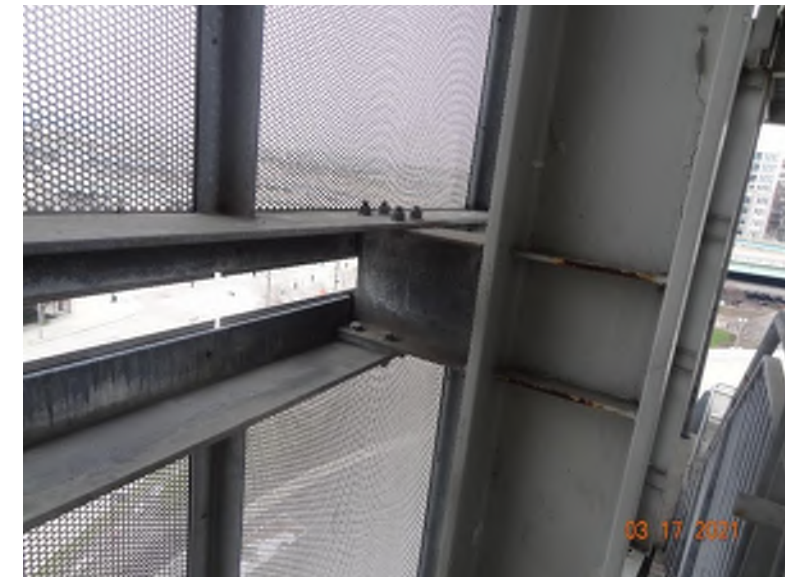
The perforated screen wall panels around the stadium are heavy gage 300-series stainless steel. These panels are connected to supporting framing made from hot-dipped galvanized steel support brackets, plates and bolts. The galvanized steel attachment pieces are unpainted. The perforated steel panels and their attachment brackets appear to be in good condition and received mechanical fastening replacements in 2020.

Panel connection

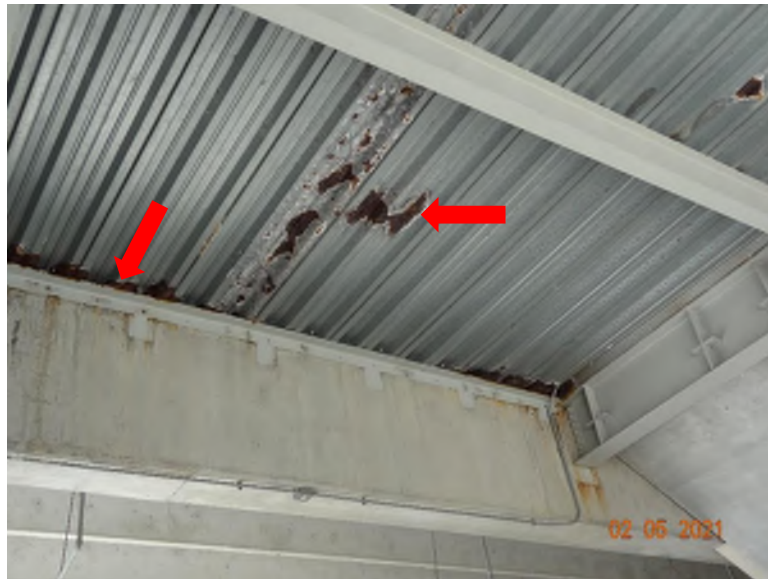
Concrete ramps and stairs connect the levels from the main concourse up to the upper concourse. On the west side, the ramp extends down to the service level. The concrete along the edge of the slab areas near several stairs and ramps have cracks in the concrete. Rain water appears to have penetrated through the cracks in the slabs and is leaking to the spaces below. The metal decking supporting the concrete ramps and the concrete landings of the exterior stairs has rusted in several

locations. The rust is visible from the underside of the metal deck. However, capital improvements during 2021 addressed these issues and are continuing in 2022.

Exterior stair – rusting metal deck

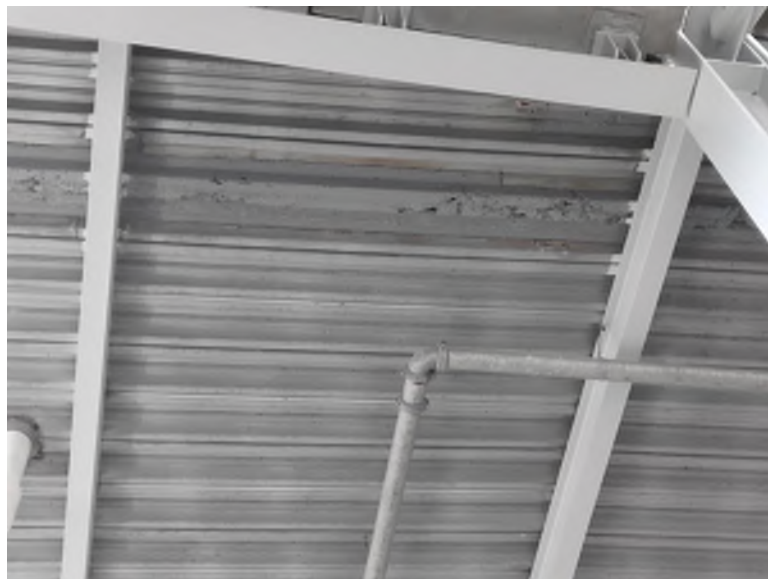
Metal deck after replacement

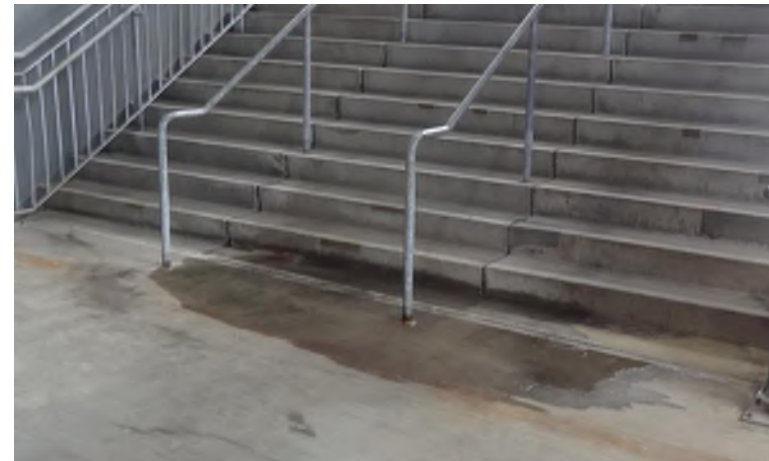
The rain water is dripping on the stairs, landings, ramps, railing, and other components below. These components are rusting and are covered with deposits leaching from the concrete and the steel deck. Water is ponding on the landings.

Exterior stair – ponding from leak above

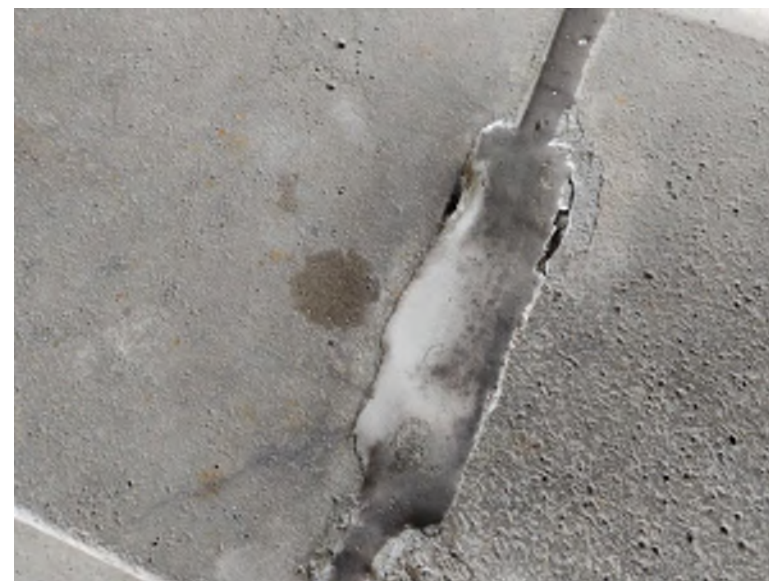
Joint sealants between the stair sections and at the base of the railing posts are aged, weathered and showing early signs of failure. The joint sealant between the walls of the ramps and doors and other materials is also aged and showing signs of failure. Joint sealants at these locations should be replaced.

Exterior stair – failing joint sealant

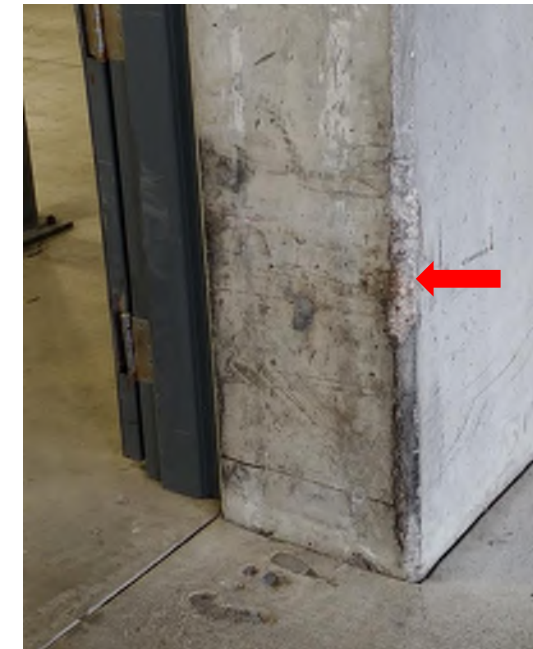
Exterior ramps – damaged wall corner

The concrete walls at the entrances to the ramps have been chipped and scraped from traffic. These areas will be patched and bollards or durable steel corner guards installed for protection during the next few years as a part of planned repairs.

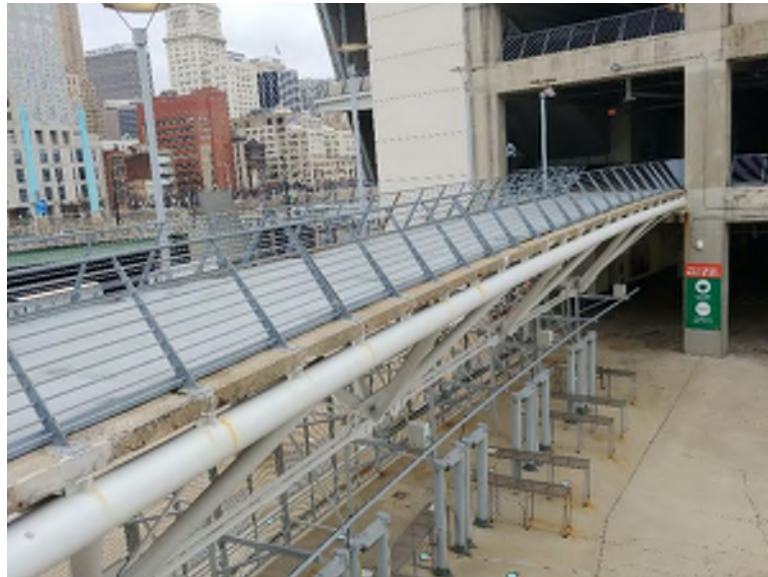
North Bridge over Gate C with water damage

The concrete has spalled at the edges where the railings have been installed and steel reinforcement within the concrete is exposed and rusting. In addition, water is draining to the expansion joint at the west end of the bridge and ponding is observed at the east end near the expansion joint.

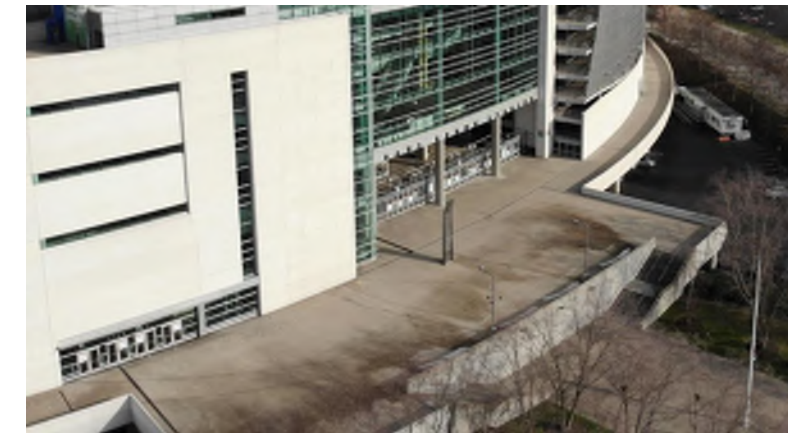
At Gate A there is a pinch point where the pedestrian ramp comes up from the south (river side). With the development of new parking at the Hilltop Site, the Bengals anticipate an increased use of Gate A as a result. Upgrades to this area should be scheduled to coordinate with the new parking area.

Gate A and West Plaza entry showing lack of space for approach from South (right)

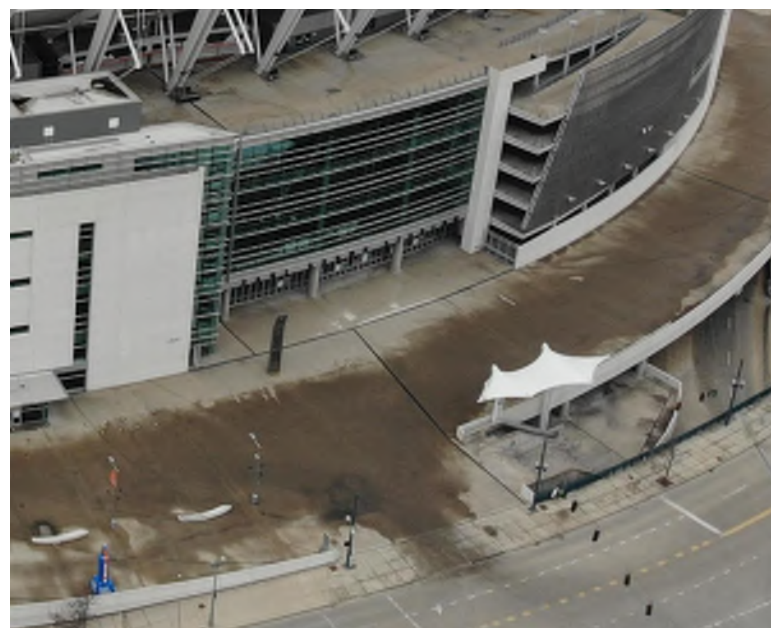
Gate D accommodates up to 60% of entering fans due to location near tailgating lots and downtown parking. The spectators enter the exterior plaza at the auto entrance, which is not wide enough to accommodate these crowds. The fans queue at the nearest gate – Gate D – and quickly block access to other gates on the east side of the stadium. This exterior plaza at this gate should be reconfigured to improve flow of pedestrian traffic as well as providing wayfinding to direct visitors to other gates.

East Exterior Plaza - Gate D and automobile entrance

Future changes and gate configuration flexibility should be considered.

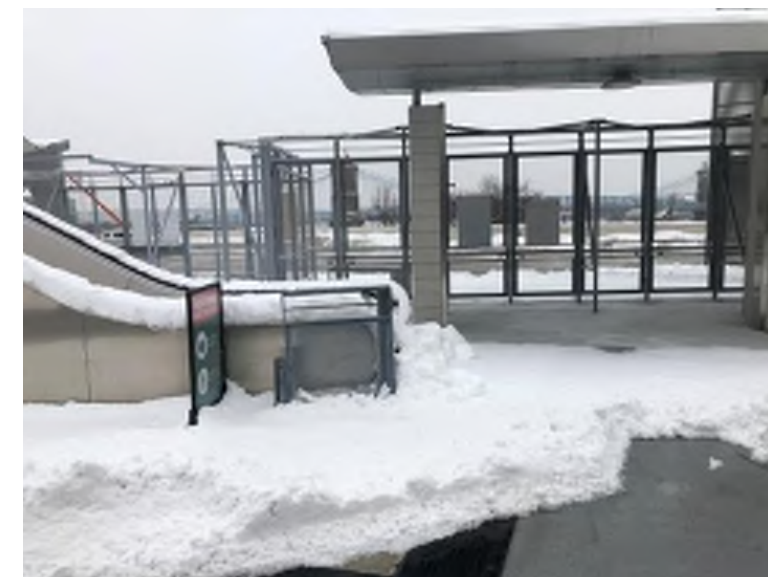
Tight areas inside the gates slow the entry of fans. At Gate D more space should be developed at the Plaza Level overlook. At Gates B and E, the fence is too close to the escalators.

Gate E and Escalator: Inadequate clearance inside gate. No wayfinding present.

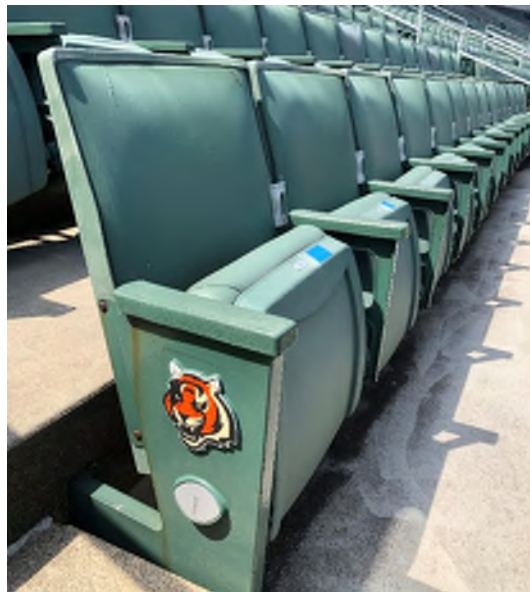
Club Level cushioned type seating

There are 16,500 cushioned seats at Club Level. The shaft which operates the spring-loaded retractor breaks on a regular basis. In 2019 there were 1,900 replacements of broken plastic retractor shafts. Materials are out of warranty and the shafts are in short supply. PBSL has about two years' supply of the metal pans for the seating backs. Irwin has given notice that they will be using plywood for replacement of the pans for the backs.

The Club Level seating metal backing plate is no longer manufactured and is currently fabricated from marine grade plywood. It is recommended that the Club Level seats be replaced with new industry standard premium seating.

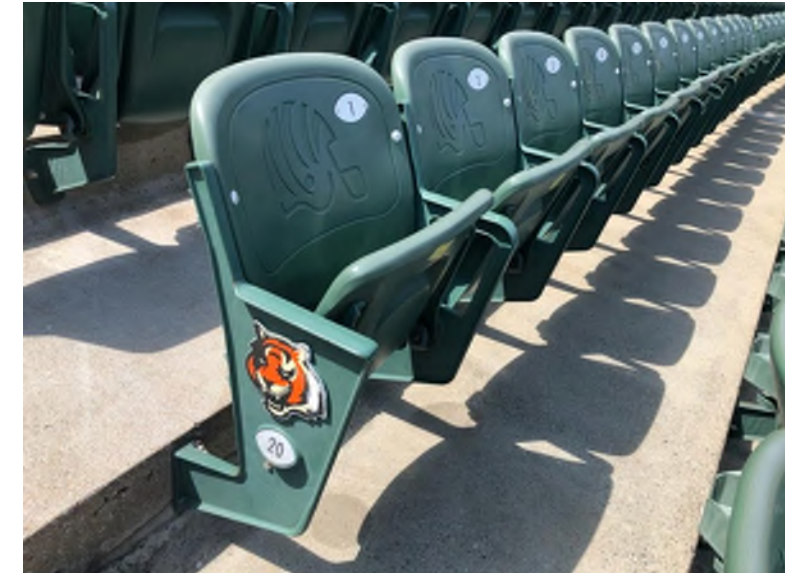
Some of the issues with the hard plastic seats are loose anchors for the stanchions and broken seat backs. Other issues include the rusting of anchor bolts in the seat bottom and deterioration of the stanchions themselves.

Hard Plastic seating in Lower Bowl Level

Parts for the plastic seats, such as seat backs, are often adapted from other stadiums, and for PBSL need to be modified in the stadium shop. In general, the plastic seats have been more durable and easier to re-order than the cushioned seats. These seats are not yet at the end of their service life but should be replaced in the next 3-5 years. However, there is only a five year supply of replacement parts on hand, so if the source for more parts cannot be secured, replacement may need to be sooner.

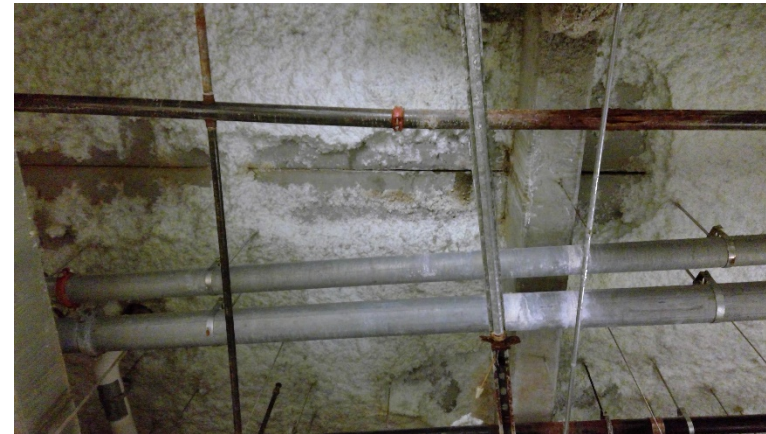
In the mechanical rooms, the ceiling is the exposed concrete underside of the concourse deck above. Water is leaking through the cracks in the concrete topping and the failing water proofing to drip onto the mechanical equipment.

Rust was observed on the air handling unit in sector 1 from a leak in the concourse deck and mold was observed on the chiller in sector 7 from a leak at a stair landing.

Leaking water from Plaza above in mechanical room

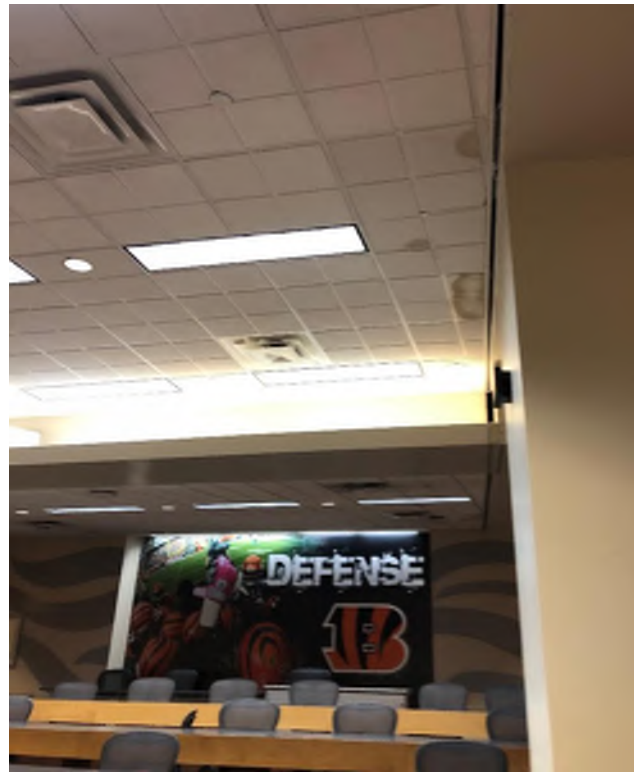
The two main auditoriums have frequent leaks above ceiling that are a constant problem. The large auditorium has a nice wood veneer ceiling, but the small auditorium has acoustic ceiling tile that looks dated. The speaker system is also outdated and should be replaced. White boards are not functioning properly due to warping over years. Noise travels from Training Room (gym) and Locker Room.

Small Auditorium ceiling.

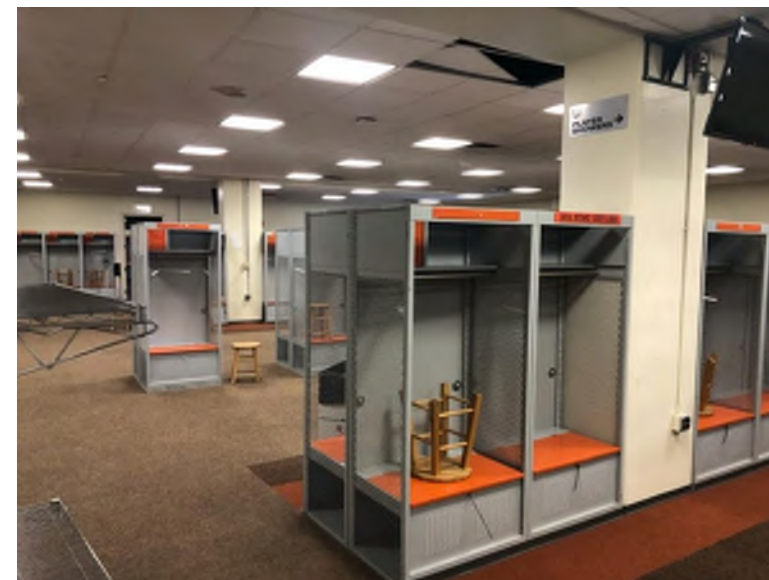
Visiting Team Locker Room with water damaged ceiling

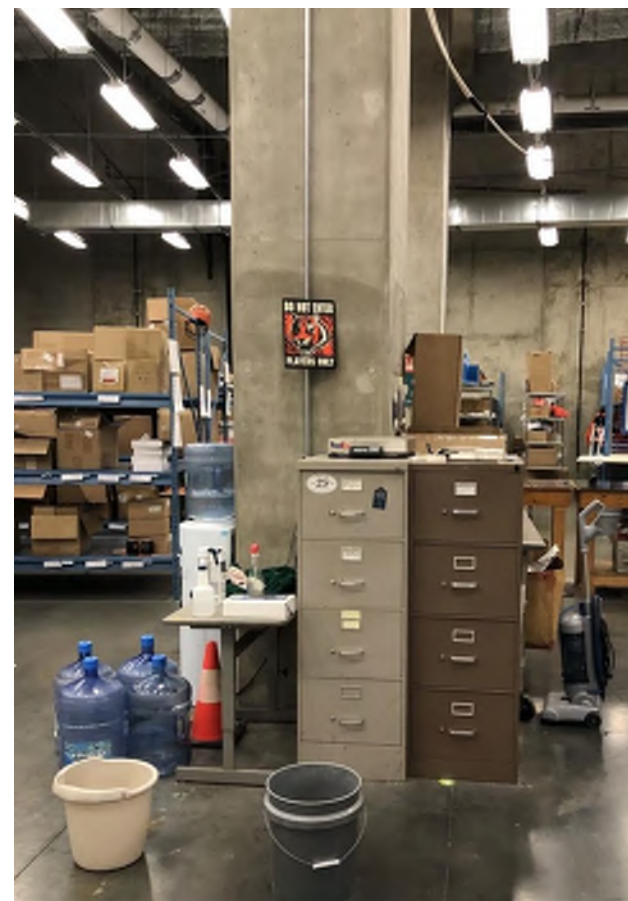
Retail Warehouse has water leaking from Plaza deck above

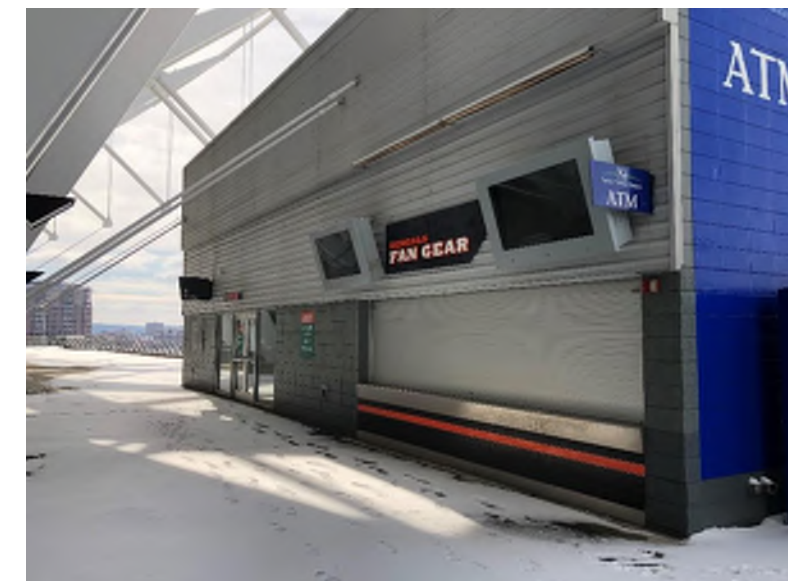
Satellite retail spaces also include stores on the upper concourse level. Signage is not prominent and water leaks in through under the counterfront wall at several locations. The casework is in poor condition and roll-down shutter doors do not close properly. Heating and lighting are in need of upgrade. Electric and data outlets are not located in areas facilitating ease of use, often requiring wires to be taped to the floor or walls.

Typical satellite retail space on upper concourse level

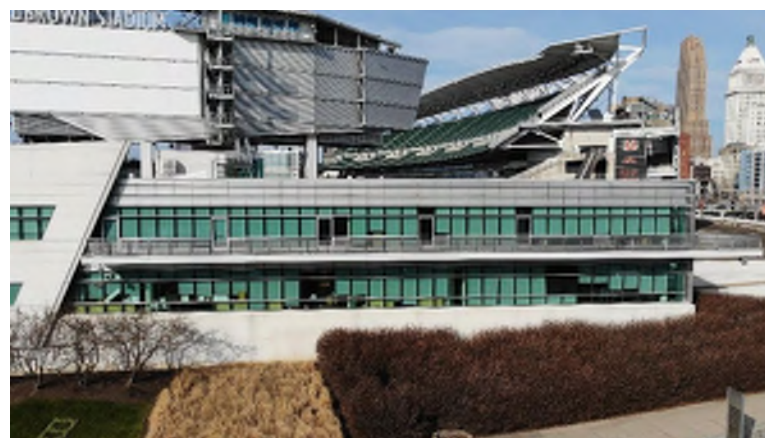
Street side of the Administration Building

The office is well appointed and is in generally good condition.

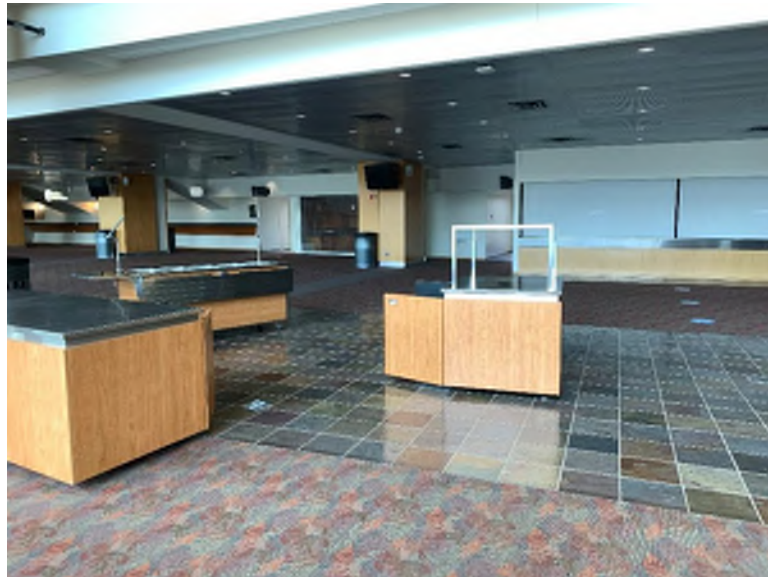
The interior design of club spaces has a very minimal and corporate aesthetic, not reflective of a modern stadium, premium space, design. The broadloom carpet has been frequently maintained but is dated and showing wear. Carpets throughout the club and premium spaces have permanent stains. The slate tile flooring is a premium aesthetic but is easily damaged and costly to maintain. The vomitoriums have recently received epoxy flooring and epoxy base for durability and longevity. The acoustic ceiling tiles are in acceptable condition and are replaced when they show wear from leaks or stains. The metal ceiling tiles are in good condition and contribute to a premium aesthetic. The wood paneling and doors are in good condition except for sun-fading in the West Club.

Club space showing broadloom carpeting and slate tile flooring and movable food stands. The back of photo shows the unused countertop areas on the left, a satellite retail space with a gate in center and a concession stand on right.

1. Replace slate tile with flooring that will reduce maintenance time and expense, contribute to a premium aesthetic and maintain acoustic benefits.
2. Renovate heating.

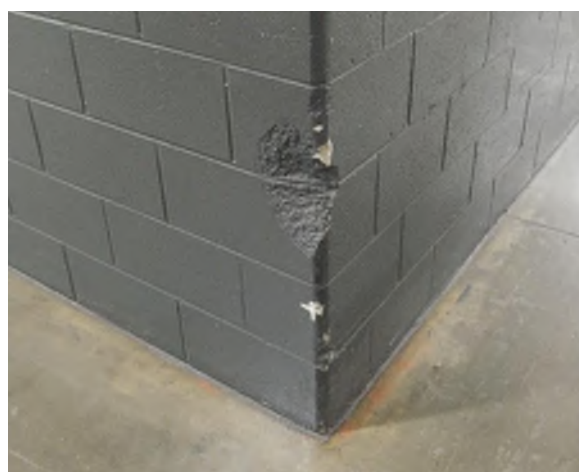
The walls on the service level and in the public areas are primarily painted concrete masonry units (CMU). These walls are in good condition overall although there is damage to them in several areas. Almost all of the walls have chipped corners from passing traffic (pedestrian, push carts, and golf carts). Older chipped areas have been painted over.

Typical condition of CMU wall corner

The CMU walls are also open to moisture penetration at all sealed joints. The sealant has adhesive and cohesive failure and should be removed and replaced.

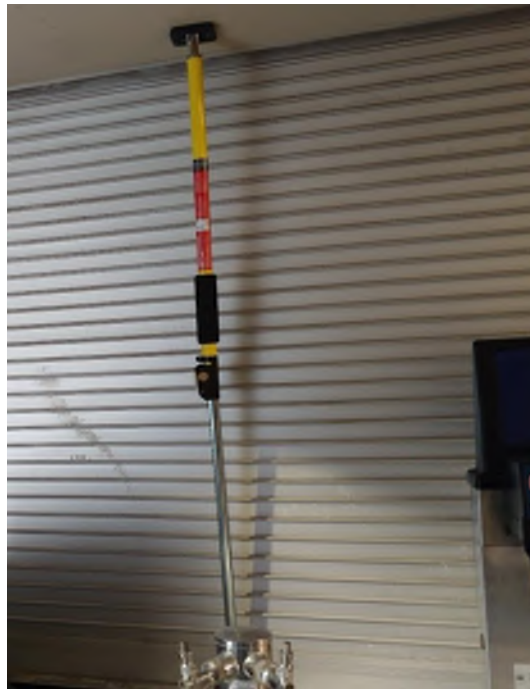
Public concession areas are located on the Main Concourse, Plaza Concourse, Club Level, Mid-Suites Level and Upper Concourse. The front façade has a steel countertop with overhead coiling doors. The overhead doors frequently have dents and/or erosion of the finish. Various doors are difficult to operate and do not seal well at the threshold, although stadium management allocates funds annually for replacement of the overhead doors. During the off-season, jacks will be installed at the overhead doors to fully close them and prevent outside air from entering the service and food prep areas.

Jack at overhead door

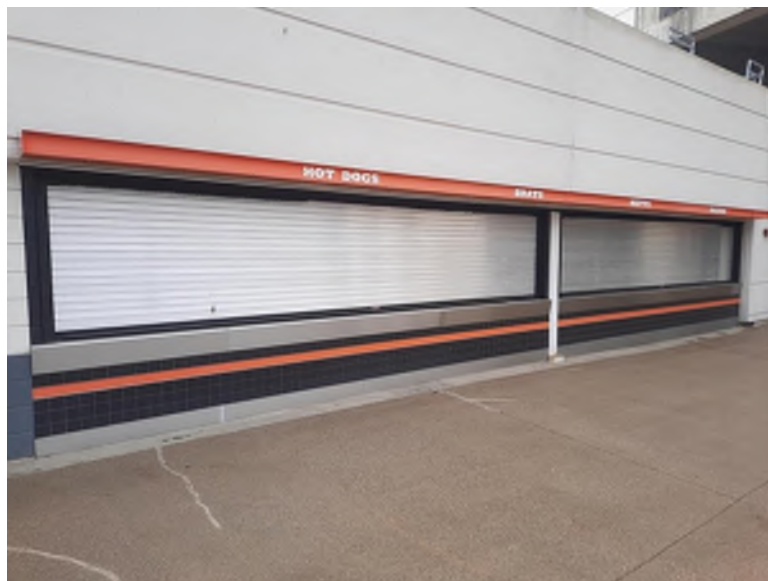
Overhead door after replacement

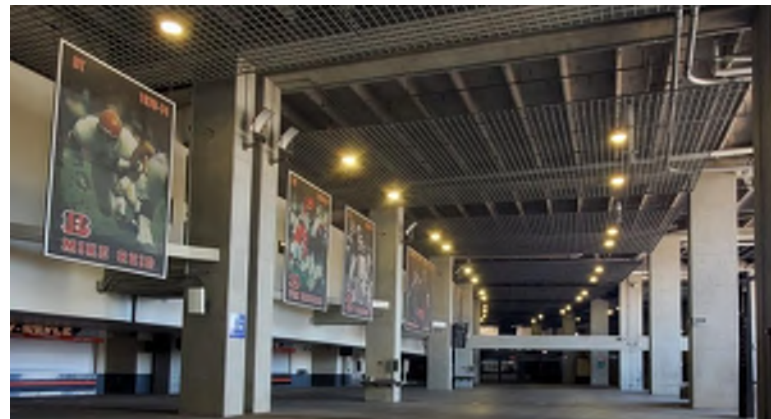
Typical LED high bay lighting

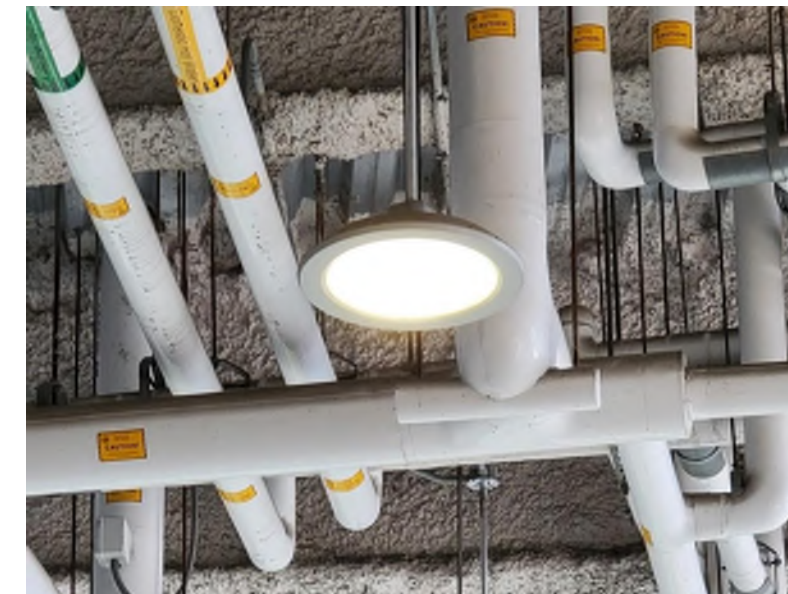
Typical Service Tunnel LED high bay lighting

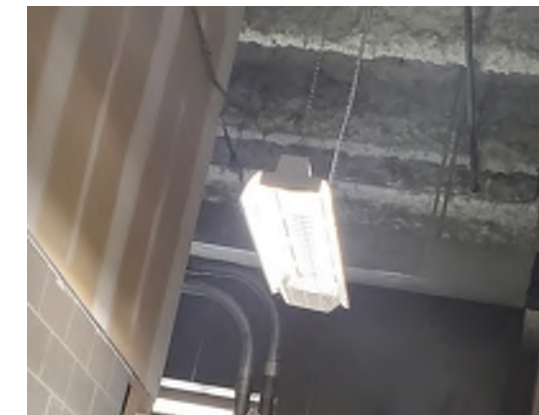
Typical mechanical/electrical area lighting

All mechanical/electrical support areas are using fluorescent lighting and should be replaced with LED fixtures.

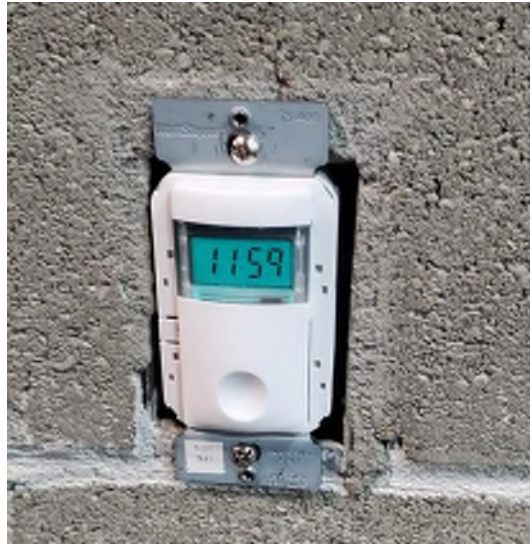
Typical lighting control timer

The majority of office areas, including but not limited to individual offices, open offices, ticketing, press and administration areas, are lit by recessed fluorescent fixtures. These fixtures should be replaced with LED fixtures to conserve power and reduce energy costs. The best long-term, cost-effective solution are LED flat panel type fixtures. These areas are controlled with wall mounted timers. These timers should be replaced with wall or ceiling mounted occupancy sensors set to vacancy control.

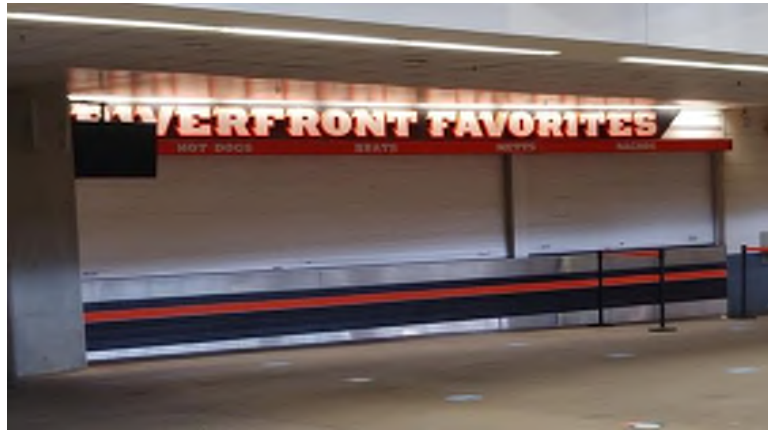
Typical concourse low ceiling fluorescent linear lighting

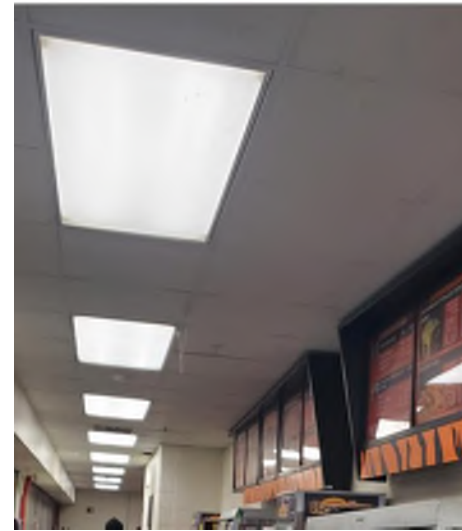
Typical concession area lighting

All existing food prep concession / kitchen areas have fluorescent lights. These areas should be reviewed with current layouts and usage to verify light levels are adequate. All fixtures should be replaced with LED fixtures.

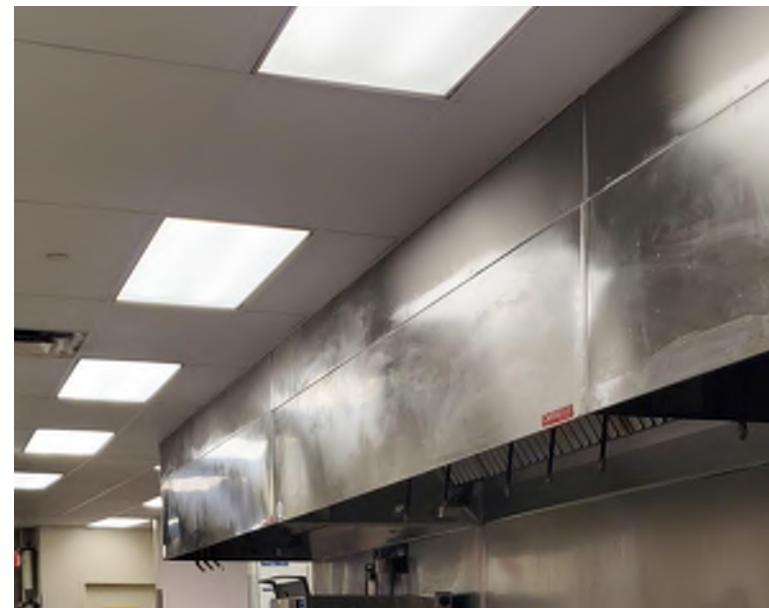
Typical kitchen lighting

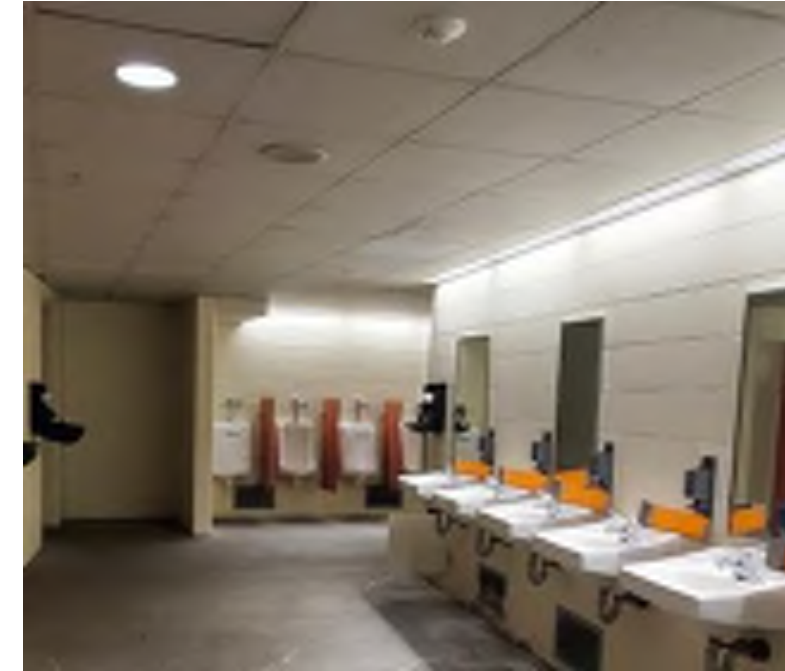
General restroom lighting

Group public restrooms are utilizing fluorescent lights and the lighting level in the area is very dim. Our recommendation is to replace existing with new LED fixtures and provide additional fixtures as needed to meet required light levels.

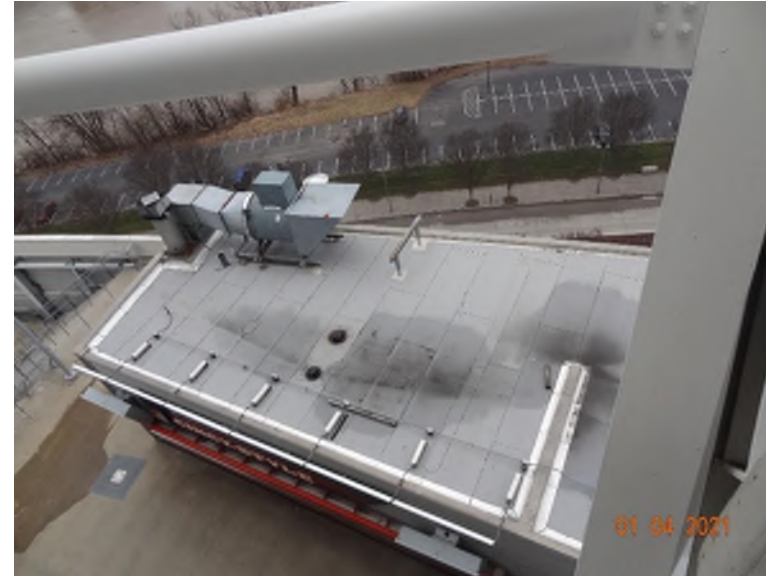
Several roof areas have serviceable rooftop equipment that are located within 10 feet of the roof edge without fall protection.

Equipment on roof

Currently, the Ohio Building Code, Section 1015.6 requires that guards or fall arrest systems be provided where serviceable mechanical equipment is located within 10 feet of the roof edge. While the stadium was originally built to code, over the last 20 years the building code has changed.

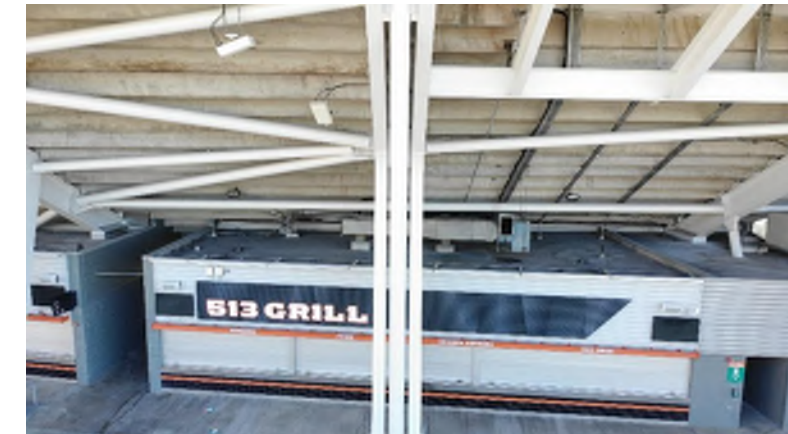
There are several roofs on the 700 Upper Concourse level of the stadium. These include roofs over concessions areas, elevators, chutes and service areas. The roofs along the outer sectors are fully exposed to weather while those along the inner sector sections are under some cover of the seating areas above.

700 level - Concession roof

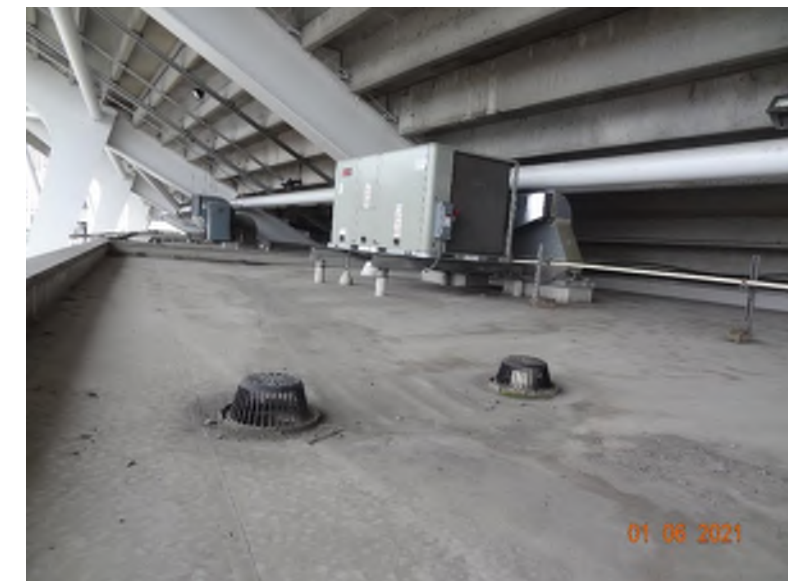
All of the roof areas in the inner sector are original EP single ply membranes. These roof areas are generally beneath the seating bowl.

Typical EP membrane roof

These roof areas appear to have performed well but are nearing the end of their service life and should be replaced.

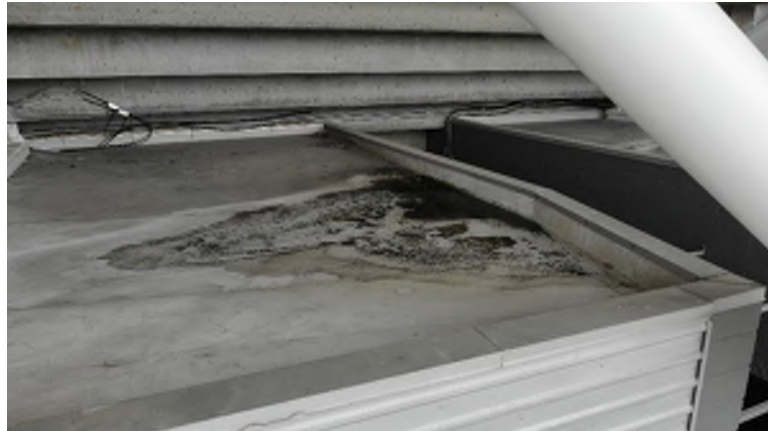
These roofs have short parapets around the outer edge areas and metal copings. Roof areas have internal roof drains and secondary overflow drains. Some areas have ponding water.

Ponding water on EP membrane

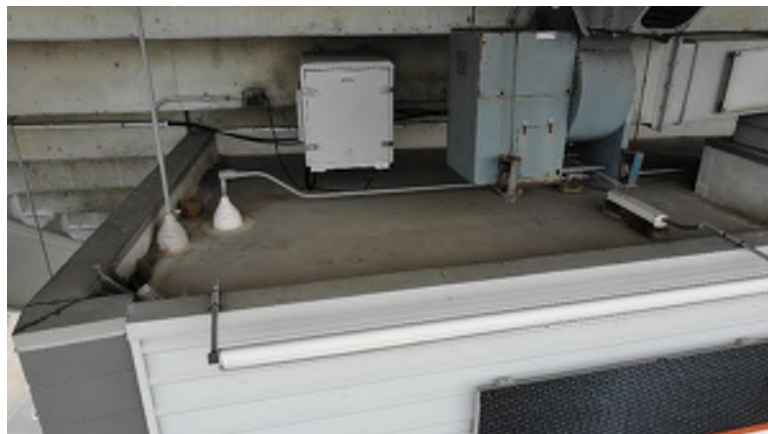
Several of these roofs have rooftop equipment that is within 10 feet of the roof edge without fall protection.

Equipment on roof near roof edge

Any planned rooftop changes (materials, HVAC placement, etc.) should be reviewed for code compliance and budget for a fall protection system in the event it becomes required. A fall protection system is recommended as good building practice.

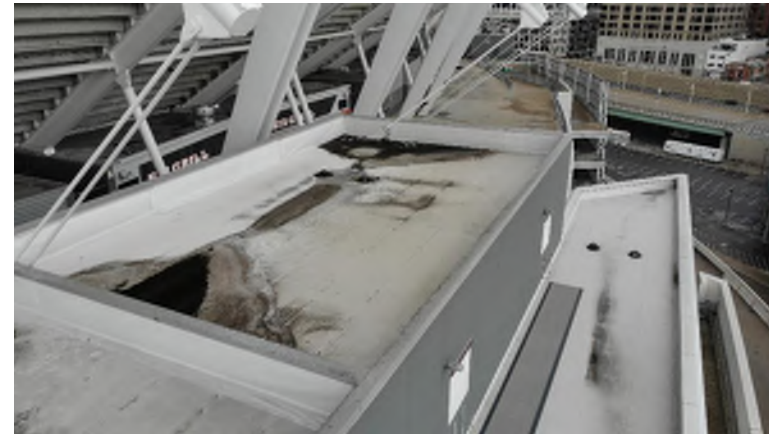
There are six roof areas along the east and west outer sector areas. Two areas along the east side still have the original EP single ply membrane.

Outer Sector: typical EP membrane roof

These roofs have short parapets around the outer edge areas and metal copings. Roof area have internal roof drains and secondary overflow drains. These roof areas are at the end of their service life and should be replaced.

1. Replace EP roofs with single ply membrane. Roof replacement to include: East and west outer sector roofs (700 Level Upper Concourse level); Pro shop canopy roof (Plaza Level); scoreboard signs, advertising signs; elevator roof of Administration building
2. Replace EP roofs with single ply membrane. Roof replacement to include: North, east and west inner sector roofs (700 Level Upper Concourse level).

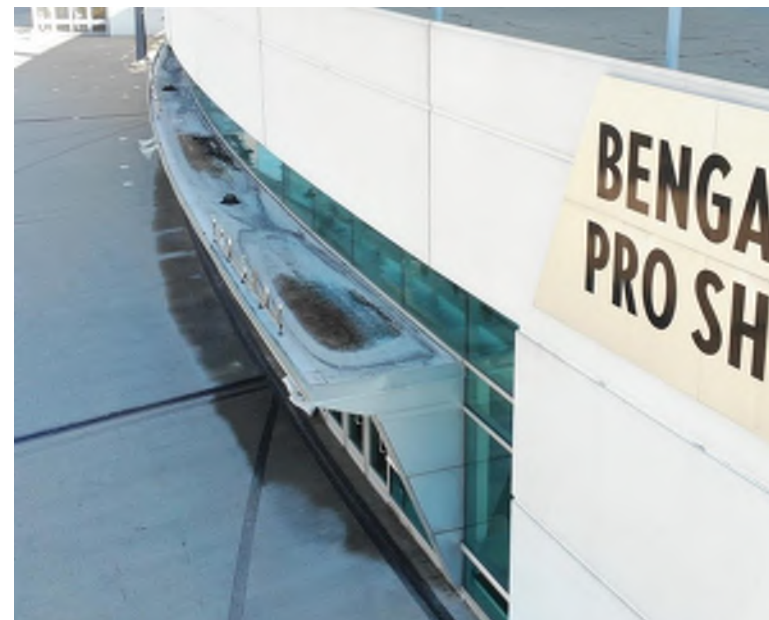
Roof at north ticket window and pro shop

The public ticket windows and entrance to the Pro Shop on the north side of the 300 Plaza Level has a narrow canopy over the storefront, windows and entrance.

The roof over the canopy is at the end of its service life and should be replaced. Improving rain drainage as part of the roof replacement would be desirable, but given the small size, long shape and edge conditions (curtain wall behind and fascia edge

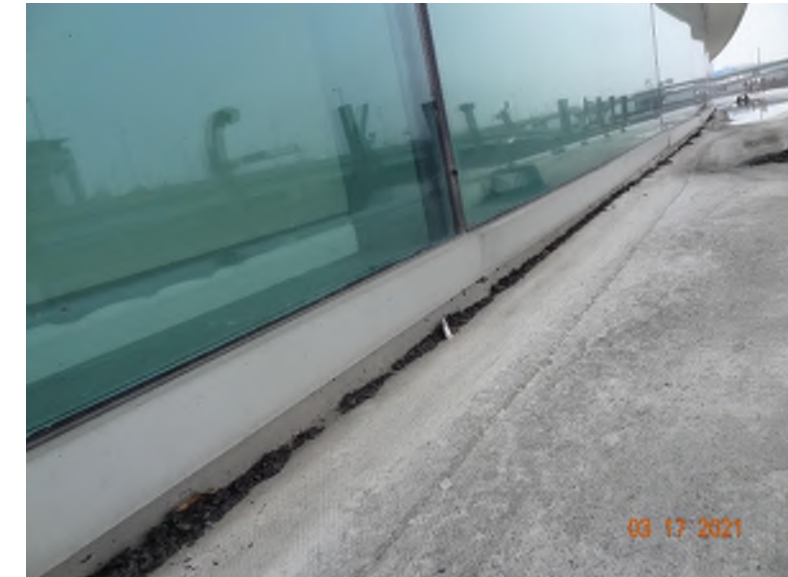
The roof over this canopy is the original white EP membrane. There are three internal roof drains spaced along the roof area. There are no secondary overflow drains. The roof edge has a metal fascia. The back side of the canopy abuts the glazed curtain wall and the glass extends down to near the roof line.

Glazing above pro shop roof
