OVERVIEW & EXECUTIVE SUMMARY

Venue Solutions Group (VSG)[®] was engaged by Gensler Sports on behalf of Hamilton County and the Cincinnati Bengals to provide a comprehensive facility condition assessment of Paul Brown Stadium that benchmarks the current condition of the facility. As part of the assessment, VSG, in partnership with their consultant team, has developed a 20-year capital expense matrix to assist the owner in establishing priorities for major repairs, potential upgrades and maintaining the facility in a professional manner. The ability to plan and maintain the stadium as it transitions from years 18 to 30 is crucial in extending the life of the facility as well as its relevance in the competitive and ever evolving regional and national marketplace. In addition to the facility assessment, VSG has also provided information related to the practice field, bowl cleaning and event-day trash removal.

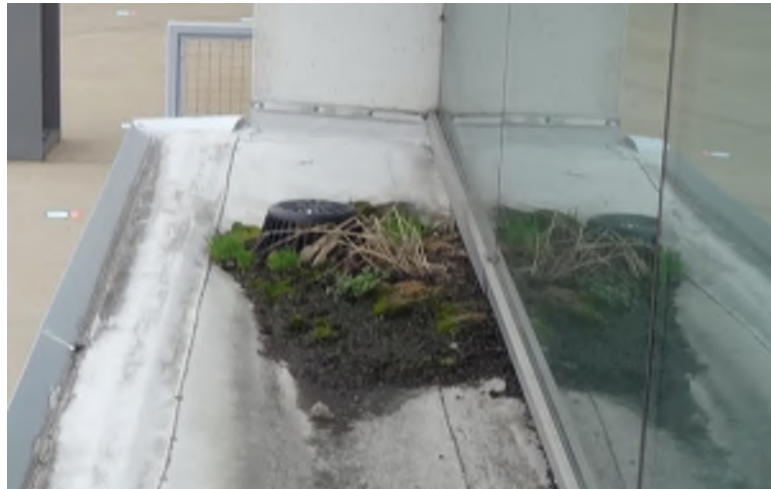
Given the long narrow shape of the canopy, combined with low slope, a shallow roof edge fascia and lack of secondary overflow drains, the roof is vulnerable to ponding water and the potential for wind-driven rain to blow over the roof edge and onto the canopy cladding below. Ponding water and lack of effective roof slope has allowed for debris to be collected in the field of the roof and created conditions for algae and moss to grow at the drains.

Biological growth at pro shop roof drain

The roof over the canopy is at the end of its service life and should be replaced. Improving rain drainage as part of the roof replacement would be desirable, but given the small size, long shape and edge conditions (curtain wall behind and fascia edge

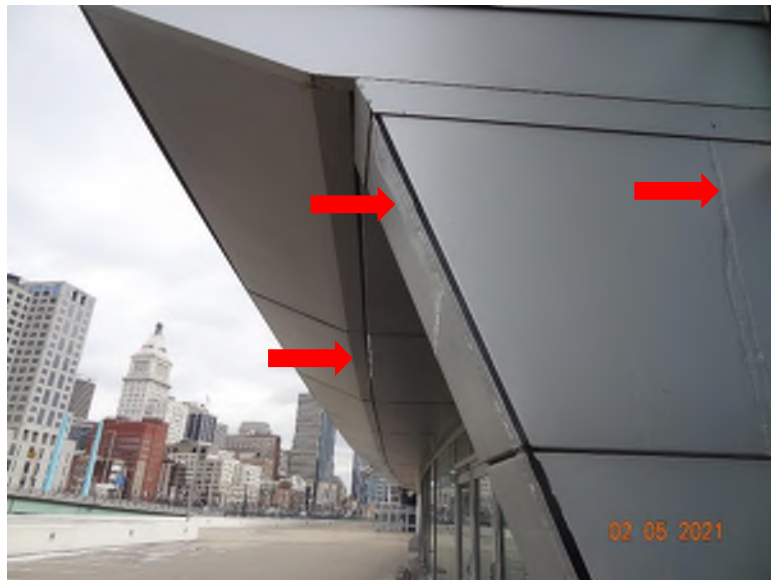
On the day of the site visit there were icicles forming on the face and underside of the canopy.

Pro Shop canopy – icicle formation

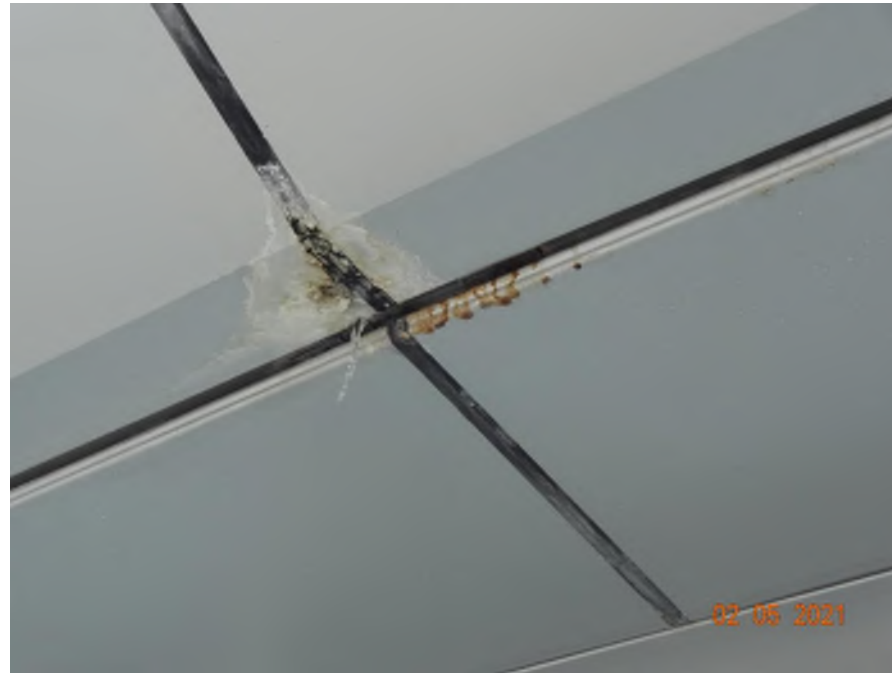
Also, some dark soiling spots and white deposits exist on the underside of the canopy cladding.

Pro shop canopy – soiling and deposits

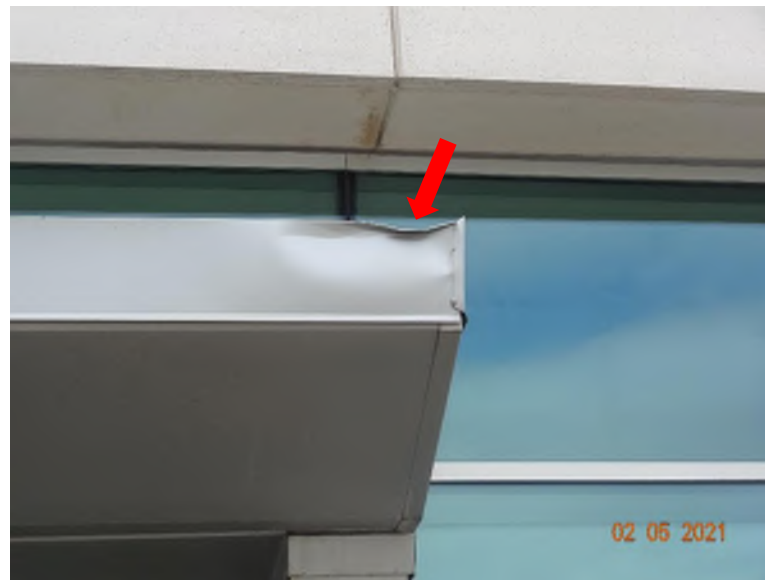
On the west end, outer edge of the canopy, there is an impact dent on the corner of the canopy. This may have been caused by a delivery truck.

Pro Shop canopy – dented corner

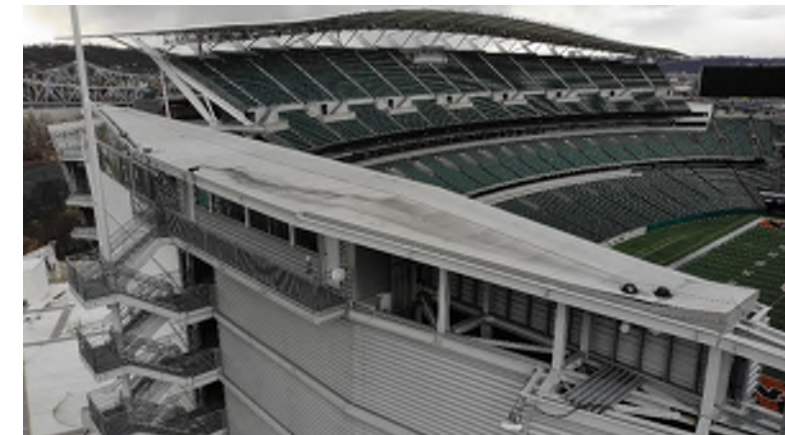
The roof over the long and narrow scoreboard is the original EP single ply membrane. There is a set of roof drains near the east end of the roof (primary and overflow). The roof membrane terminates into a metal edge fascia. Although there are roof drains, given the long narrow shape and high wind location, it is likely that most rainwater blows off the roof edge before reaching the roof drains.

South scoreboard roof

1. Replace EP roofs with single ply membrane. Roof replacement to include: East and west outer sector roofs (700 Level Upper Concourse level); Pro shop canopy roof (Plaza Level); scoreboard signs, advertising signs; elevator roof of Administration building
2. Replace EP roofs with single ply membrane. Roof replacement to include: North, east and west inner sector roofs (700 Level Upper Concourse level).

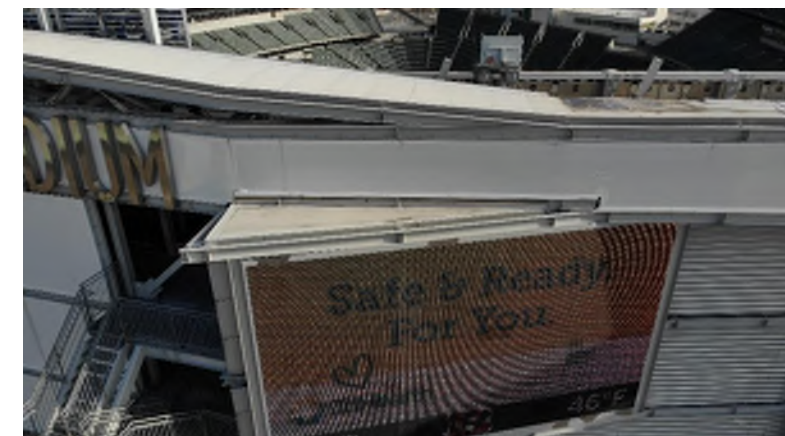
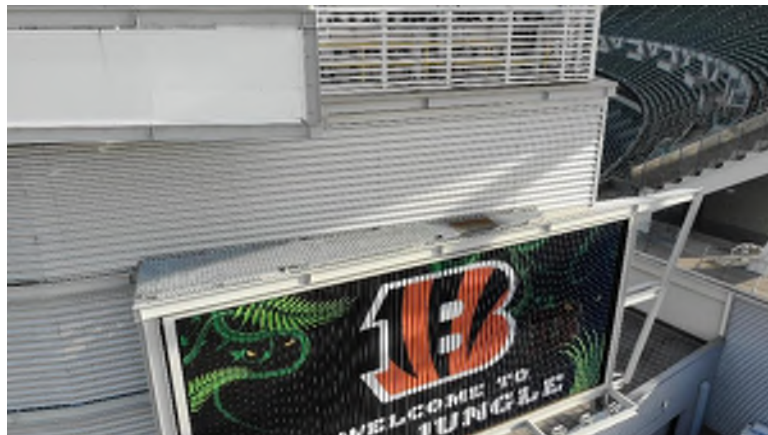
There are a couple wedge shaped roofs on the backside of the north scoreboard. These roofs have similar conditions as the south scoreboard, and are at the end of their service life.

Wedge roof at north scoreboard

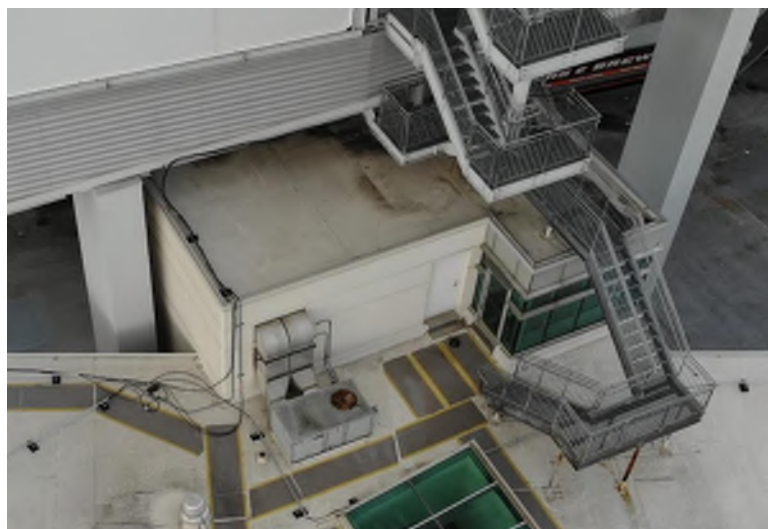
The roof over the Administration Building elevators (and under the south scoreboard) has the original EP single ply roof membrane.

Administration Building elevator roof

There are reports of roof leaks in this area. Leaks could be from this roof area or from other areas above that form the scoreboard and access stairs.

The original EP roof systems are either at or nearing the end of their service life and replacement should be scheduled. If roof replacement is to be completed over time in a phased sequence, the priority order recommendations are as follows:

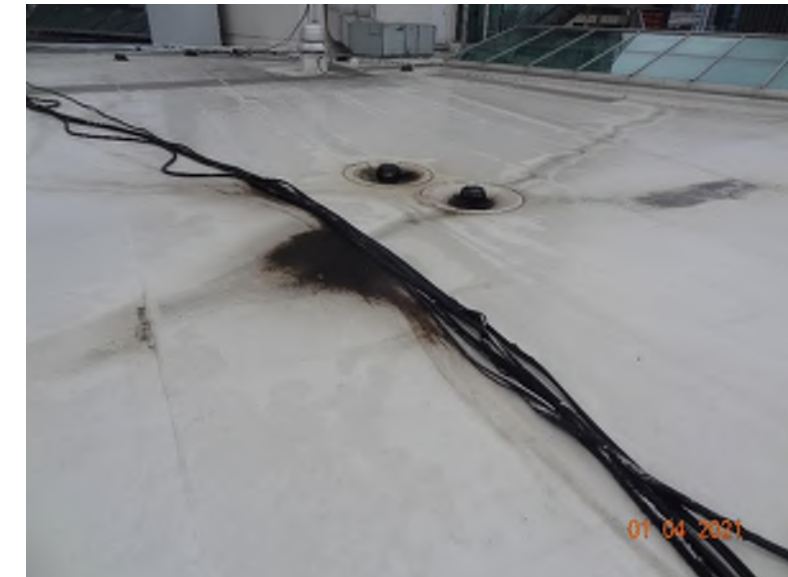
There is a service cable running across the roof and lying on the roof membrane. Rainwater flows across the cable leaving debris against the cable. To address this, the cable should be raised above the roof surface and supported by a cable tray.

Administration Building – cable on roof

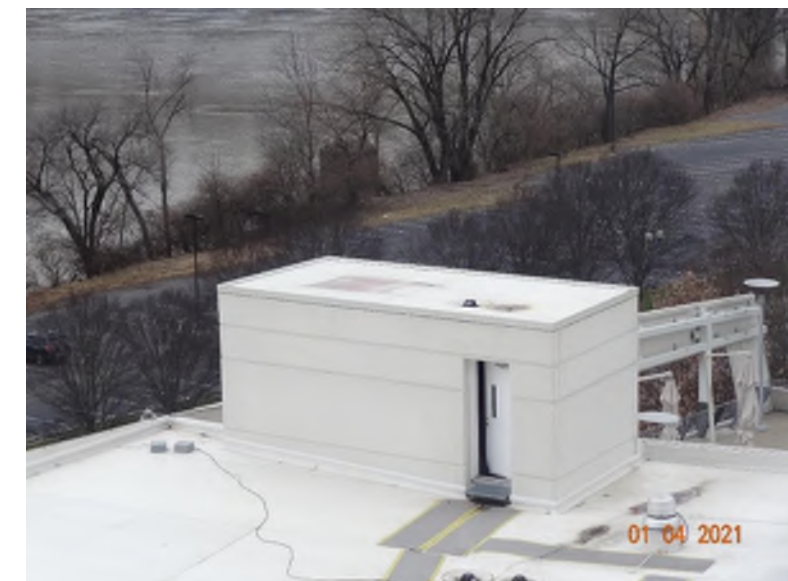
In addition to the main roof, there are higher raised roofs that serve the administration building. The stair roof over the west stairs was replaced when the Administration Building roof was replaced.

Administration Building – west stair roof

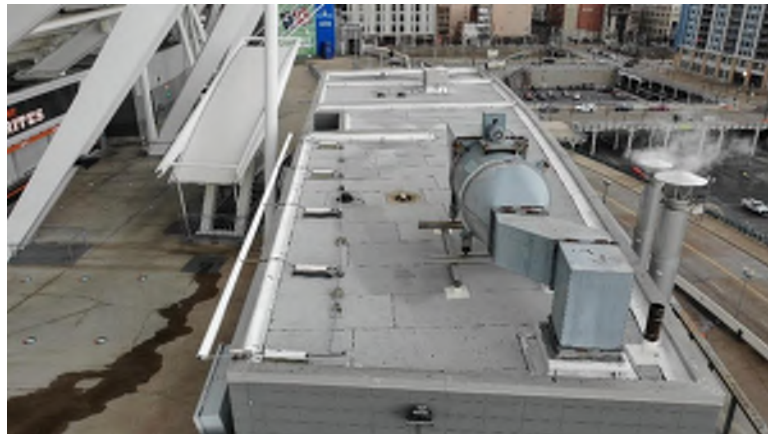
Six small roof areas have been replaced with a two-ply SBS-modified bitumen system in the past few years. These include three roofs along the outer west side 700 Level Upper Concourse, one on the east outer sector and the Club East and Club West entrances.

Typical modified bitumen roof

The modified bitumen roof membrane is polyester reinforced and has a granulated cap sheet. The system was installed using cold adhesives.

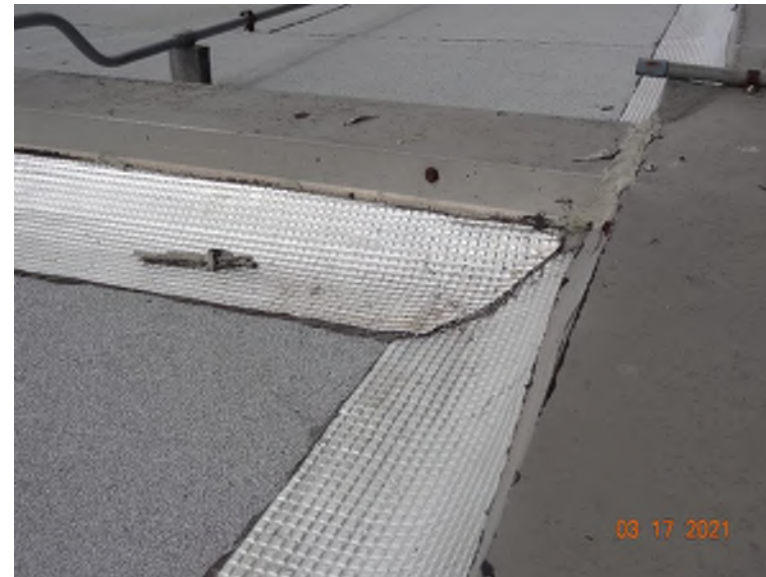
Three outer west roofs and one outer east roof on this level have been replaced with a newer modified bitumen system. Although the roof membrane was replaced, it appears that the original metal copings were left in place or reused.

New roof over original metal coping

These copings have multiple penetrations, caulked joints and are age weathered. Light fixtures that hang over the concession area below are screw attached into the top of the coping and cantilevered outward.

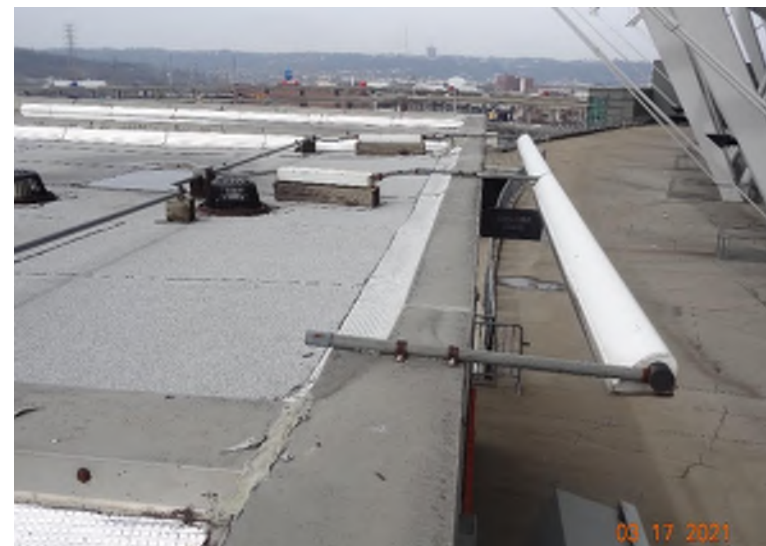
Light fixture attachment at concession area

The connection between the light fixtures and coping relies solely on the pull-out strength of screw threads through the old sheet metal coping.

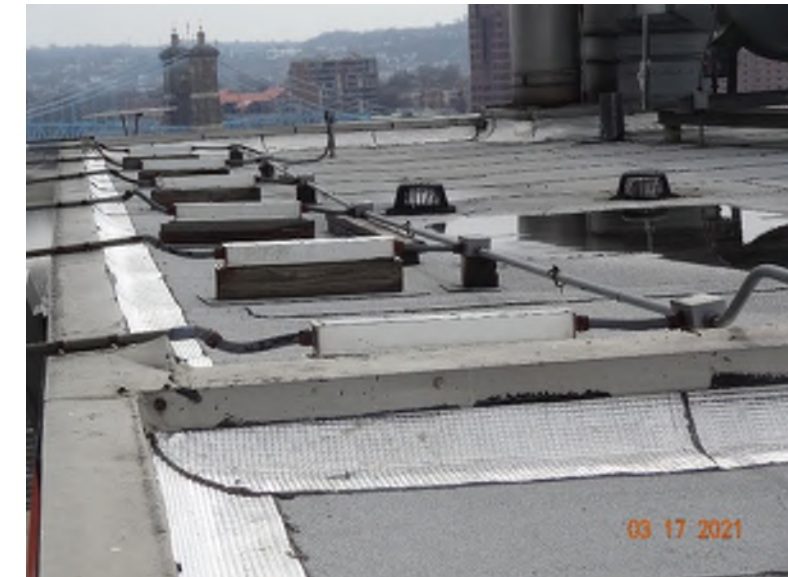
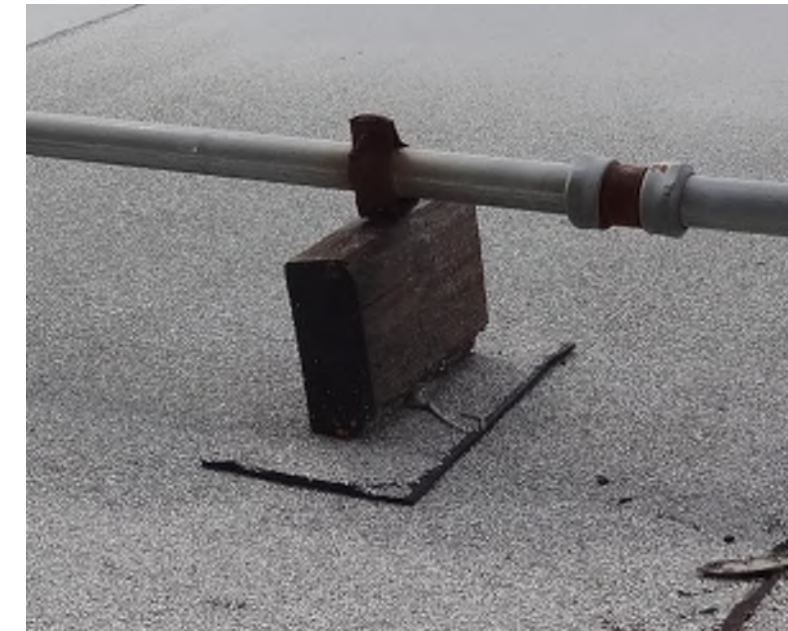
Electrical conduits that serve the lights are supported along the roof by wood blocks.

Wood blocking supports for electrical conduit on roof

Close up of wood blocking support

It appears that the wood support blocks are also remnants from the prior roof. Wood block supports are inadequate for piping or conduits. As pipes tend to move on the roof due to thermal expansion-contraction and wind, wood blocks tend to slide across the roof surface or rotate out of place, potentially causing damage to the roof membrane. As the wood weathers and deteriorates it loses its ability to provide support.

1. Replace wood blocking with pipe supports.
2. Replace roofs at the end of their service life.

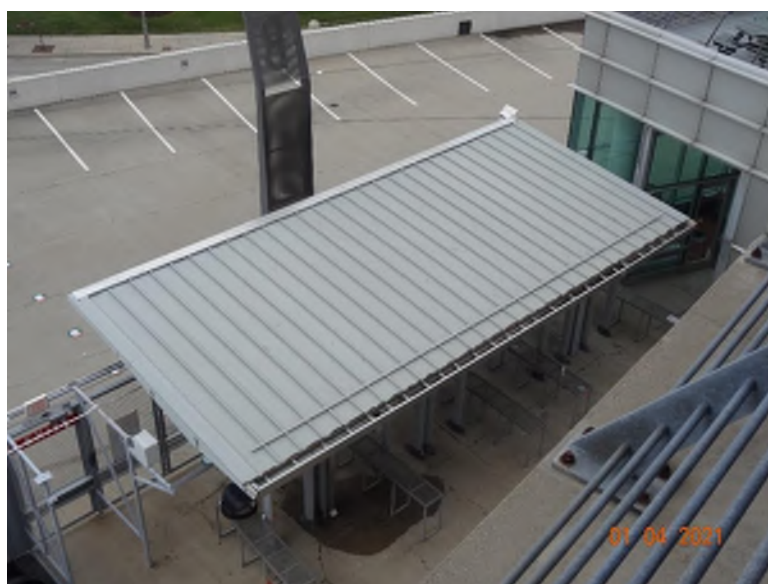
- Covered outdoor entry gates. These gate area roofs have a gutter along the lower edge and a single downspout that extends down one of the support columns.

Standing seam roof at gate

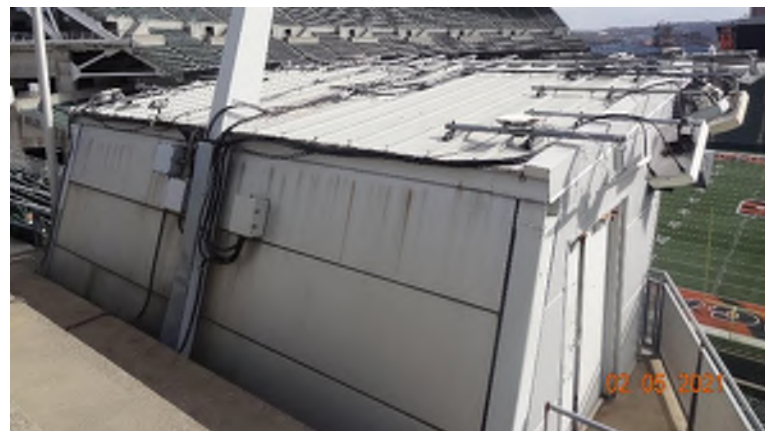
- The two small camera booth rooms on the north and west sides of the upper areas of stadium, within the seating bowl. These roofs do not have gutters so rainwater runs off the lower edge and onto the adjacent concrete seating areas. Not having gutters is not necessarily a problem in these areas considering that the entire area of the seating bowl is an outdoor exposure. It would be a problem if the concentration of rainwater flowing off the roofs caused leaks into the areas below. There is some rust along ends of the standing seams.

Camera booth roof, typical

1. Replace camera booth roofs.

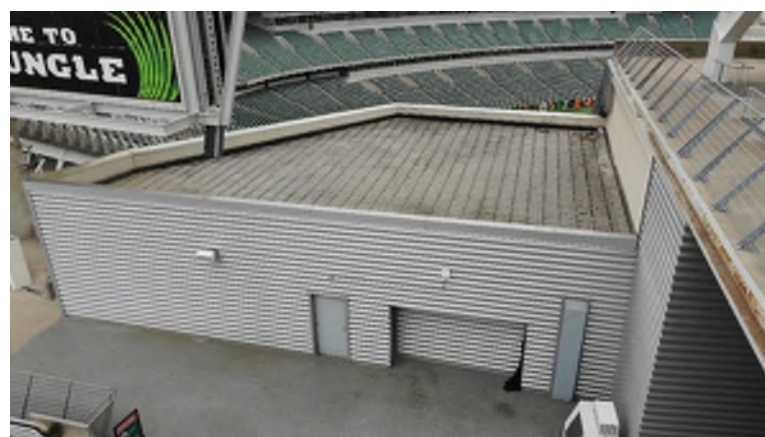
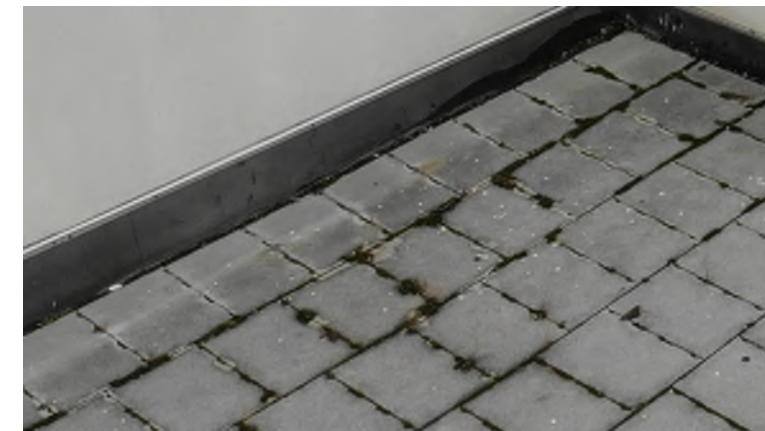
There is a roof area along the north-west areas of the 500 Level that has a single ply membrane roof protected by precast concrete pavers. The membrane extends up the parapet walls and terminates with a termination bar. There is no counterflashing to cover and protect the termination bar. No roof drains or scuppers are visible. The pavers appear to be wet in several locations and on the east side, there appears to be biological growth between and on the pavers. Further investigation is needed to determine the extent of moisture within the assembly.

Protected membrane roof

Close-up of protected membrane roof

1. Provide further investigation of the roof.
2. Replace the roof at the end of its service life.

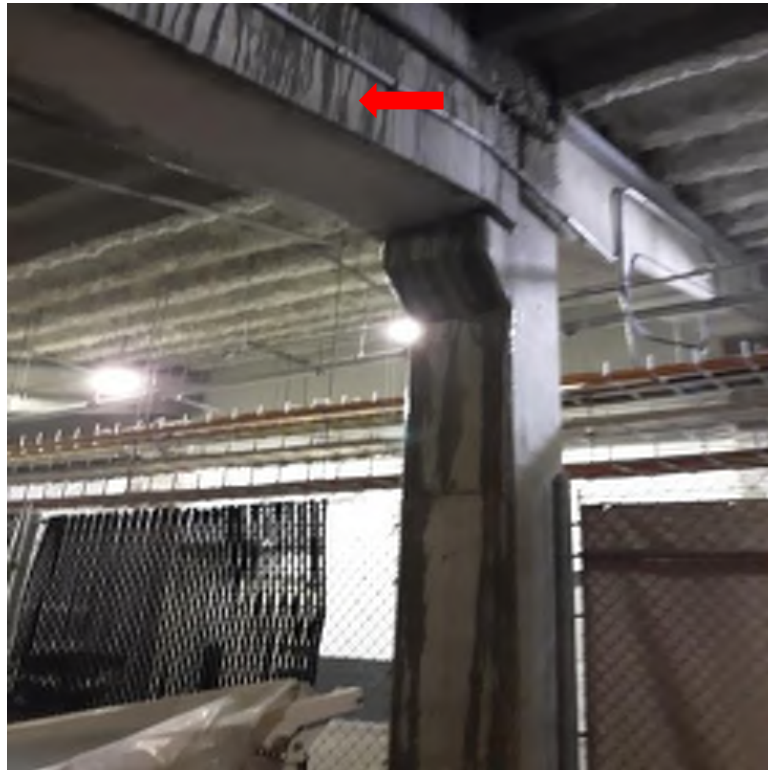
The lower level seating bowl, a precast concrete structure, is the ceiling / roof for the service tunnel. On the field level, leaks are prevalent along each column line and appear to be the result of leaking connections between the precast concrete supporting the seating above and the poured in place columns and beams supporting the precast sections. The horizontal joints between the sections of precast also appear to be leaking. Areas of sound attenuation blanket that were sprayed onto the underside of the concrete have fallen due to the leaks. The leaks have also damaged ceiling tiles and gypsum board ceilings. Every year, capital budget and maintenance budgets are appropriated for the sole purpose of ongoing proactive maintenance in the repair and replacement of vertical and horizontal sealant joints as well as concrete and waterproofing repair. Additionally, dedicated monies are used to replace the secondary gutter system at these locations.

Interior moisture damage – moisture on beam

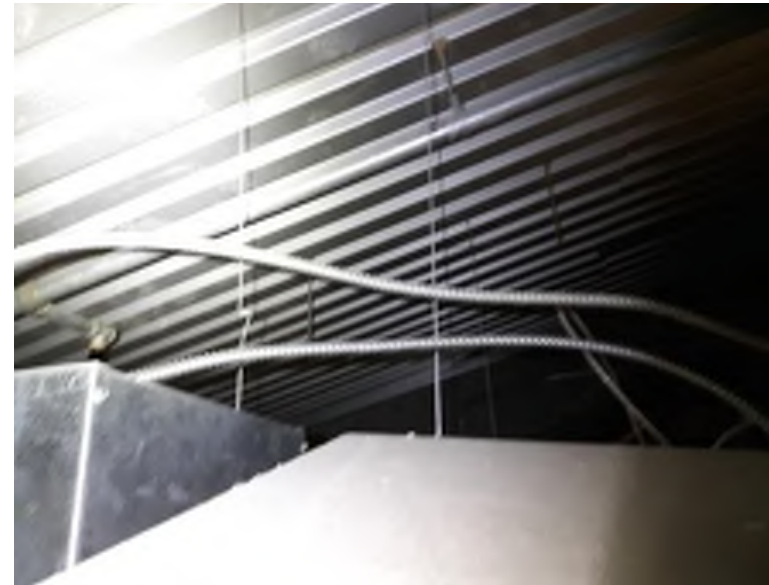
There are corrugated galvanized steel subroofs installed below the stadium seating areas in sections where finished interior spaces are located on the field level. These include but are not limited to an MRI clinic, X-Ray lab, lounge, the PBS Premium Patron Space, and maintenance office. The sub roofs appear to be in good condition except for the areas in the visiting teams' locker room. In this area, there are two large holes in the sub roofs attributed to a concentration of deicers, according to the maintenance staff.

Subroof conditions

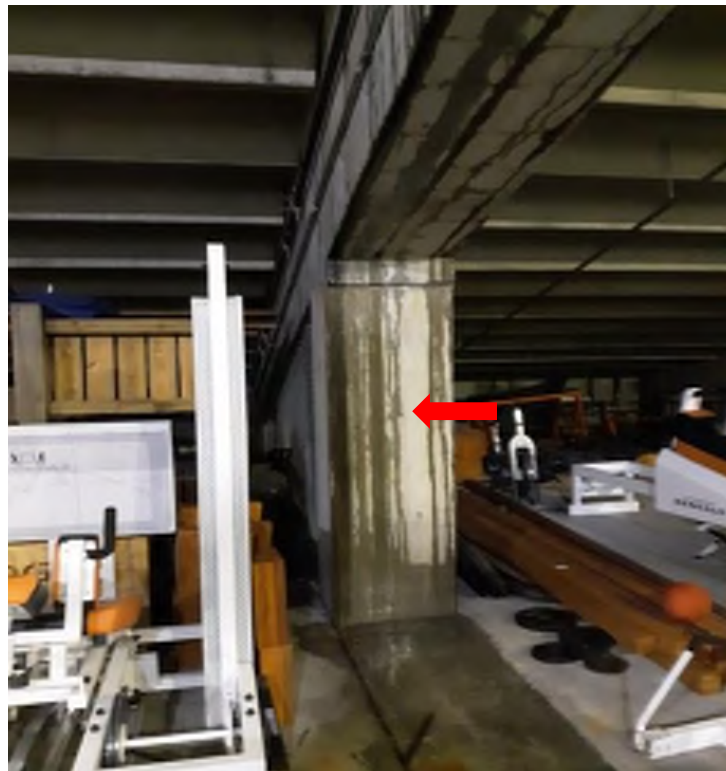
Interior moisture damage – moisture on column

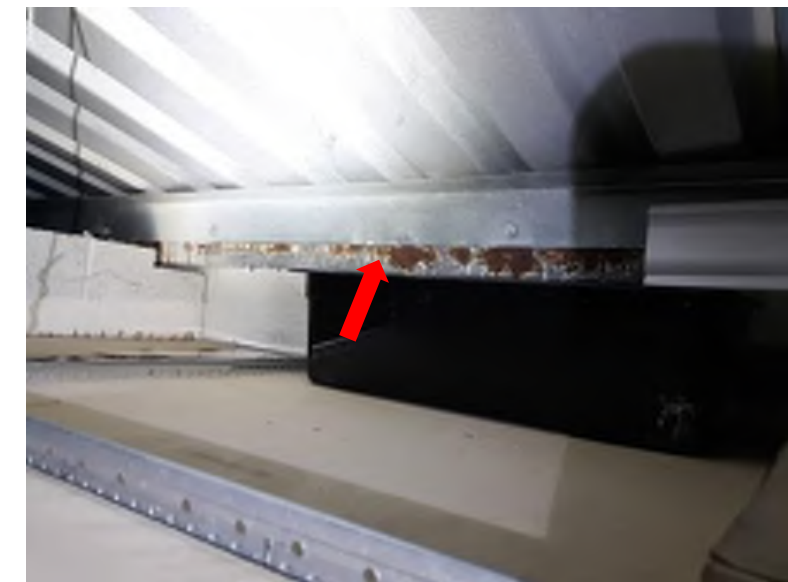
The subroofs drain into a series of galvanized gutters along the column lines closest to the field and are currently leaking in various areas throughout the service level. The leaking gutters have been reported to be a continual source of leaks since many are level and hold water laden with deicers that deteriorate the metal.

Rusting gutter

1. Line galvanized gutters with EPDM during gutter installation to protect from deicers.
2. Replace failing caulking above subroofs with new caulking.
3. Repair and coat existing concrete above subroofs with a pedestrian traffic coating.
4. Repair holes in sub roof with sections of galvanized steel decking with a matching profile including but not limited to:
 - a. Under 300 level in sector 1.
5. Flexible Epoxy injection for cracks where water is entering the structure including but not limited to:
 - a. Stair #3.08A at the 300 level landing.

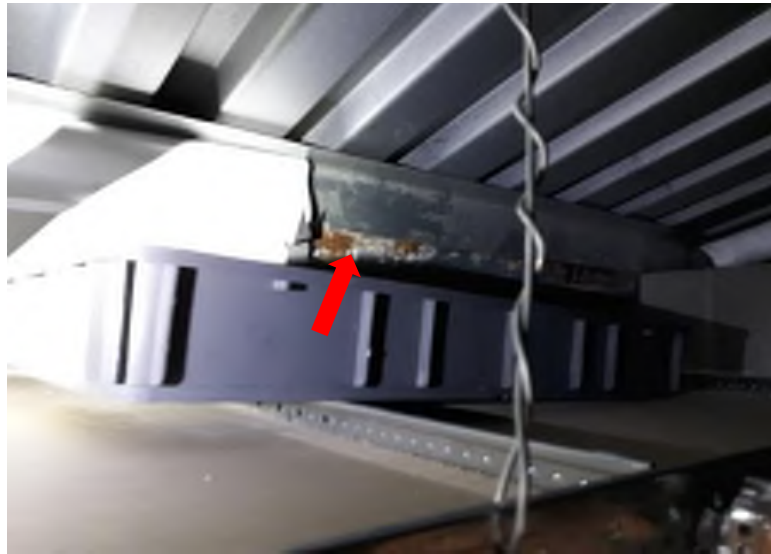
Rusting gutter

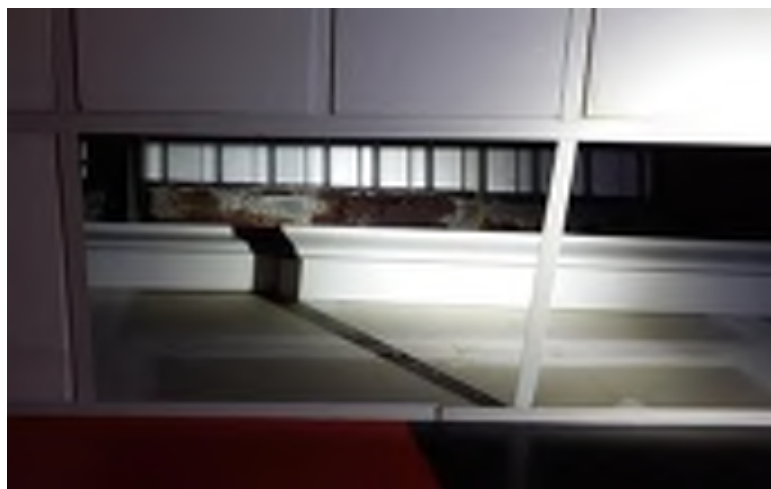
Leaks are also occurring due to the gutters failing at the end of the subroofs. These areas include the locker rooms, storage areas, mechanical spaces, Jack's Bar and Lounge by the Teams entry onto the field, maintenance work shops, MRI and team X-ray rooms.

Deteriorated gutter at end of subroof

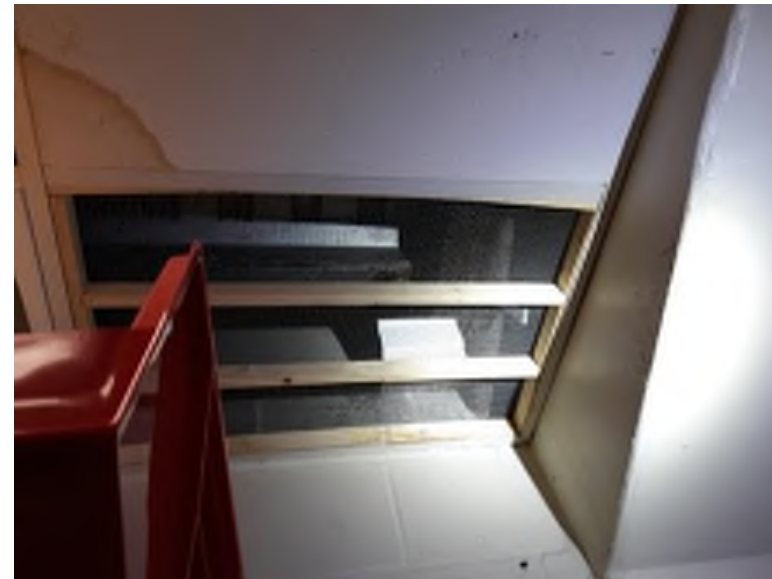
The maintenance staff has replaced the galvanized gutters with prefinished gutters above the ceilings in several areas. In the maintenance offices, where the leaks are almost constant, maintenance has given up replacing ceiling tiles and installed metal mesh supported by wood framing. The metal mesh catches falling sound insulation while allowing the water to flow freely into containers.

Wood frame with screen mesh. Note stain on ceiling tile.

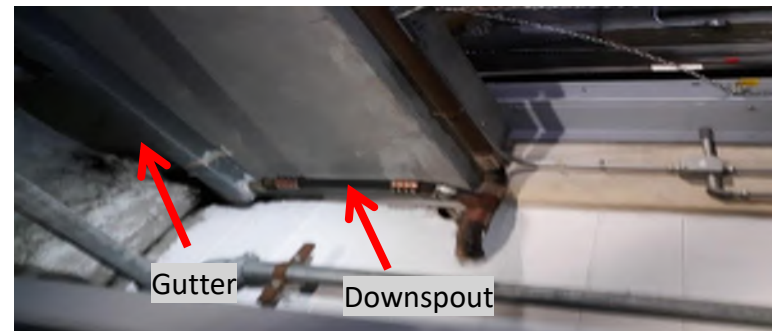
Gutter and downspout

The downspouts connected to the gutters are cast iron with no hub connections. The cast iron downspouts do not appear to be leaking in the accessible areas examined. The maintenance staff has reported that piping, collecting storm water from the subroofs, has been replaced due to cracks in the past. The damage to the piping appears to be a combination of water with de-icer chemicals, the diameter of the pipe and the flatness of some of the runs of piping. The smaller diameter of pipe does not allow for the water to expand when it freezes. The areas in the stadium where this piping is located is not heated which contributes to freezing pipes. The downspout piping also has few cleanouts.

In discussions with the maintenance staff, there is an ongoing gutter replacement effort where the deteriorated galvanized steel gutter is being replaced with new galvanized steel gutter lined with EPDM. The lining of the galvanized gutters is to counteract the effect of the deicers used extensively on the stadium.

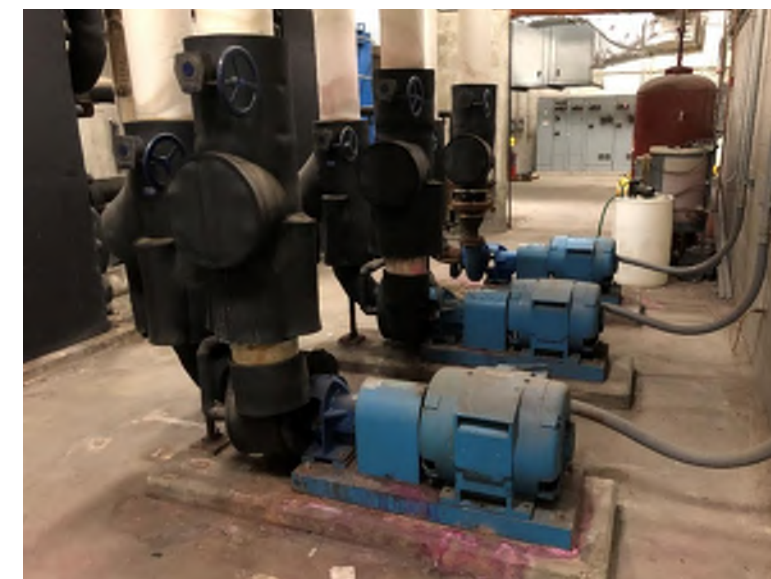
The heat exchangers and pumps are operating in good condition but are showing signs of wear. All 3 pumps have seals that are leaking, leaving glycol residue around the pumps and reducing pump performance.

Stadium chilled water pumps with glycol residue from seal leakage

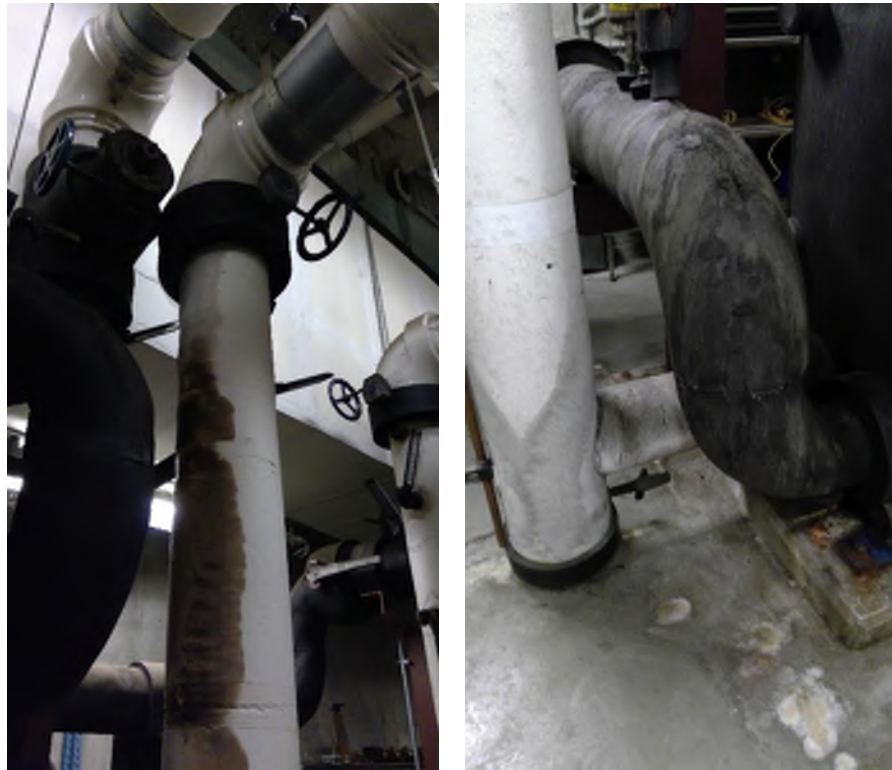
Pipe flanges at various points in the system are leaking. Chilled water that leaks from these flanges are creating mold in the pipe insulation, and possibly corroding the pipe below the insulation.

Pipe insulation mold and damage from water leakage at pipe flanges

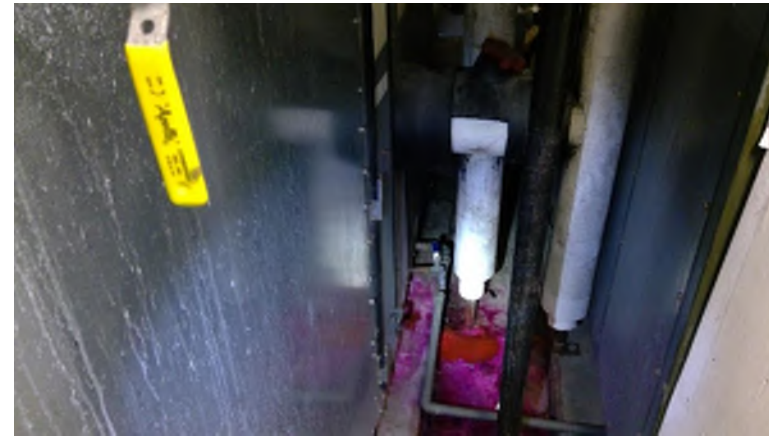
- AHU-S-2: Functions properly, but the chilled water control valve does not fully close. The maintenance staff must actuate isolation valves on the chilled water line to reduce flow through the chilled water coils when cooling demand is low. VFD and separate hot water coil introduced in 2014. Leak at chilled water coil connections causing corrosion and glycol residue. Hot water control valve functions properly.

Chilled water leak at AHU-S-2 coil connection

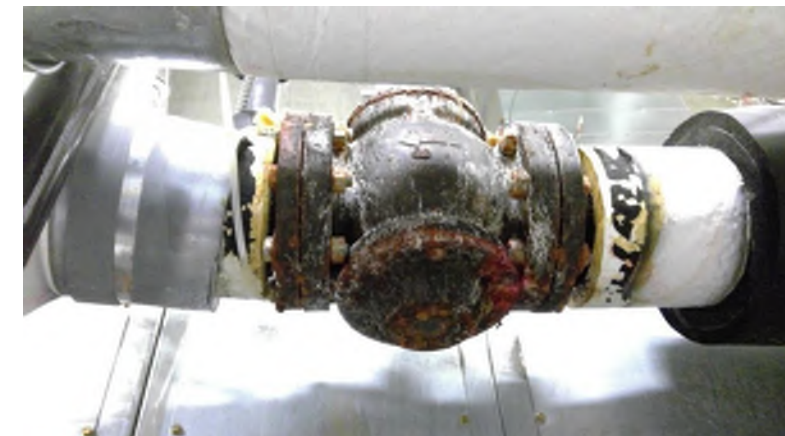
AHU-S-8 control valve corrosion.

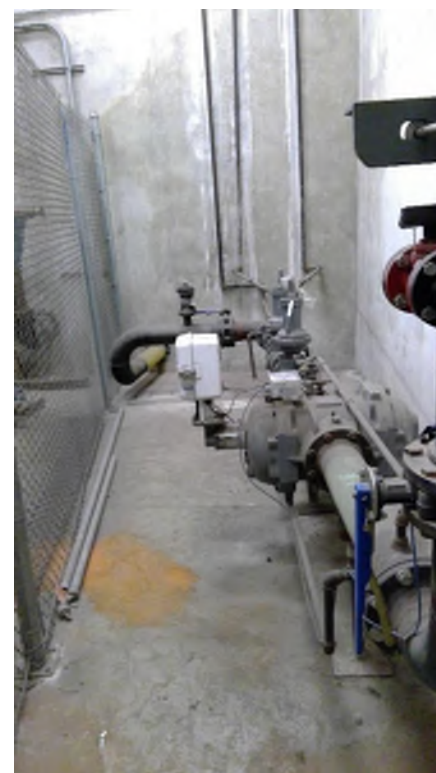
Natural gas enters the building in the North boiler room into a fenced area that separates it from the other building utilities. The piping and meters appear to operate properly.

Natural gas entry into building

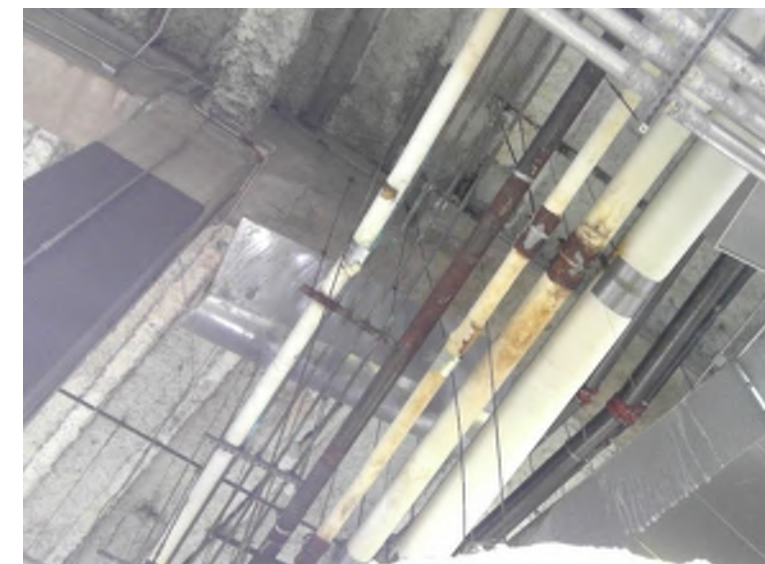
Where the natural gas pipe has encountered water on the outside of the pipe, corrosion is visible and sometimes extensive.

Natural gas pipeline corrosion due to water leakage onto pipe exterior. Damage to other exposed metal is evident, indicating external sources of water onto the pipe. Another indication of an external source is the white streaking down the duct shown in the lower right of the image.

The corrosion shown above is at the ceiling just outside of the chilled water mechanical room in sector 1 of the service level. The damage to pipe and duct in this room is extensive, where water from the ceiling has corroded pipe and duct throughout the room. Maintenance staff states that during heavy rainstorms, water leaks through the stadium structure throughout the stadium. Corrosion found in other areas indicates that this is the case. Below is an image of corroded garage exhaust duct that is close to the wall.

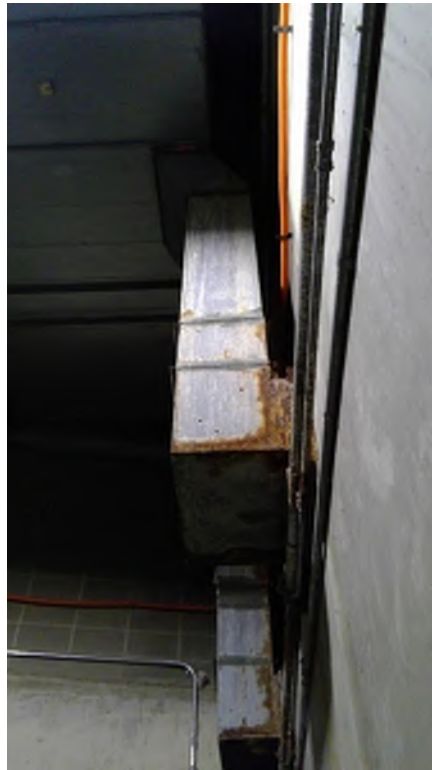
Corroded exhaust duct in sector 2 of the service level. Corrosion is external to the duct and close to areas with contact to the wall of the stadium.

Over time the external corrosion to pipe and duct from water leaking through the facility will cause leaks in the pipe and duct themselves.

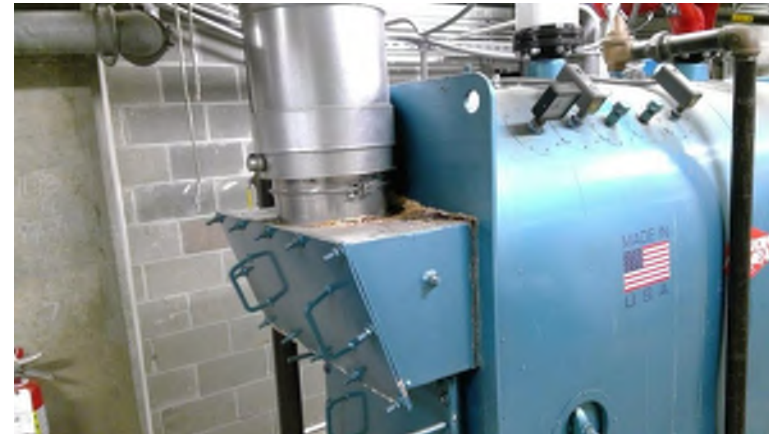
- The domestic hot water skid HWHX-3 that uses heat from the field heating boilers in Sector 11 has glycol leaks from the pump seals and at the heat exchanger connections.
- Corrosion and scale are accumulating on Boiler #3 in the South Boiler Room (Sector 8). The damage is minimal.

Corrosion to boiler and flue from water accumulation

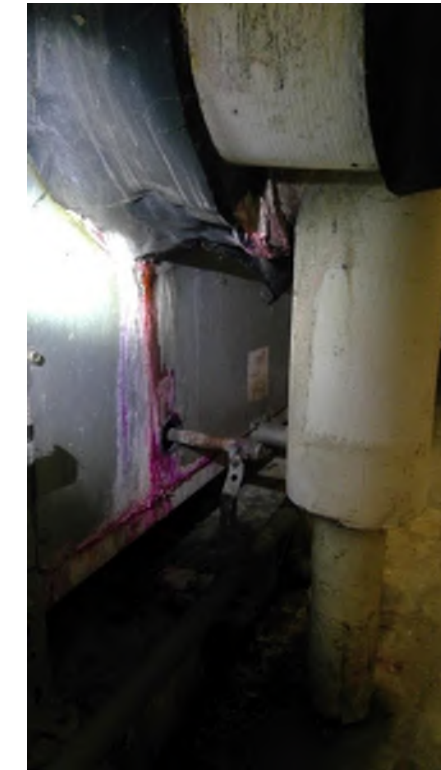
- AHU-P-1 (East): Functions properly, small leak at coil connection.

Leak at coil connection of AHU-P-1

1. AHU and VAV filters should be placed on a replacement schedule. VAVs should continue to be fixed/replaced as they break.
2. Both AHUs should have their CHWS/R pipe checked for corrosion under insulation at the coil connections. Extensive corrosion may require pipe replacements.

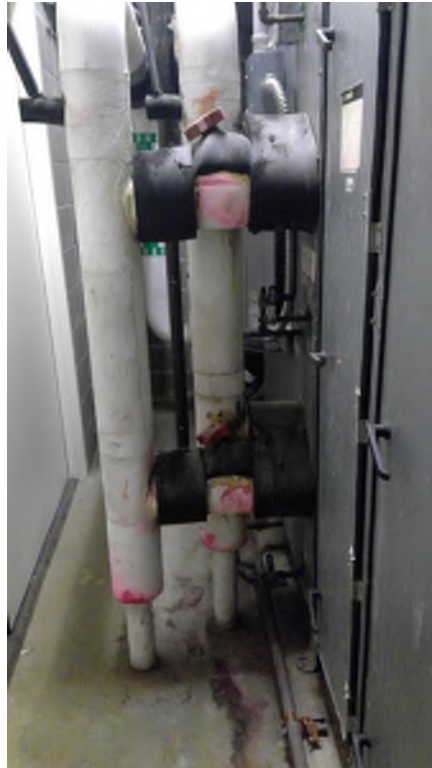
- AHU-P-2 (West): Functions properly, new control valve. Minor glycol leak from valve stems and minor insulation wear.

Minor insulation wear and glycol leak at coil connection of AHU-P-2

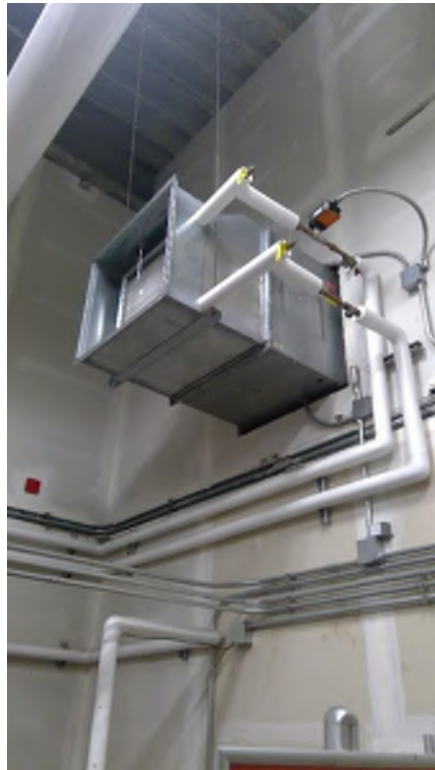
There is a fan coil unit (STX-US-1) combustion air fan appears to be off and may need to be recommissioned. Currently boilers use their supply fans to pull air from outside through a small transfer grille between the outside and the boiler room. Variations in air temperature and humidity decrease boiler efficiency.

Fan Coil Unit STX-US-1 inside the East boiler room

3. In the East and West Boiler rooms, replace the hot water pump seals and place on a regular checkup/maintenance schedule. Consider full pump replacement in 5-10 years.
4. Re-commission STX-US-1 and STX-US-2 for combustion air duty.

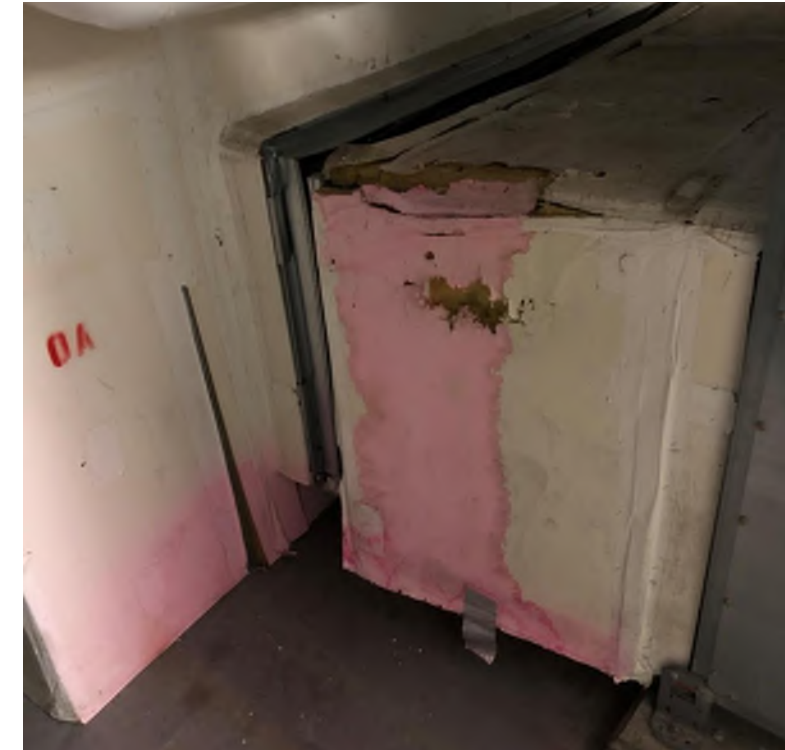
- AHU-UL-5: Proper function, no visible leaks, control valve replaced in 2014. There is duct insulation damage at the discharge air duct.

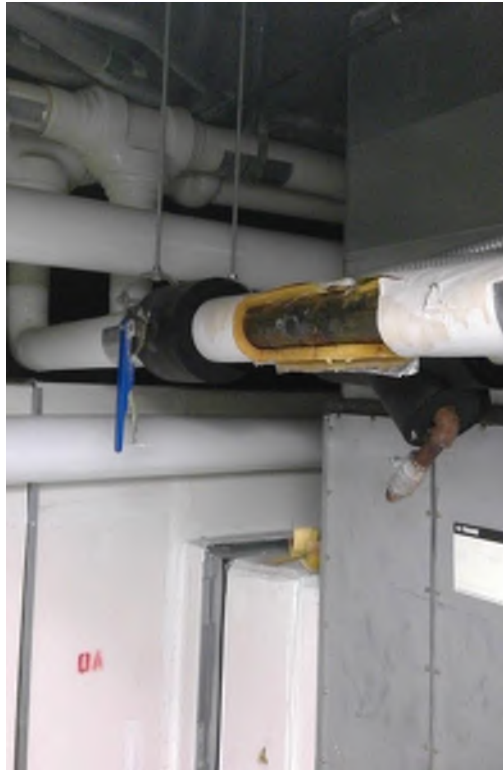
- AHU-UL-6: Does not function properly, no visible leaks, control valve replaced in 2014 and permits unmetered flow. Maintenance staff currently uses isolation butterfly valves to reduce flow through the coils. Runaway heating is felt in the spaces served during winter months.

Butterfly valve almost completely closed to reduce flow through AHU-UL-6.

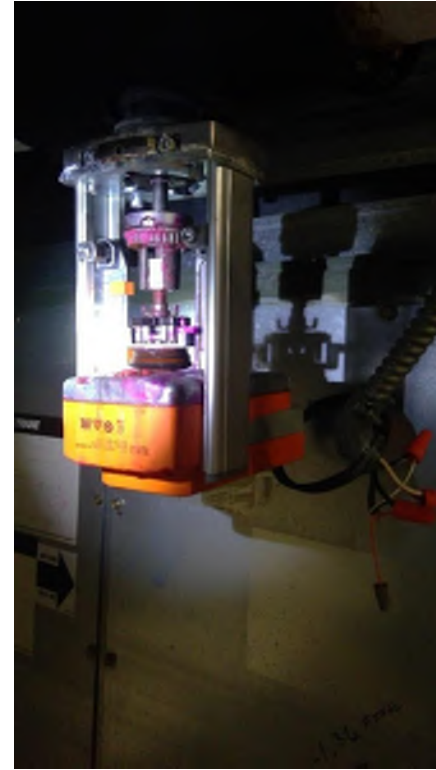
- AHU-UL-7: Proper function, control valve replaced in 2014 and leaks.
- AHU-UL-8: Proper function, control valve replaced in 2014; has significant leak collected in barrel. Insulation damage from leak is evident.

Major leak from control valve of AHU-UL-8

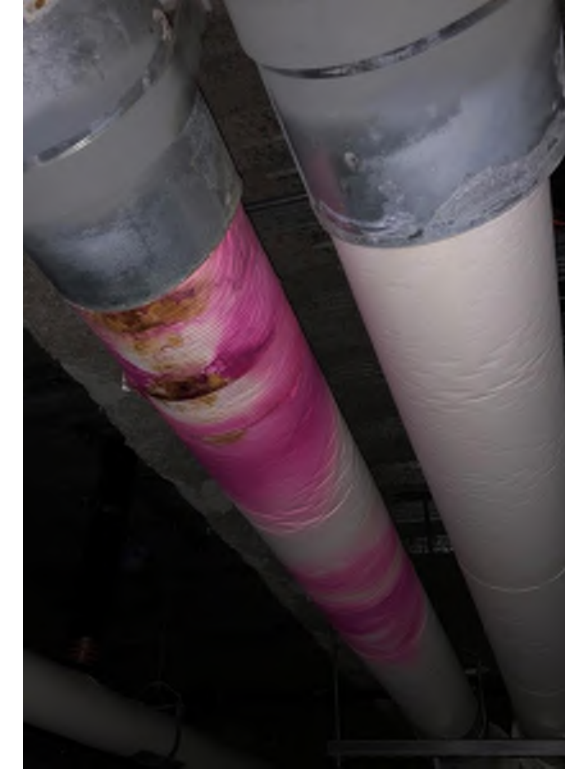
- AHU-UL-9: Proper function, no visible leaks, control valve replaced in 2014 and operates without issue.
- AHU-UL-10: Proper function, no visible leaks, control valve is original to building.
- AHU-UL-11: Proper function, control valve is original to building and leaks fluid from motor shaft.
- AHU-UL-12: Proper function, minor leak at coil connection, control valve is original to building and electronics are exposed.
- In the main dual temp coil serving the AHUs in Sector 8, there is evidence of a leak in the main.

Leak in the dual temp main in Mezzanine Sector 8. Rust coloring of insulation indicates possible pipe corrosion under insulation.

1. Leaks in water pipe mains should be addressed and corroded pipe should be replaced.
2. Exposed water pipe used for heating or cooling should be insulated and covered in a vapor barrier. Corroded pipe from exposure should be replaced.
3. Roof top units should be placed on a regular filter replacement schedule. As these units break over time, they should be replaced with units that utilize modern refrigerants.
