OVERVIEW & EXECUTIVE SUMMARY

Venue Solutions Group (VSG)[®] was engaged by Gensler Sports on behalf of Hamilton County and the Cincinnati Bengals to provide a comprehensive facility condition assessment of Paul Brown Stadium that benchmarks the current condition of the facility. As part of the assessment, VSG, in partnership with their consultant team, has developed a 20-year capital expense matrix to assist the owner in establishing priorities for major repairs, potential upgrades and maintaining the facility in a professional manner. The ability to plan and maintain the stadium as it transitions from years 18 to 30 is crucial in extending the life of the facility as well as its relevance in the competitive and ever evolving regional and national marketplace. In addition to the facility assessment, VSG has also provided information related to the practice field, bowl cleaning and event-day trash removal.

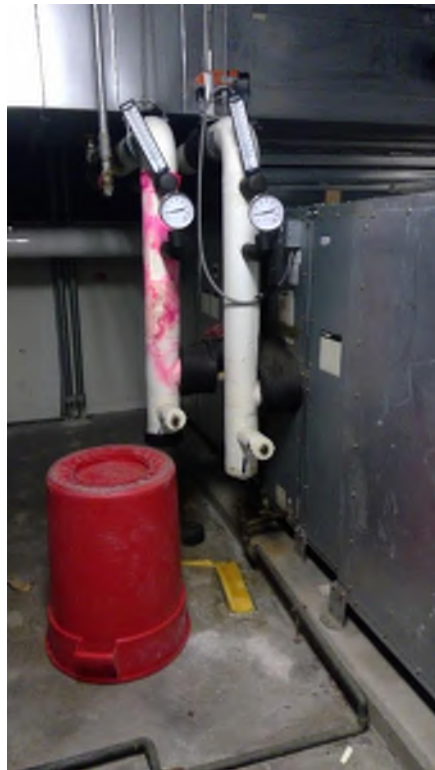
- AHU-UL-13: Proper function with new control valve. There is a leak at one pressure gauge connection.
- AHU-UL-14: Proper function with new control valve. Y-strainer is leaking.
- AHU-UL-15: Proper function with new control valve. Y-strainer is corroded and leaks glycol onto floor.
- AHU-UL-16: Proper function with new control valve, leak in pipe riser at coil connection.

Leak in pipe riser at coil connection of AHU-UL-16

Damage to insulation may reduce heat transfer resistance. Pipe corrosion due to water leaks will eventually lead to local pipe failure.

1. Leaks in water pipe mains should be addressed and corroded pipe should be replaced.
2. Exposed water pipe used for heating or cooling should be insulated and covered in a vapor barrier. Corroded pipe from exposure should be replaced.
3. Roof top units should be placed on a regular filter replacement schedule. As these units break over time, they should be replaced with units that utilize modern refrigerants.

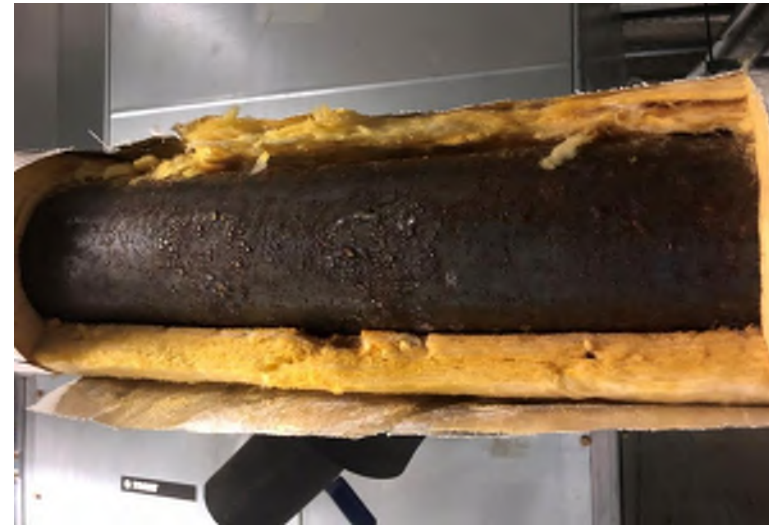
In all AHU branch lines, a segment of insulation has been cut away for presumably testing purposes and has not been replaced.

Pipe corrosion due to missing insulation and vapor barrier. Water is condensing out of the air onto the pipe. Water will cause corrosion of the pipe over time.

All piping should be reinsulated to preserve pipe longevity and energy savings.

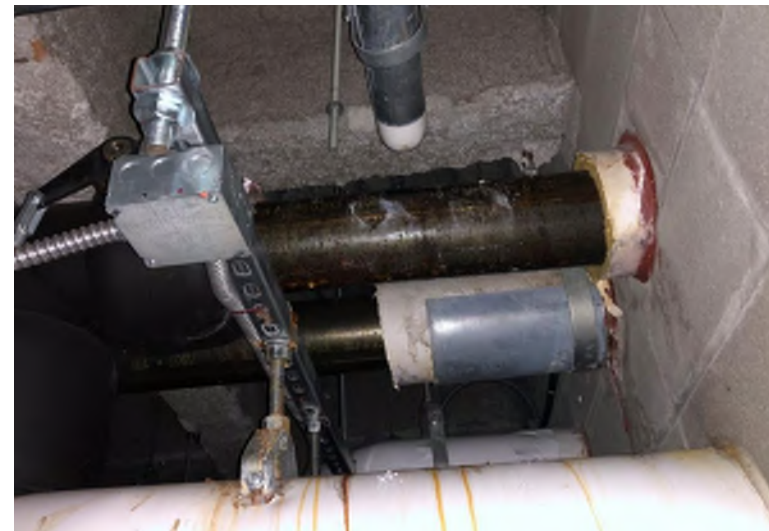
Exposed pipe in dual temp main in mezzanine in sector 5.

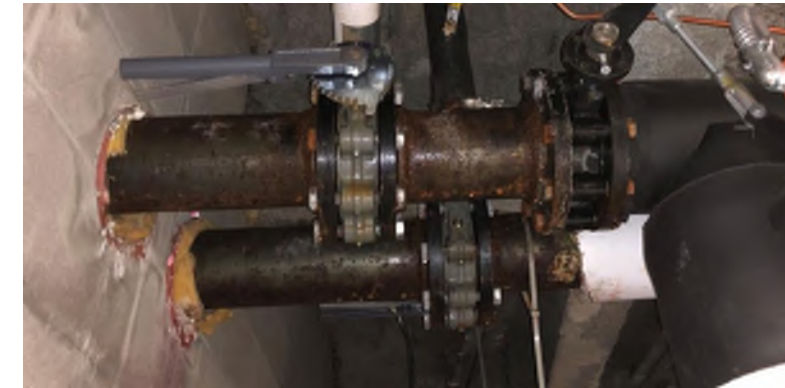
Exposed pipe and valve flanges in dual temp main in mezzanine in sector 8.

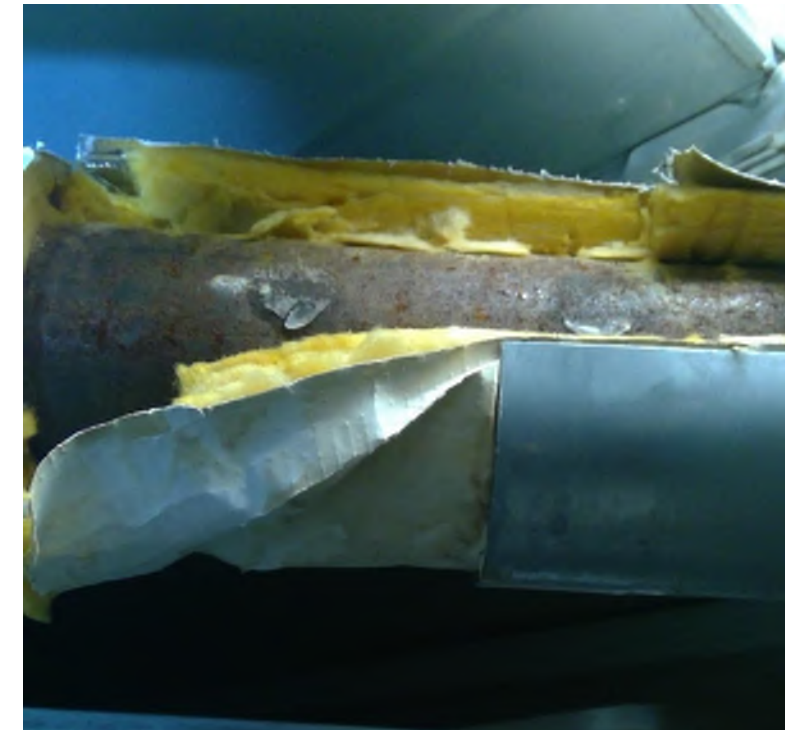
Pipe corrosion due to missing insulation and vapor barrier

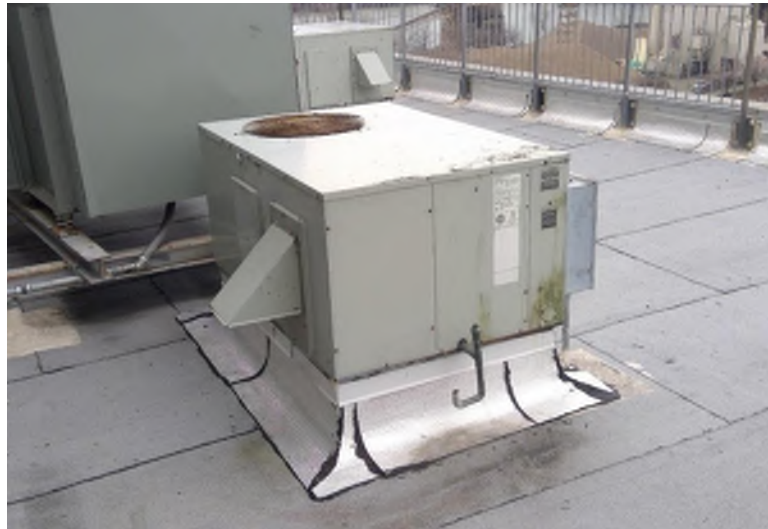
There are 8 roof top units that supply conditioned air to the offices and concessions on the upper concourse. These units are original to the facility, have their filters replaced at least once per year, and have parts replaced upon failure. The units utilize R-22 and should be replaced via an acceptable phaseout replacement schedule.

RTU on roof in upper concourse

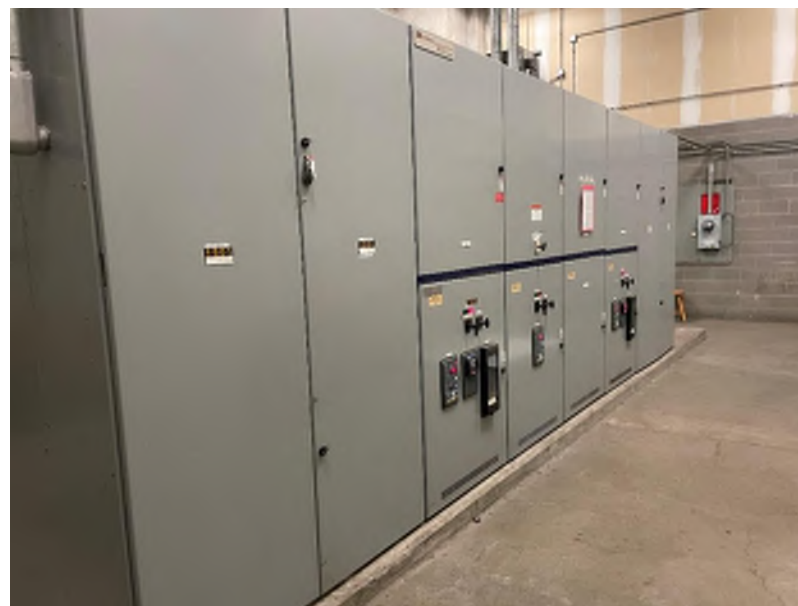
The 15kV medium-voltage service entrance circuits are terminated to a main-tie-main service entrance switchboard with power circuit breakers as well as metering equipment for both the utility (entrance side) and facility (customer side). This switchgear is in good visual inspection condition and manufactured by Eaton / Cutler-Hammer.

Medium-voltage service entrance main-tie-main and metering

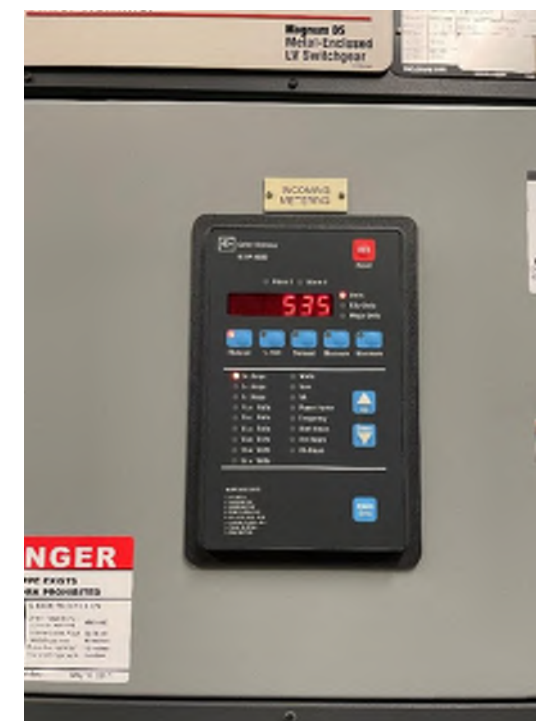
Metering is on incoming secondary only and displays instantaneous, demand, and peak loading along with power factor and power quality data for frequency and distortion.

Typical substation main meter

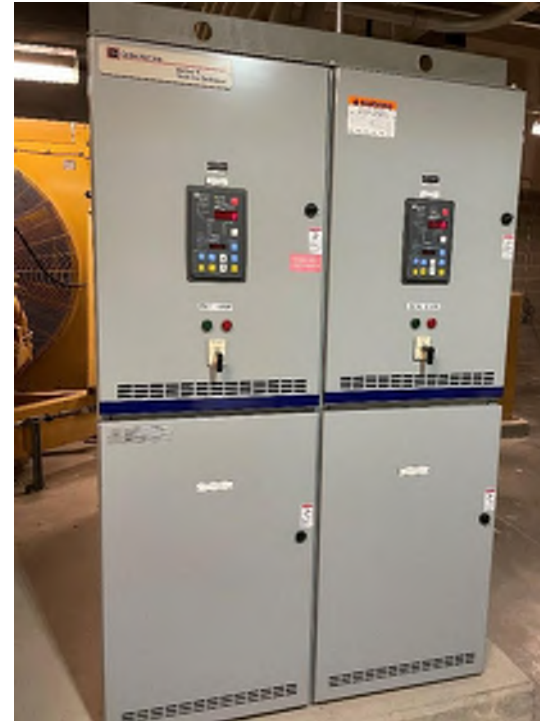
Generator distribution breakers to substations and fire pump

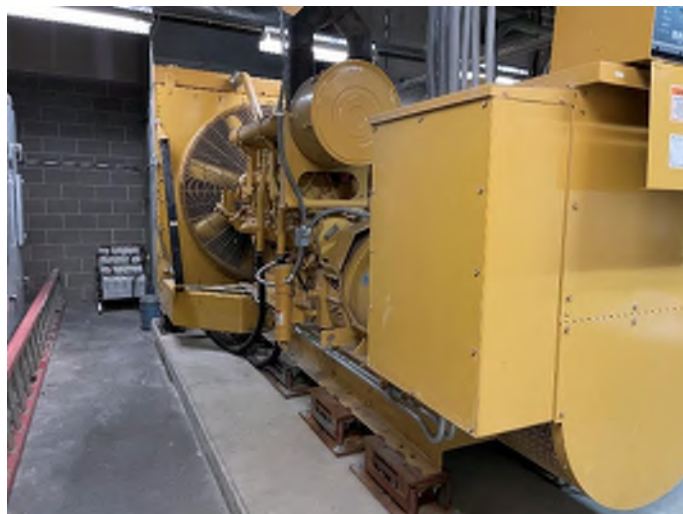
The generator itself is in good condition and is maintained by a service company. One known issue is that the controller for the generator is obsolete and cannot be replaced but will need an upgrade. This work should be prioritized to prevent an extended delay in restoration of emergency power should the controller fail.

1500kW generator

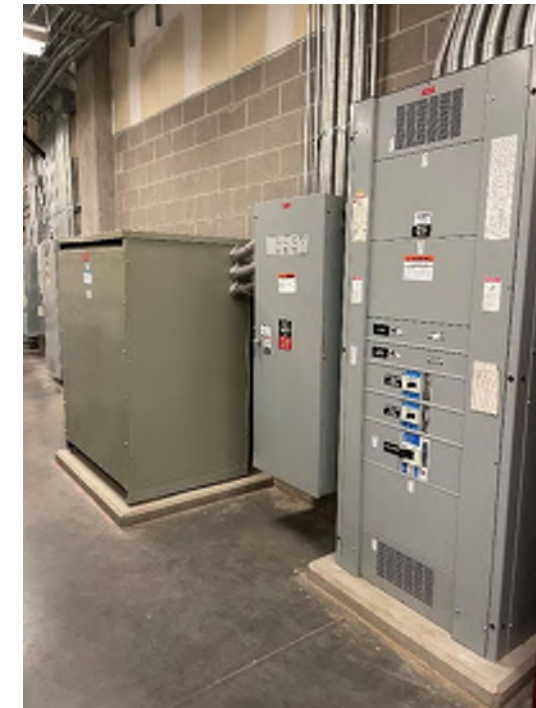
Typical emergency transformer, ATS, and distribution panel

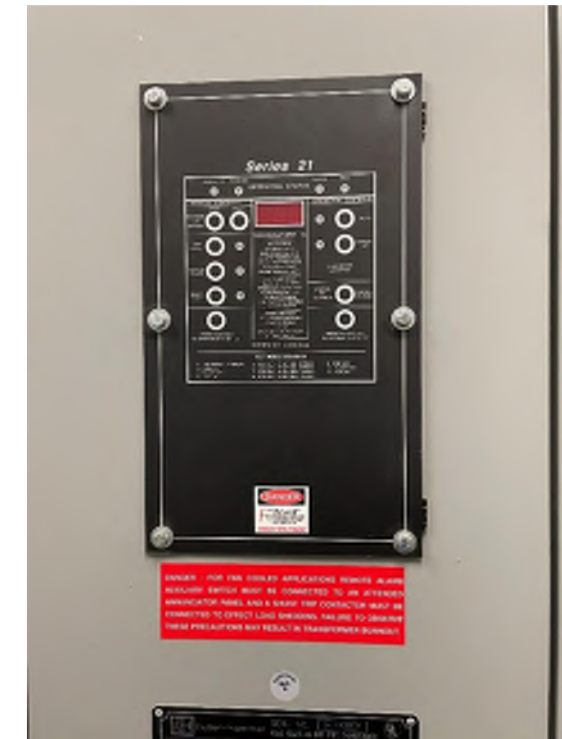
Non-functioning substation transformer cooling controls

4. Commission substation transformer cooling systems. These fans and controllers were never wired at original construction. The relatively low loading on the substations have made this a lower priority issue but summer temps can be high in these rooms and cooling will ensure a longer life.

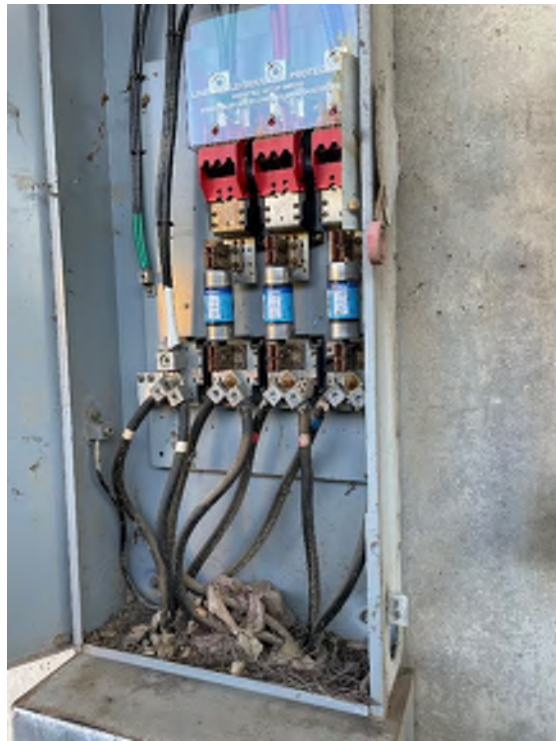
1. Approximately six (6) exterior boxes for media trucks, of varying ampacities, should be cleaned, tested, and replaced when in poor condition. Visual inspection shows gutters with debris but adequately maintained mechanical connections and operators.

Exterior broadcast truck power panel with debris and uncovered openings

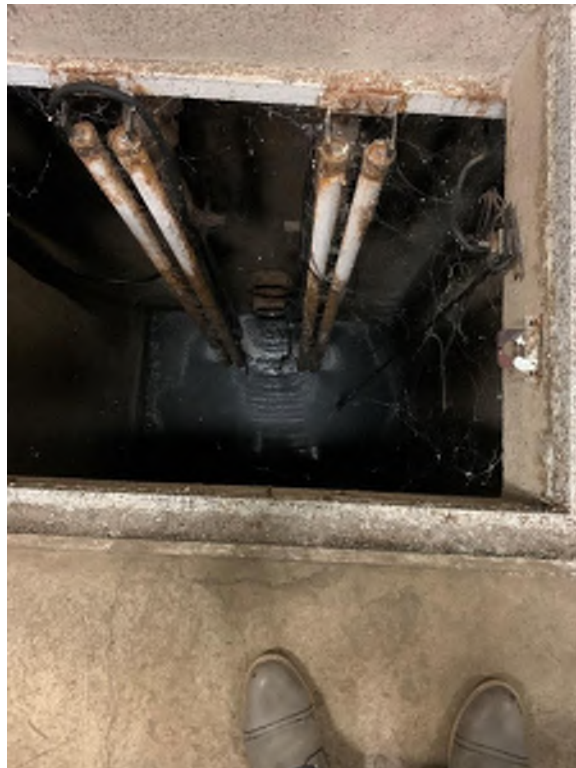
1. Sewage Pumps (approx. 7' x 7' x 16') are in the North and South MER. The sewage pumps and lift rails are original while the controls have been upgraded. The equipment appears to be working but the sequence of operation of the upgraded controls is uncertain. Recommissioning/Training is required.

Rusted sewage pump rails

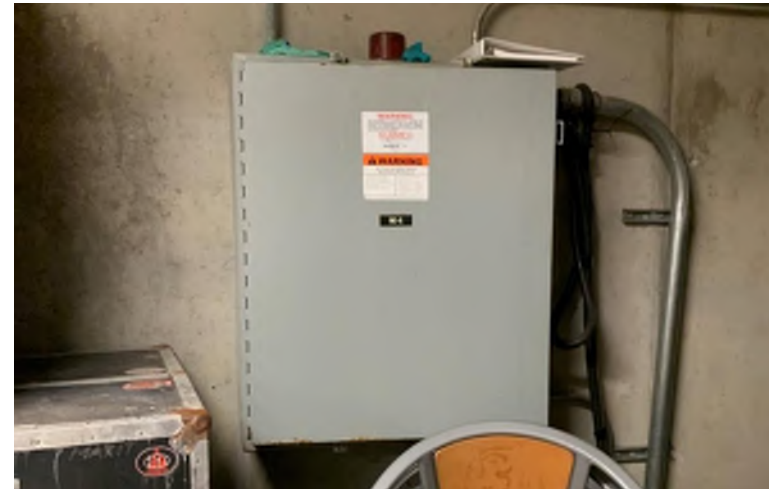
Sewage pump control panel

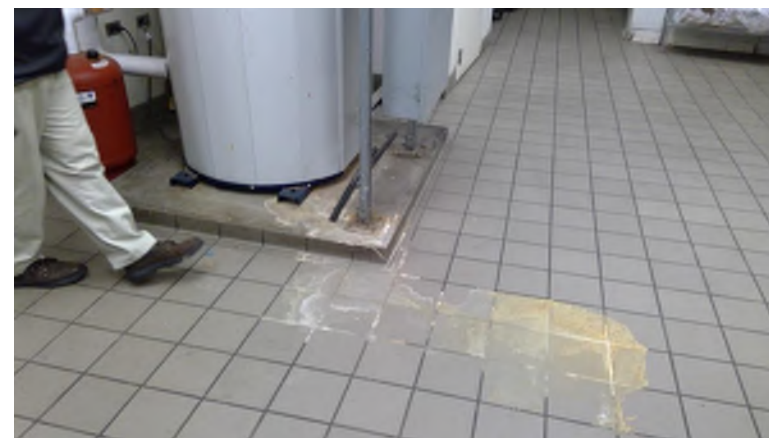
1. North and South Domestic Storage Tanks were replaced in 2017 and 2018 and appear to be in good working order. The staff indicated there are water quality issues with the existing system; a water filtration system may be required and is discussed in the recommendations section.
2. Main kitchen water heaters are in need of repair or replacement. Heaters in both kitchens show corrosion around the bottom and water leaking out. Both heaters were replaced in 2017.

Main kitchen water heater

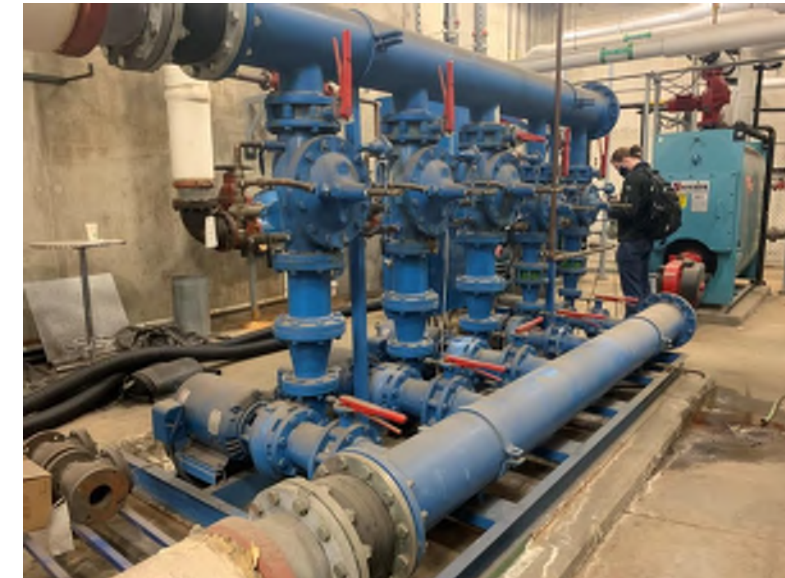
1. North and South stadium domestic water booster pumps, controls, and valves are original.
 - a. The PRV's show evidence of leaking, indicating failing seals.
 - b. One pump/motor appears to be running poorly.

Domestic water pumps

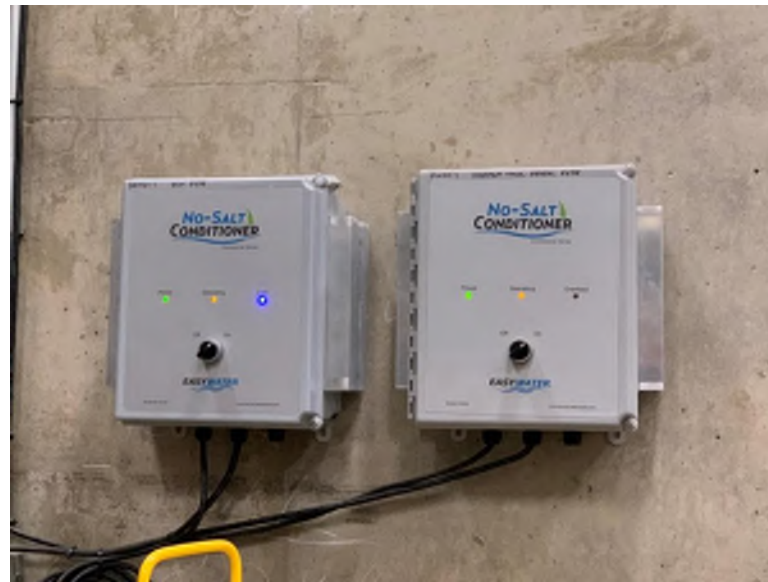
1. During the 2014 water heating upgrade, it was discovered that the original water softeners were no longer in operation.
 - a. A new chemical free No-Salt water conditioner was installed on both domestic hot water heating plants via the cold-water inlet to the domestic hot water system.
 - b. There is concern that the No-Salt system is not working but a recent water quality study indicated the film coating the HTX plates was zinc based, not typical water scale. The interior of the glass lined domestic water storage tank appeared to be clean. Further investigation is needed to resolve this issue, but our current belief is that water filtration may be needed to remove the residue permanently. See domestic water recommendation later in this report.

Water conditioners

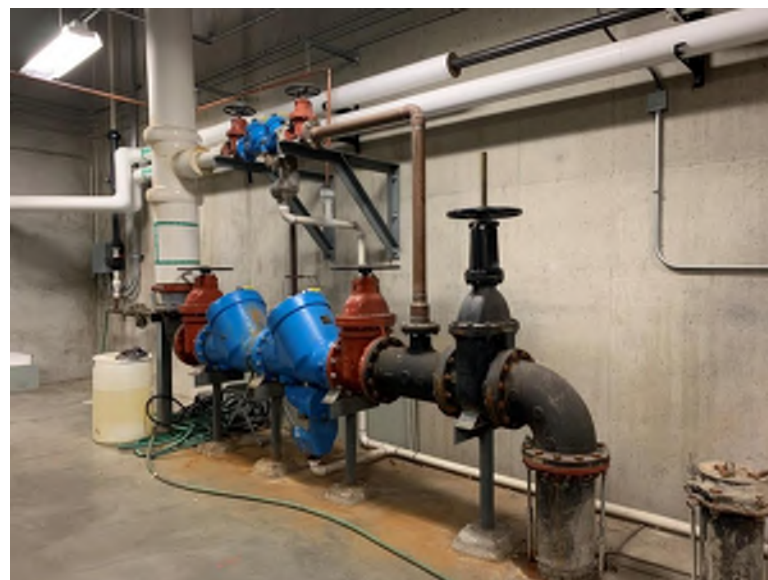
1. Building city water backflow preventers were rebuilt in 2019. Valve internals were replaced with plastic parts.
 - a. The BFP's are tested on annually consistent with the Greater Cincinnati Water Works GCWW requirements.

Building backflow preventer (Rebuilt in 2019)

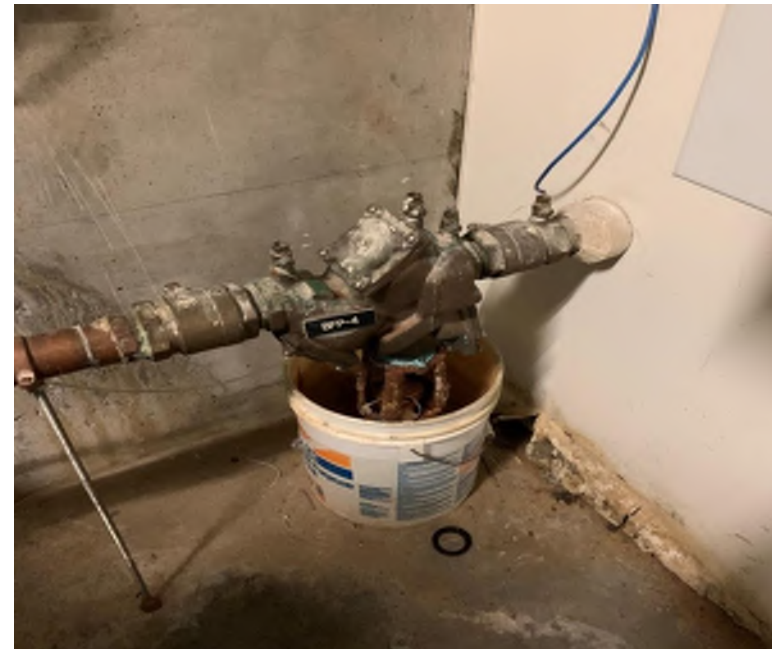
2. Irrigation backflow preventer (BFP-4) currently discharged into a bucket.
 - a. Check seals and repair BFP.

Irrigation backflow preventer

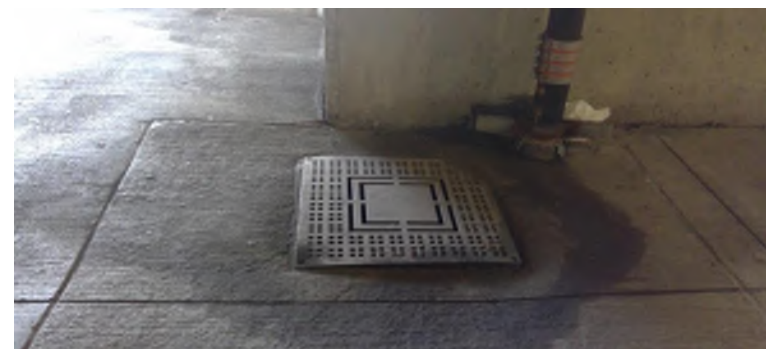
1. Floor drains, throughout the stadium, were generally in good condition.
 - a. Some grate covers were rusted and collecting debris and should be cleaned to correct water flow.
 - b. In a few location concourse area drains are "bulged" from water collecting and freezing under the grate. These conditions should be fixed to prevent tripping and encourage proper drainage.

Bulged concourse drain cover

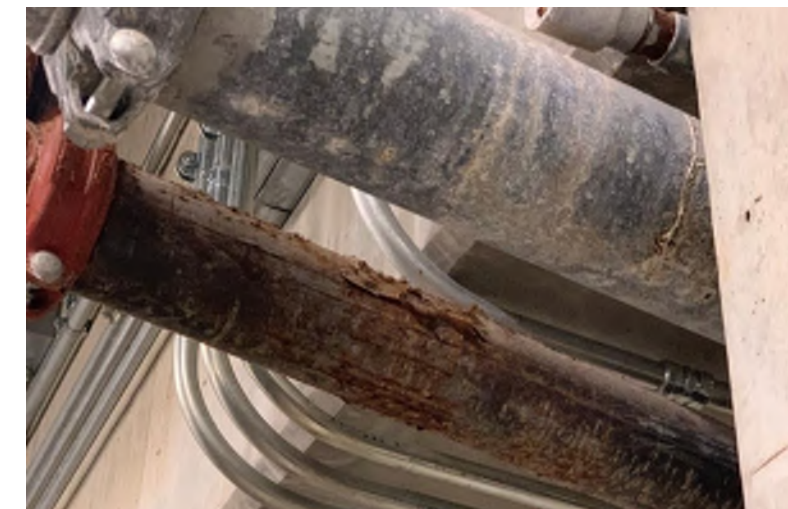
- a. In general, the sanitary, storm, waste, and vent piping is in acceptable condition and will last another 20 years in the stadium. Exceptions to this condition are listed below with examples.
- b. In areas where the piping was exposed to moisture or leaks, the piping had surface rust present as seen in the image below. As this piping was observed from the ground, the extent of the top rust could not be determined.
- c. There have been cases reported where sanitary piping has ruptured along the top of the pipe causing sewage to overflow out of the pipe during peak usage. We believe that this may be due to "super flush" conditions inside the stadium causing higher than design flows in the sanitary piping.
 - a. The pipe size can be recalculated for super flush conditions reducing diversity and increasing pipe size - this would alleviate this issue.

Rusted steel piping (Fire Line)

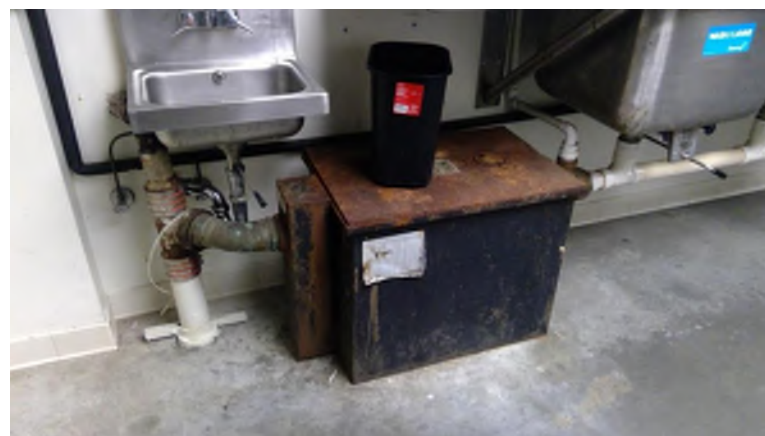
1. Over time or due to freezing, some water pipes have failed, been capped, abandoned, and rerouted causing dead legs in the system.
 - a. All of this piping is served from the floor below, fed-up through the floor into walls or piping chases that have walls in common with exterior unconditioned space.
 - b. Due to capped and abandoned lines it has become a challenge to shut-off and turn on water to these areas not knowing which valve serves active, broken or abandoned lines.
2. Water is seeping between floor slab and drains during wash down/clean-up of the areas leaking into spaces below.
3. Floor mounted grease interceptors, the basins of all the grease interceptors show major deteriorated and rust. Many have completely rusted through and grease latent water is present on the floor under the interceptors.

Floor mounted grease interceptor

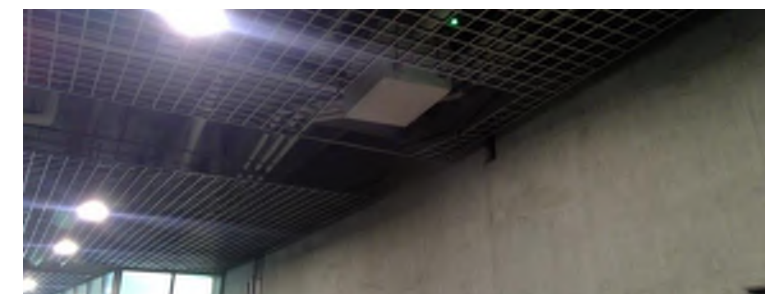
maintenance of the device. The interceptor is located approximately 40 feet above grade. The ceiling was cut open to allow access to the interceptor, but the opening was not cut large enough to allow access to the top of the device.

Suspended grease interceptor

- b. The interceptor was installed directly below the existing floor opening. It is recommended that the floor above be cut open, side extensions installed on the interceptor and a metal hatch installed to give access to the top of the device.

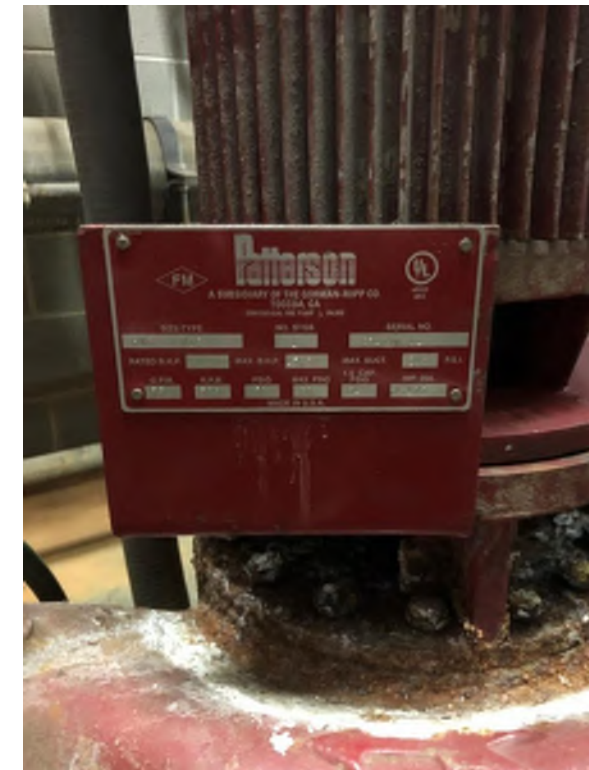
1. The fire pump located in this room is a Patterson Pump Co., Model 6 x 6 VIP, Serial No. FP-C-19644, 750 GPM, 70 PSI, 40 HP, vertical In-line pump with a 7.125" Impeller. The jockey fire pump is a Grundfos Model No. CR2-5OU rated for 10 GPM and 80 PSI. Both appliances are 460V/3PH. The pumps appear to be in good working order and are tested monthly and inspected annually. The main fire pump shows signs of having a bad seal that was repaired in the past, a fire pump replacement should be considered in the future.

Fire Pump with repaired bad seal.

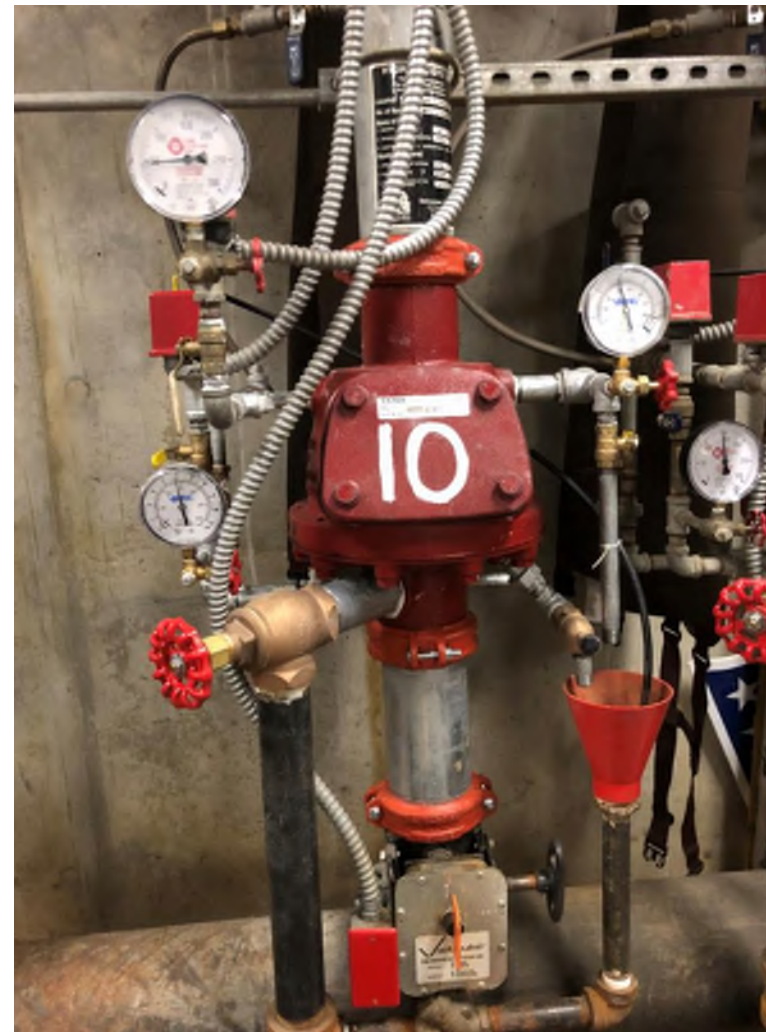
1. Wet and Dry system risers Sector 5 1-11 are in this room and in general serve the Service Level, SE stadium zones, parking garage, and ramps.
2. Coverage for these zones varies from 0.10 GPM/SF over 1950 SF to 0.15 GPM/SF over 1950 SF with a 250 GPM hose allowance.
3. Two air compressors provide air to the dry system valves in this room and appear to be in good working order. The newer air compressor is rated for 5.5 SCFM at 90 PSI with a 30-gallon reserve tank.
4. All equipment appears to be in good working order at this time, although it appears that two dry valves have been previously replaced (#10 and #11).

Replacement dry valve with new gauges and trim.

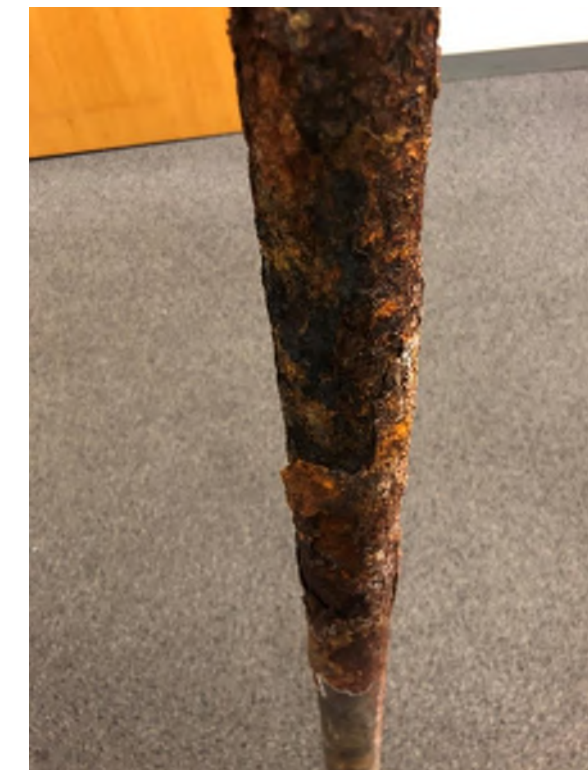
The weight room renovation from 2014 & 2015 converted a large storage room into the new Bengals Weight Room. The renovation extended and modified the existing wet sprinkler system in this area to new sprinkler heads and layout with piping above new ceilings which included integral drain pans that directed water infiltration to the side walls and down to grade. The piping above this ceiling is subject to degradation in this space from the water infiltration and it is hard to find until a leak occurs as it is hidden from sight. The pipe below was from a recent replacement. Other failures may continue to occur until leak remediation is complete.

Sprinkler pipe removed and replaced above Bengals Weight Room.

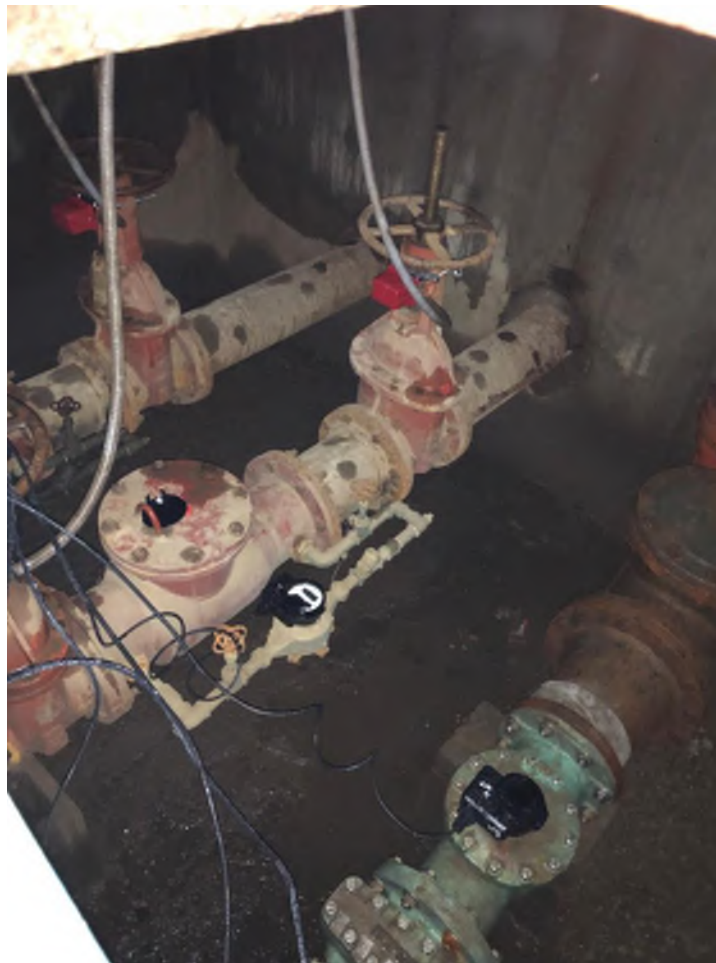
1. Fire Pits are located on grade and appear to be in acceptable condition. They are damp and muddy, but no standing water is on the bottom of the pit.
2. In the past, floods have shorted out water-resistant tamper switches which have been replaced.
3. It appears that remote meter readers have been installed on the city water and fire protection meters. Cabling should be strapped together and moved out of the way of ingress and egress for better access and protect the cabling from damage in the future.

Fire pit remote meters & cables

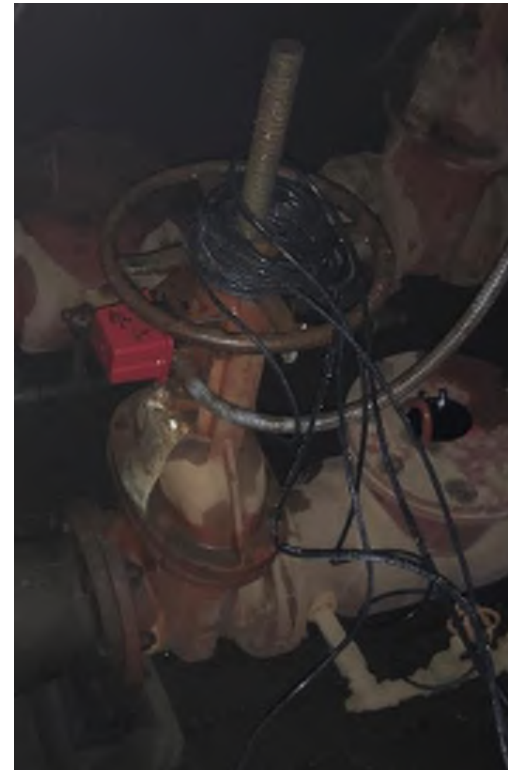
Fire pit remote meters & cables

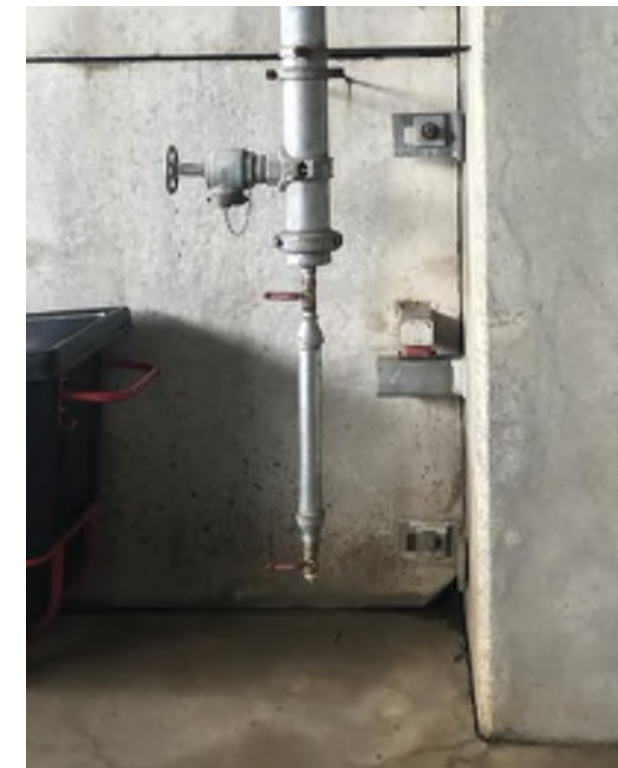
Upper ball valve should be opened on dry system drains.

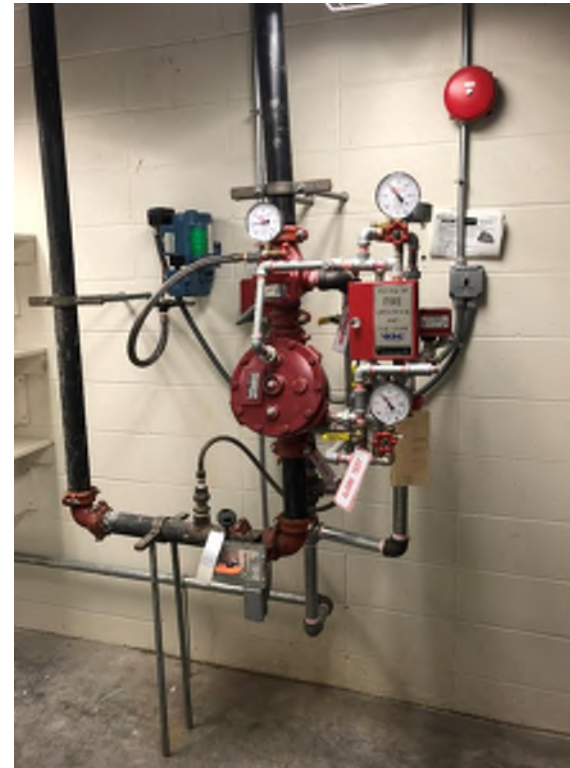
1. The Scoreboard Control Rooms (Video Production and Scoreboard Control) are protected by a Pre-Action Fire Suppression system installed by Fyr-Fyter in 2000. The system consists of the following equipment:
 - a. (2) Pull Stations.
 - b. (1) Alarm Bell
 - c. (1) Alarm Horn Strobe
 - d. (6) Detectors
 - e. (1) AutoPulse 442-D Control Panel.
2. The Sequence of Operations for the Pre-Action system operates as follows:
 - a. A single detector sounds the alarm bell and sends a signal to the fire alarm panel.
 - b. A second detector in an opposite zone will sound the horn/strobe and open the pre-action valve.
 - c. A manual pull will immediately open the pre-action valve, send an alarm signal, and sound the horn/strobe.
3. The system is inspected annually.

4. The system is well maintained and in good working order and does not require upgrade or replacement at this time. System pressure logged at 100 PSIG water and 50 PSIG air side.

Pre-Action System & Air Compressor

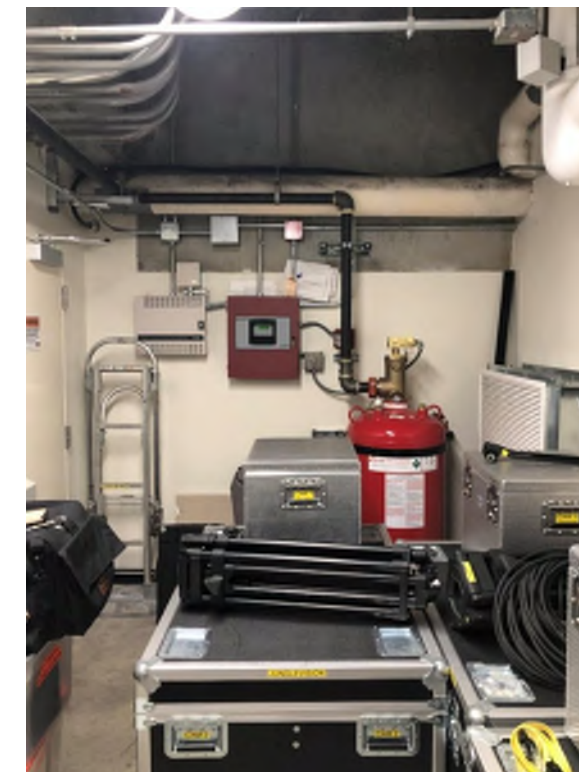
1. A new room for high-end audio-visual equipment associated with Jungle Vision was built in 2014 from open concourse adjacent to the Jungle Vision room.
2. The dry sprinklers in this area were rerouted to provide space for a Clean Agent system installed in the Rack Room.
3. The Clean Agent System is an FM-200 system and includes the following equipment:
 - a. (1) Notifier - Fire Alarm Control Panel RP-2002.
 - b. (11) Photoelectric smoke detectors
 - c. (2) Alarm bells
 - d. (6) Horn strobes indoor, (1) outdoor
 - e. (2) Abort stations
 - f. (2) Pull stations
 - g. (1) 600 lbs. of FM-200 Clean Agent stored in a single tank
4. The system is well-maintained and appears new although the room that hosts the equipment has collected equipment in front of the FACP and should be de-cluttered.

Clean Agent Storage Room Clearances

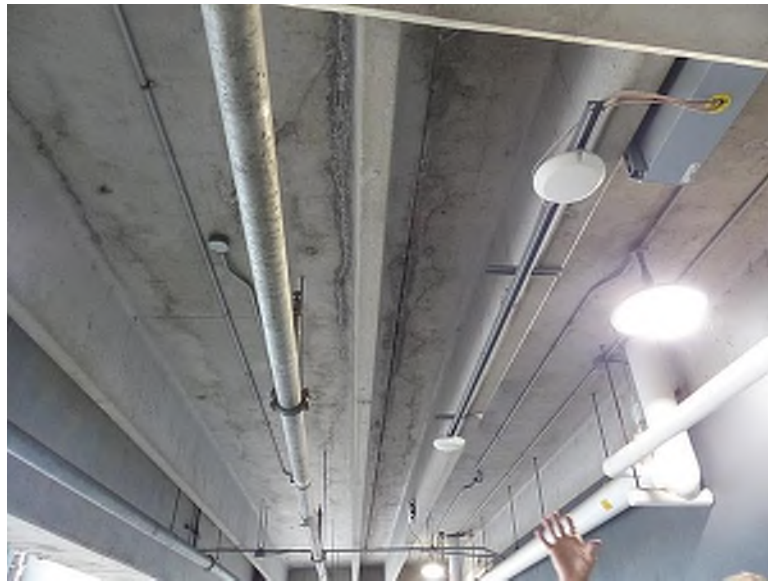
Leaching was visible along the underside of the precast double tees. Efflorescence is induced by moist conditions and unsealed concrete is particularly susceptible. The efflorescence observed appears to be following the length of reinforcing bars and it is likely that the rebar beneath has begun to corrode.

Leaching along the underside of precast double tees (Club Suites West, northwest concourse)

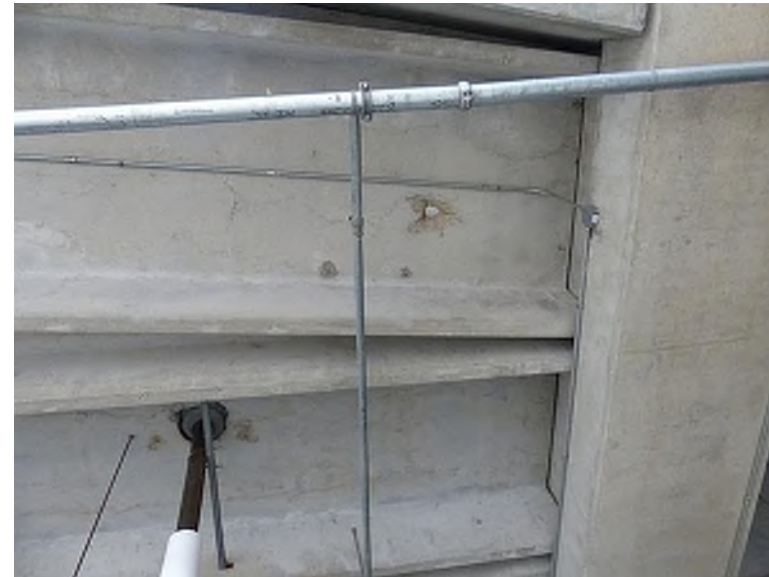
Delaminated concrete and exposed reinforcing steel were present on the underside of precast double tee members and along precast beams. Delamination may be caused by thin concrete cover, poor concrete consolidation, and/or concrete expansion and contraction due to the freeze/thaw cycle.

Localized concrete delamination on the underside of a precast double tee member (Club Level, northwest concourse)

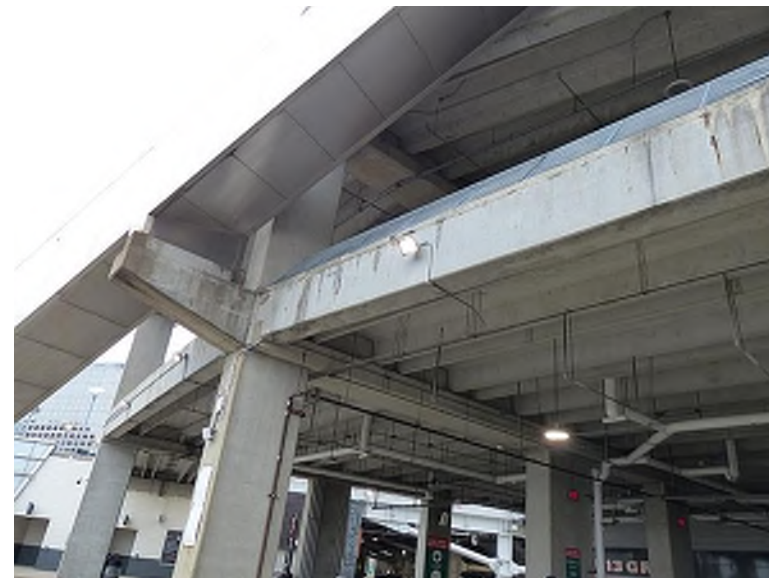
Multiple locations of exposed reinforcing steel along the length of a precast beam (Plaza Level, southeast concourse)

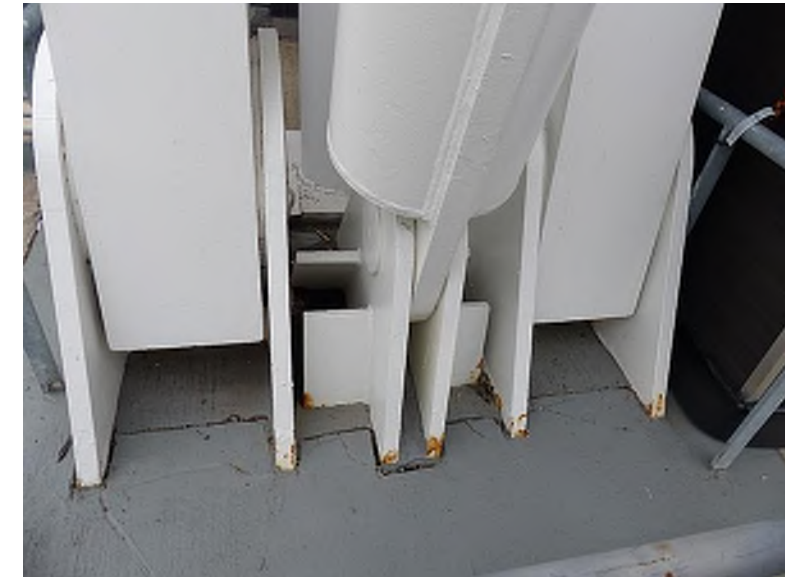
Corrosion was present at some locations along the bases of the steel boomerang structure at the upper concourse level. Most structural steel had been painted within the last year.

Corrosion present at the interface between the steel boomerang column base and concrete topping; boomerang steel was painted in 2019.

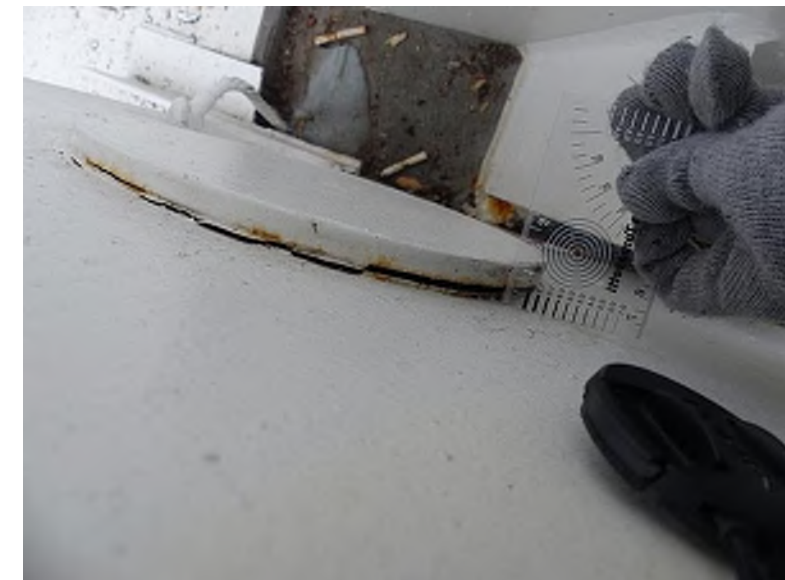
Gapping was present between the pin end caps and upstand plates at the base of the boomerang columns, which gives a path for water to flow between the two surfaces and potentially corroding the pinned connection. Bolts throughout all boomerang columns were replaced within the past two years.

Gap present along steel pin end cap and upstand plates that receive the boomerang column (Club Level, north concourse)

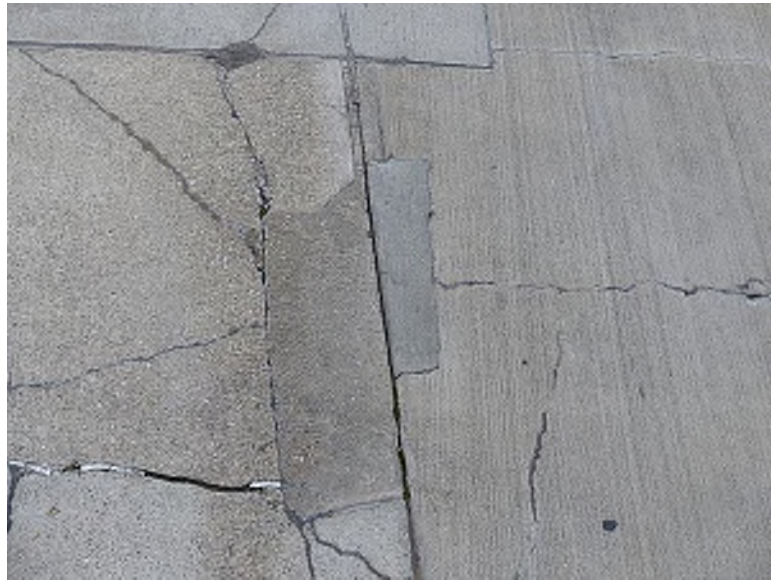
Failed concrete patches were located throughout the architectural topping slab on the exposed concourse levels. Sealant or caulk was used to repair cracks had worn away or dislodged from the crack. This material does not appear to properly adhere to the concrete substrate for any significant time duration. Remedies may range from simply applying a new topcoat to the most expensive option of replacing entire topping slabs and waterproofing material.

Cracking along a previous concrete patch with failed sealant along one crack (Upper Concourse, west)

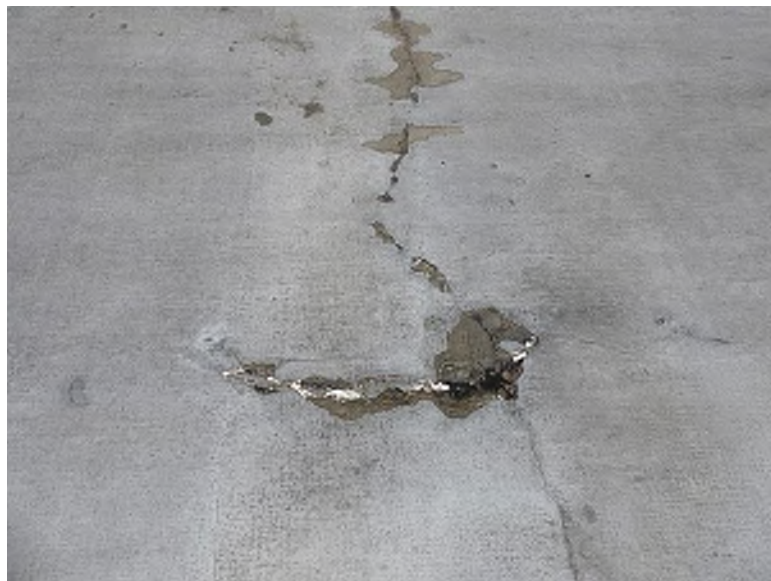
Failed concrete patch beneath deteriorated traffic coating (Club Level, north concourse)

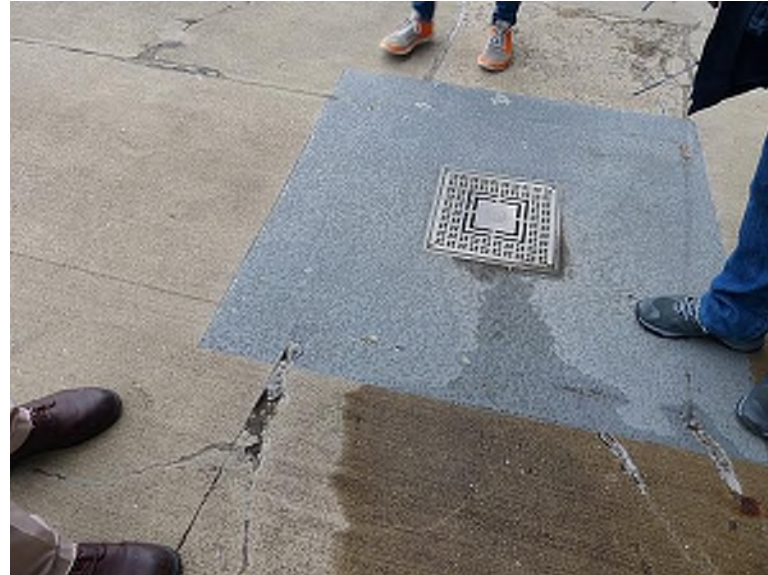
Failed concrete patches adjacent to the traffic coating along the floor drain (Upper Concourse, west)

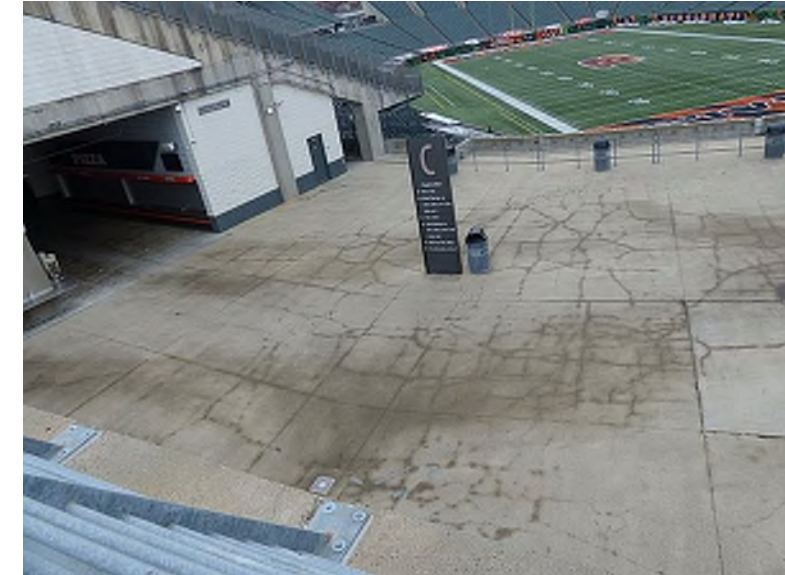
Extensive cracking throughout topping slab (Plaza Level, northeast concourse)

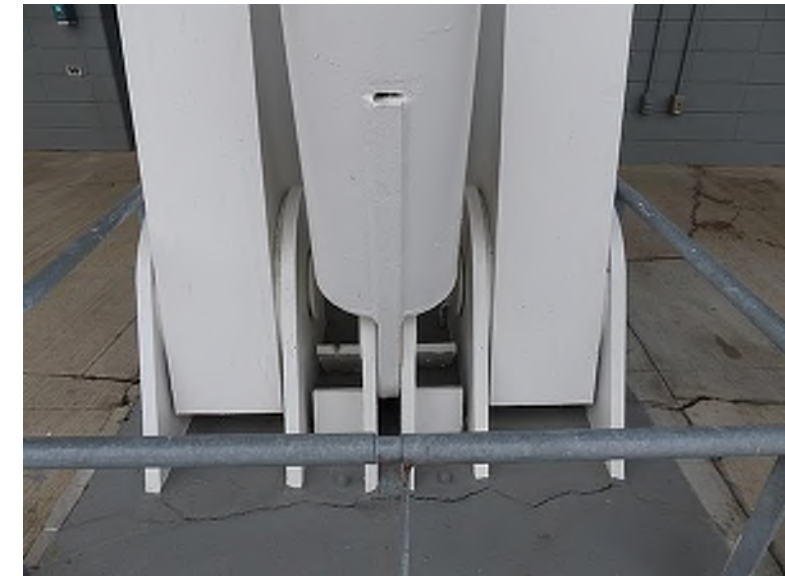
Cracking in the topping slab along the boomerang column base (Club Level, north concourse)
