OVERVIEW & EXECUTIVE SUMMARY

Venue Solutions Group (VSG)[®] was engaged by Gensler Sports on behalf of Hamilton County and the Cincinnati Bengals to provide a comprehensive facility condition assessment of Paul Brown Stadium that benchmarks the current condition of the facility. As part of the assessment, VSG, in partnership with their consultant team, has developed a 20-year capital expense matrix to assist the owner in establishing priorities for major repairs, potential upgrades and maintaining the facility in a professional manner. The ability to plan and maintain the stadium as it transitions from years 18 to 30 is crucial in extending the life of the facility as well as its relevance in the competitive and ever evolving regional and national marketplace. In addition to the facility assessment, VSG has also provided information related to the practice field, bowl cleaning and event-day trash removal.

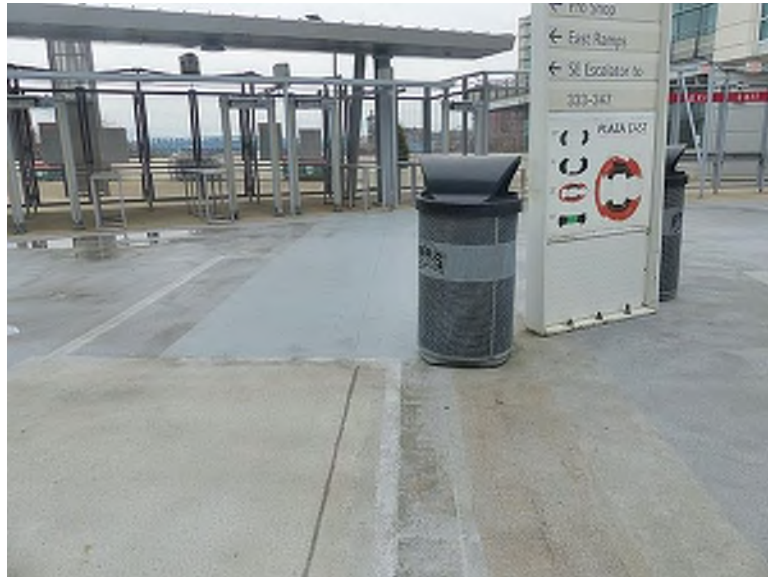
Deteriorated traffic coating was present throughout the stadium and is likely past its lifespan. Traffic coatings may deteriorate more rapidly by service carts driving over with hard wheels, de-icing salts and standing water.

Multiple patches of traffic coating present with a crack in the coating along the construction joint (Plaza Level, south concourse); coating is scheduled to be replaced in 2022 at this location and the south end zone in general

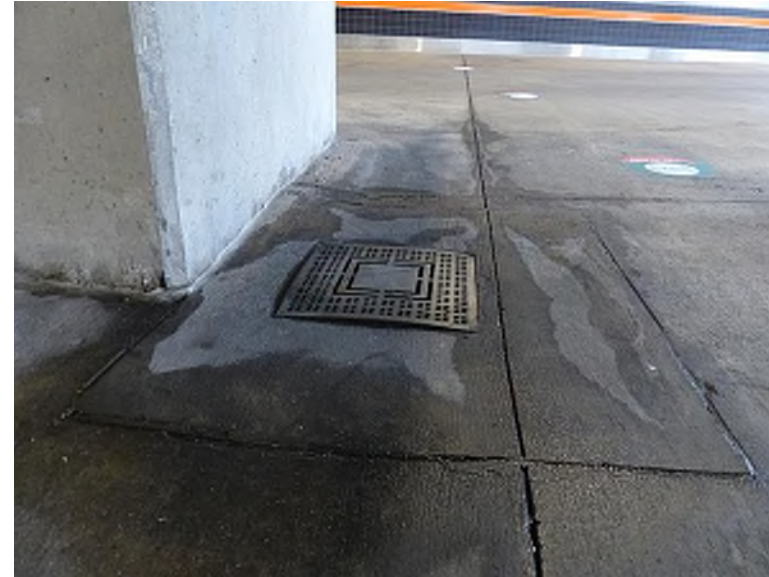
The exposed drain covers that feature the Bengals logo are fastened on top of the original cast iron drain covers. A majority of the logoed drain covers have buckled but do not have compromised fasteners. The issue is architectural in nature and it is possible that there is an incompatibility of materials.

Buckled drain cover adjacent to concessions (Plaza Level, northeast concessions)

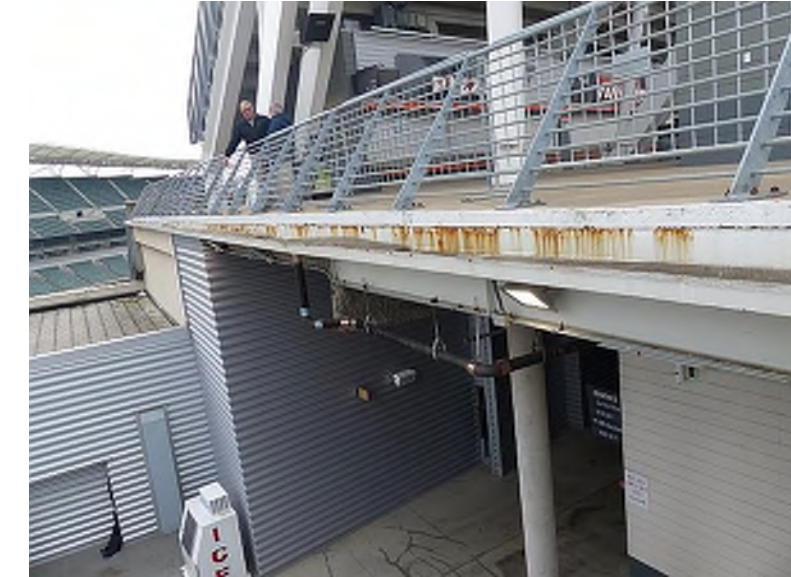
Corrosion residue was present along exposed slab edges where water had drained between the topping slab and structural slab. It is likely that the presence of corrosion is due to exposed reinforcing steel within the topping slab assembly and due to poor detailing.

Corrosion residue along slab edge where water drains into the attached gutter (Club Level, north concourse)

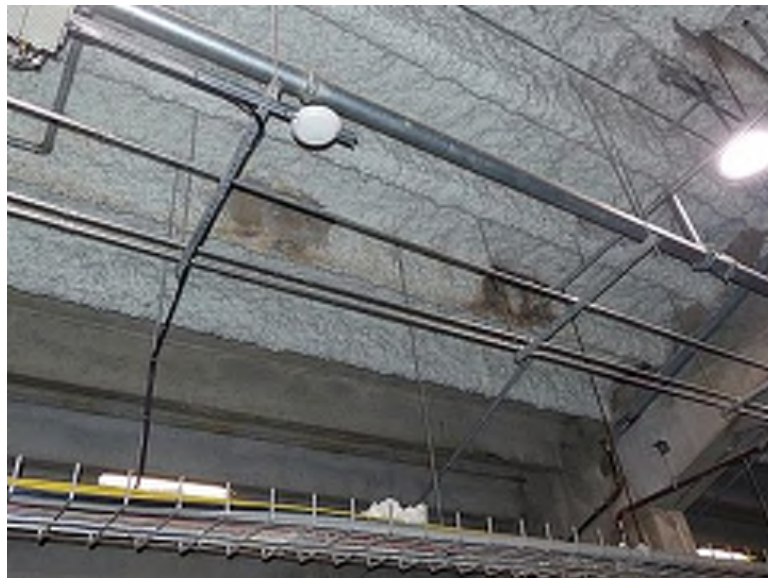
Delaminated direct applied sound attenuation system spray on material was located along the underside of the precast seating risers throughout the field level concourse. In some areas, the concrete beneath had deteriorated, exposing the reinforcing steel. The delamination of the system is due to water infiltration from between the individual precast riser units and between where the precast risers rest on the raker beams that has leaked through and de-bonded the fireproofing. Sustained moisture on the underside of the riser can deteriorate the concrete, causing spalling and exposure of reinforcing steel.

Delaminated acoustic insulation on the underside of precast seating risers (Service Level, adjacent to column line 15)

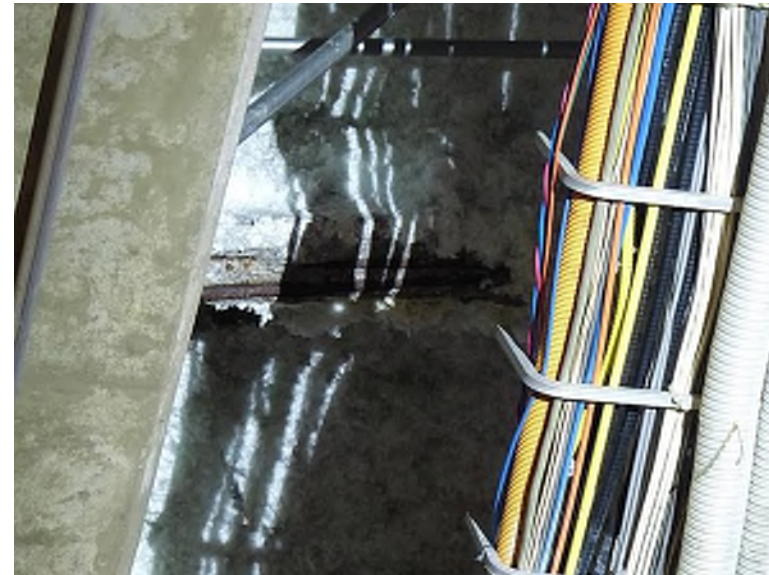
Delaminated acoustic insulation with exposed reinforcing steel on the underside of a precast seating riser (Service Level, adjacent to Vis Team Locker Room)

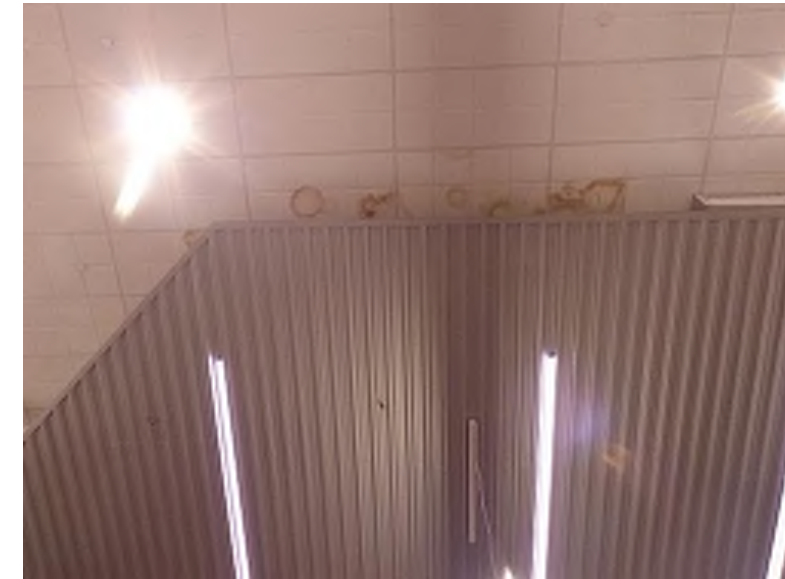
Water staining was visible along ceiling finishes in enclosed spaces located beneath the seating bowl and beneath the plaza concourse. Additional investigation is necessary to determine the source of water leaks and determine the extent of any damage to the structure above.

Water staining visible on ceiling tiles located in the fitness area, located below the plaza concourse

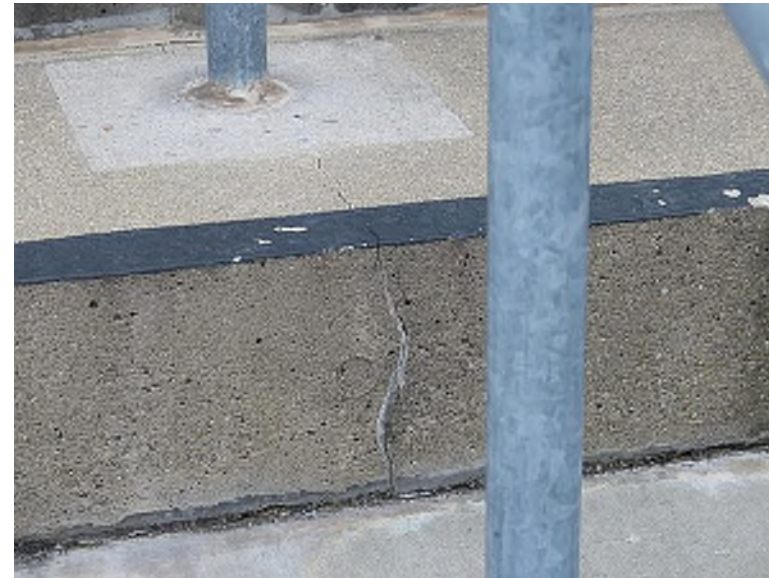
Cracks occurred throughout many of the intermediate concrete steps at the location of the railing stanchions. Cracking may be the result of stresses incurred from movement of the railing when in use. Any cracking that was formed will be exacerbated through water infiltration, which may also cause corrosion at the base of the stanchion or the rebar within the step due to water infiltration. Water may also seep through the unsealed edges of the step, causing further deterioration.

Transverse crack through the intermediate step at the location of the stanchion (Club Level, Section 211 Row 5)

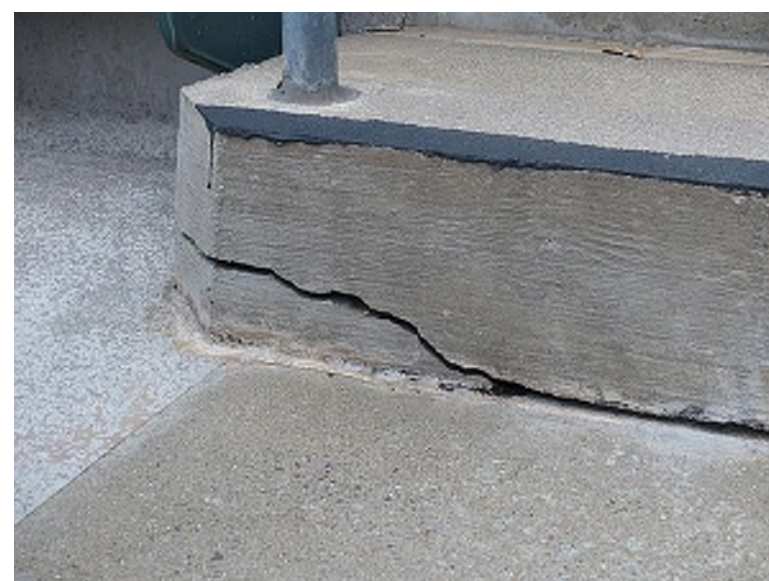
Cracking at the bottom corner of the intermediate step at the location of the stanchion (North Seating Bowl, Section 228 Row 8); sealants should be installed to prevent "freeze/thaw" issues from occurring

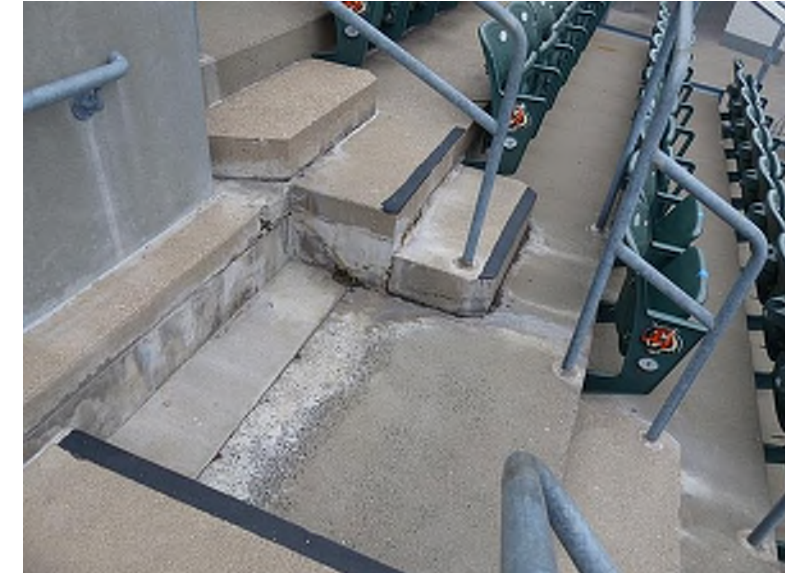
Water leaking beneath steps at north end of stadium (North Seating Bowl, Section 230 Row 10)

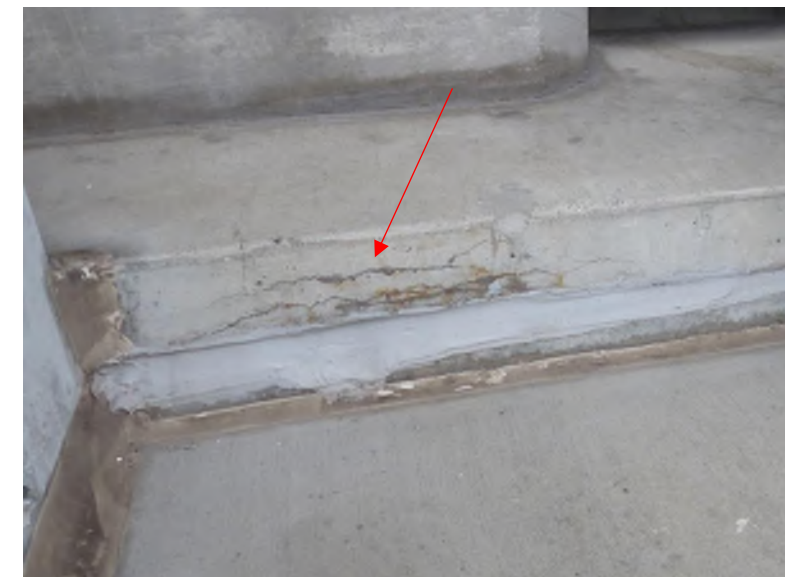
Delaminated concrete occurred along precast seating risers, precast raker beams, and cast-in-place intermediate steps and corrosion was often visible along the surface of the delaminated concrete elements. Delamination, especially with the presence of residue from corrosion, can be caused by improper concrete cover over the reinforcing steel.

Concrete and corrosion delamination along edge of precast riser beam (Club Level, Section 202 Row 31)

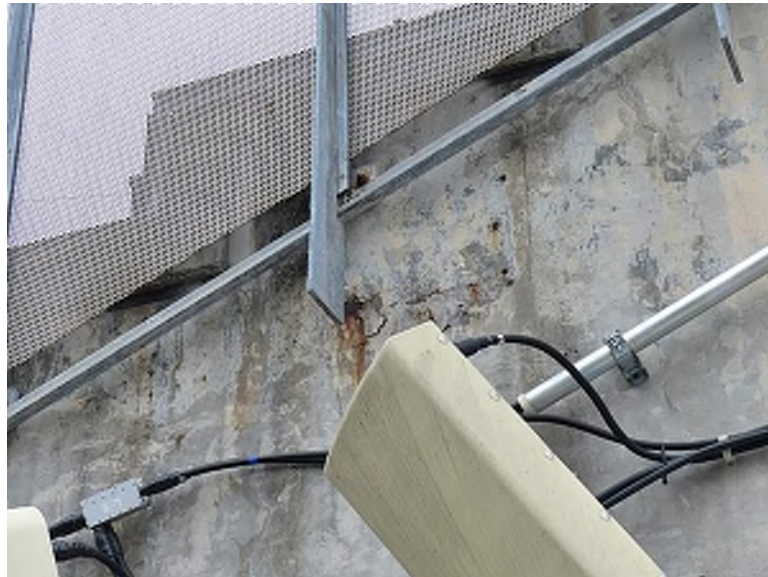
Delamination and corrosion along the exposed side of the raker beam (Club Level, south end of east seating bowl)

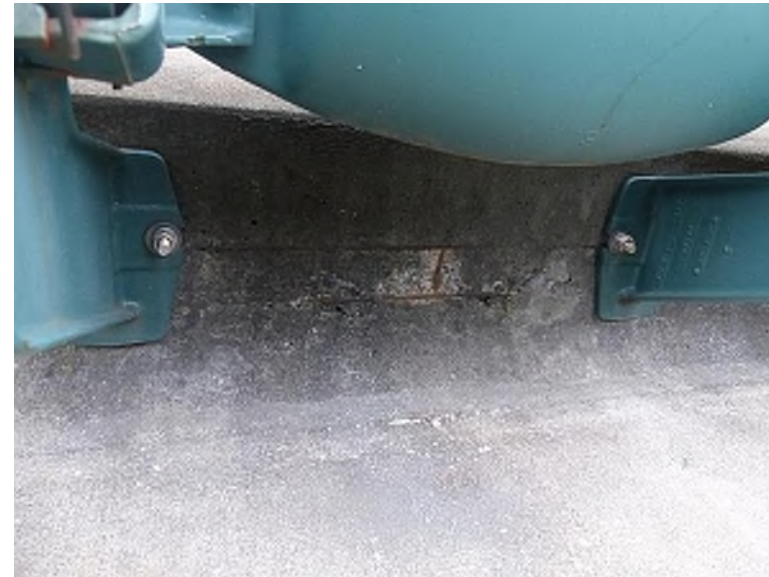
Exposed longitudinal reinforcing steel along the vertical surface of a precast seating riser (Lower Seating Bowl, Section 140, back rows)

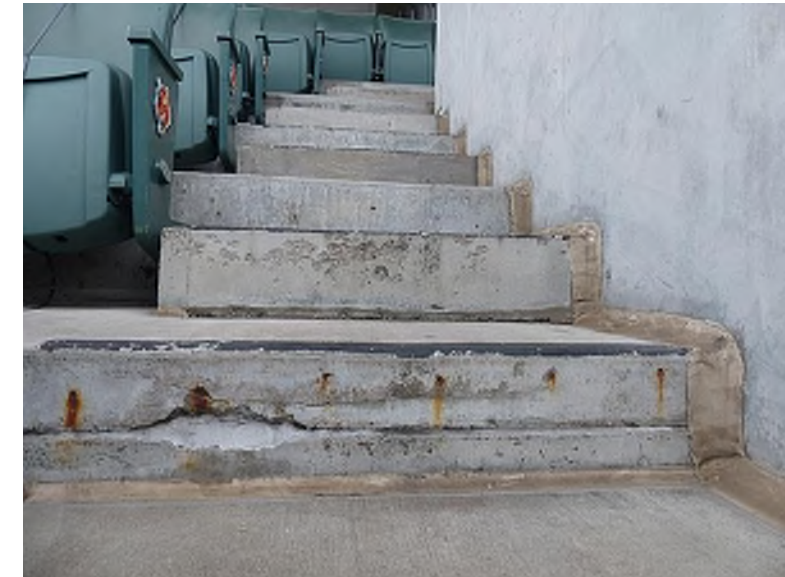
Exposed transverse reinforcing steel along the vertical surface of a precast seating riser (Club Level, Section 202 Row 14)

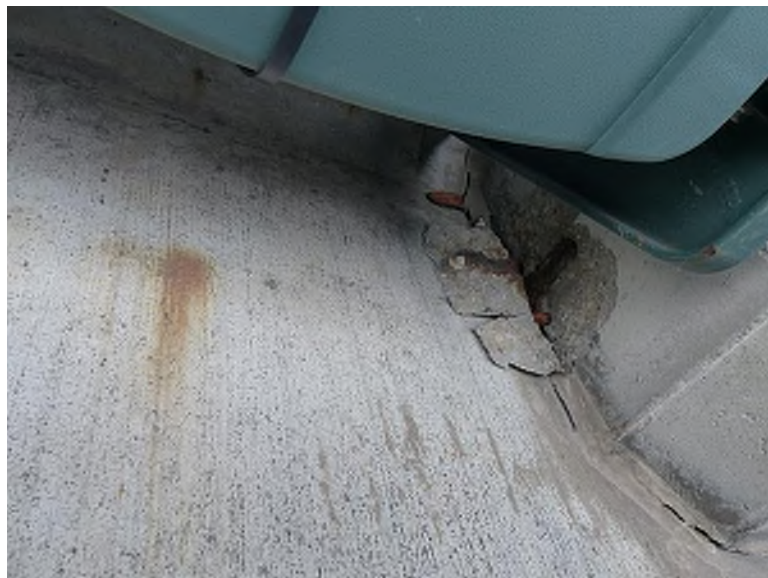
Delaminated concrete with exposed corroded rebar on the edge of the intermediate step (Club Level, Section 241 Row 14)

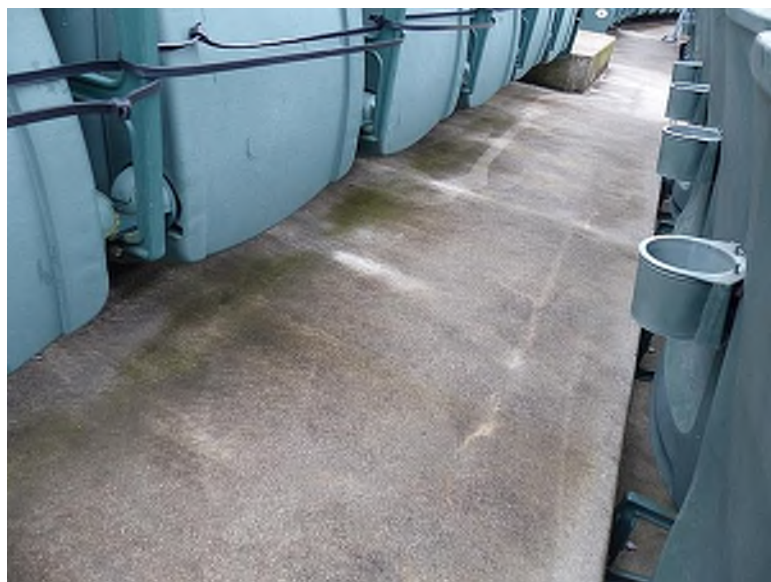
Biological growth was found throughout the stadium seating, precast risers, and intermediate steps and is the result of sustained moisture present on the surface of the concrete. This can be caused by poor drainage, improper slope of surfaces, and clogged surface drains.

Biological growth along the top surface of precast seating risers (Club Level, Section 203 Row 3)

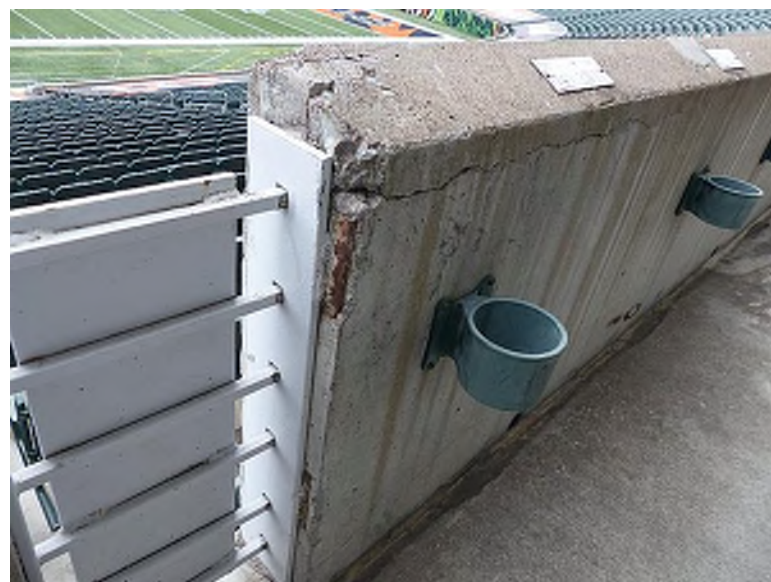
Cracks occurred in concrete wall elements, such as the barrier wall along handicap seating and vomitory walls. Cracking adjacent to a railing is caused by shallow embedment of the

connection plate, allowing for concrete to spall and additional cracks to propagate outward. A cold joint is located between the top of the precast portion of the wall and the sloped capping and the presence of water running along the joint can cause cracking and spalling along the joint over time. Cracking in vomitory walls is likely due to shrinkage, expansion and contraction due to excessive temperature differences, poor quality control during casting, or a combination of the two.

Cracked and spalled concrete located at the embedment plate of the railing wall (Lower Bowl, Section 140 Row 32W Seat 11)

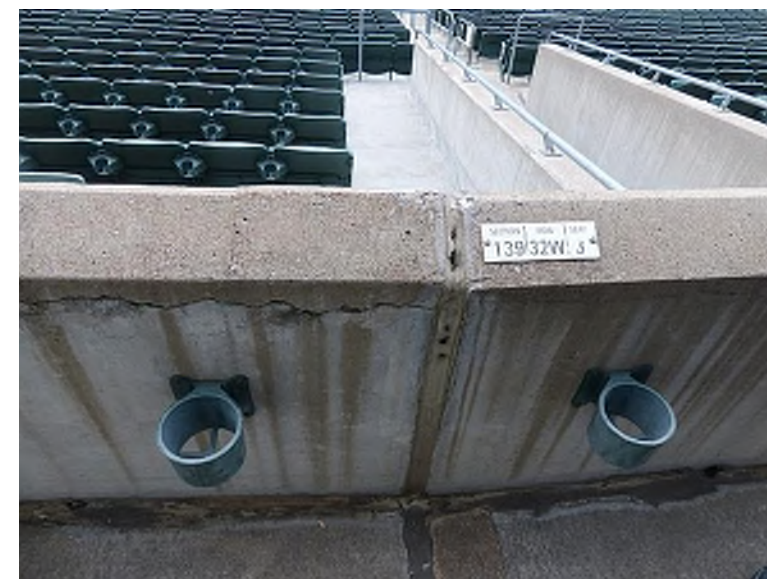
Cold joint located between the top of the precast wall panel and the sloped concrete cap (Lower Bowl, Section 139 Row 32W Seat 3)

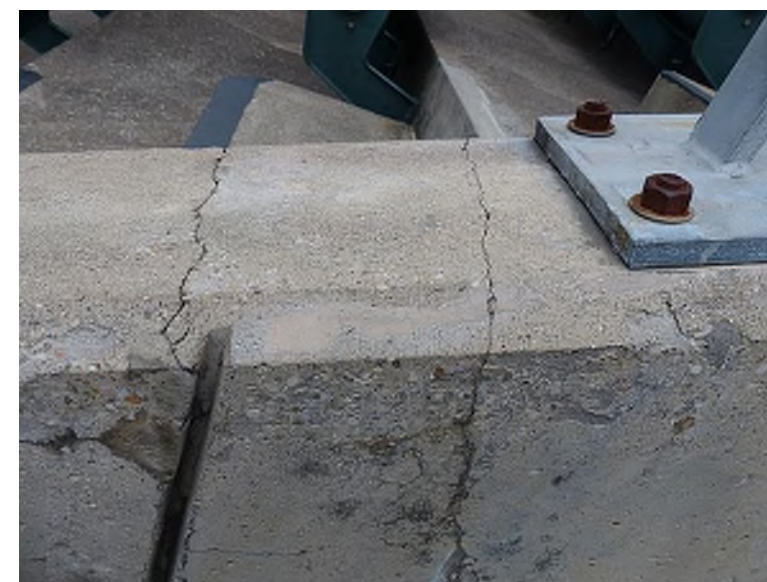
Concrete cracking along the top of the vomitory wall (South Seating Bowl, Section 154)

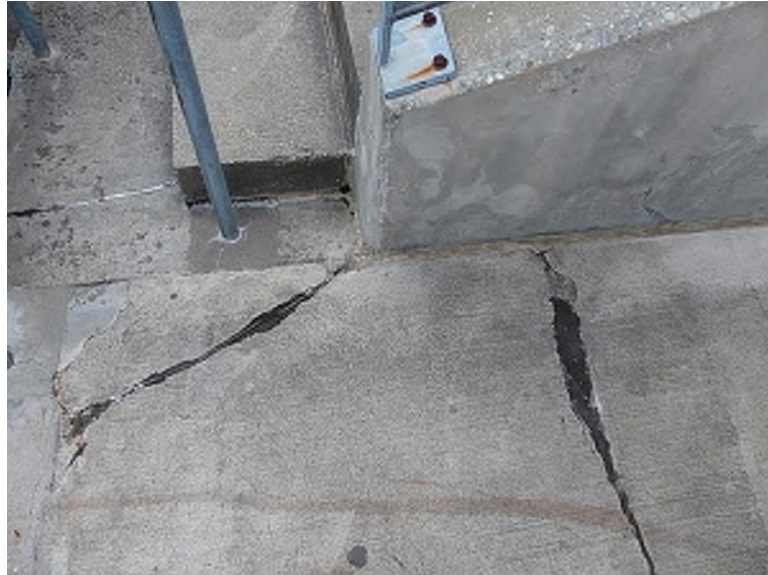
Cracks in the architectural topping slab and precast risers were repaired using some type of sealant or caulk. This material is not the recommended repair method for horizontal concrete surfaces, as the sealant or caulk appears to have a limited lifespan, deteriorates or dislodges because the material does not properly bond to the substrate for any significant time period. Some previously applied concrete coatings are building up causing water to disperse away from the drains resulting in ponding water in the seating aisles.

Deteriorated sealant used for repair in topping slab adjacent to a vomitorium (South Seating Bowl, Section 152)

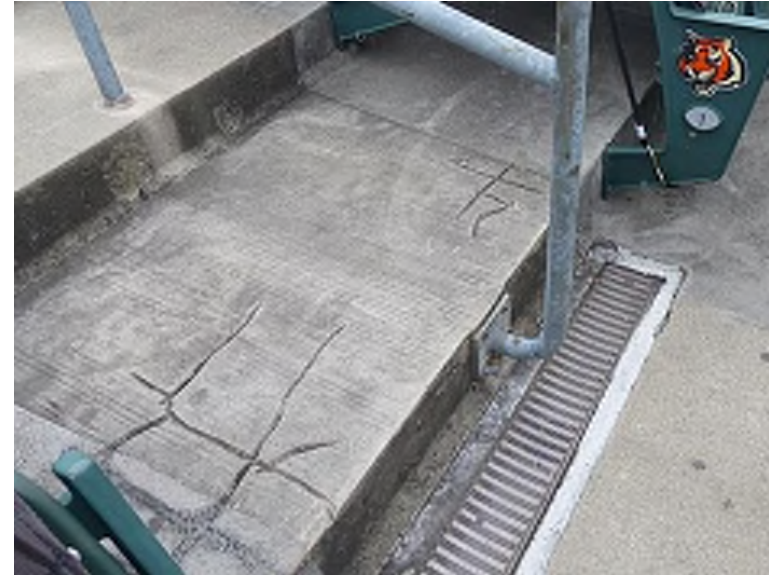
The material used to repair cracks in the precast risers has been worn away (Lower Bowl, Section 142 Row 1). Concrete coating build ups are causing water to disperse away from drains causing ponding water in the seating aisles.

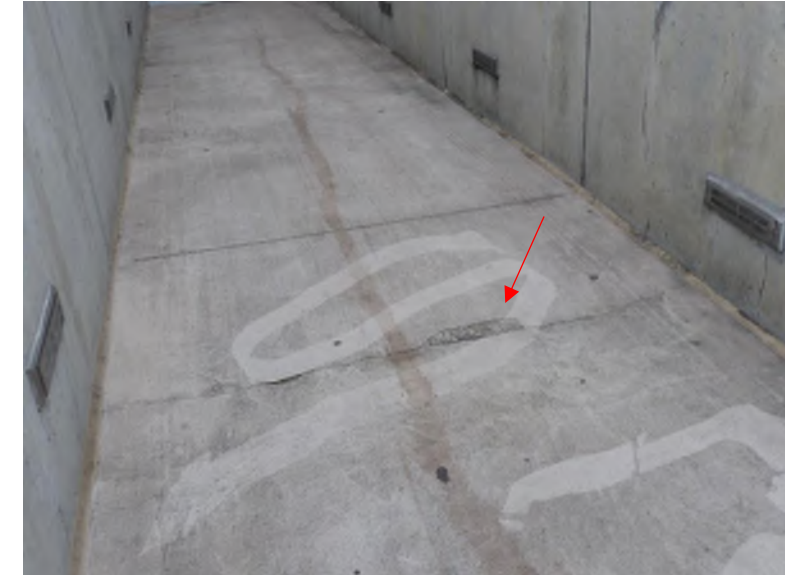
Cracks in the topping slab are located throughout vomitories and walkways adjacent to the bowl seating. Cracking may be due to high water content in the concrete mixture, poor workmanship and lack of sufficient shrinkage control joints when topping slab was originally placed, environmental conditions, de-icing salts and/or wear due to high traffic. The topping slab is a protective topping over the structural concrete and cracking does not affect the structural integrity of the structural floor slab. Cracking does, however, allow for water to permeate below the topping slab and possibly impact the structural slab below if there are leaks in the waterproofing system.

Crack and spall located in the topping slab of the vomitorium (South Seating Bowl, Section 152)

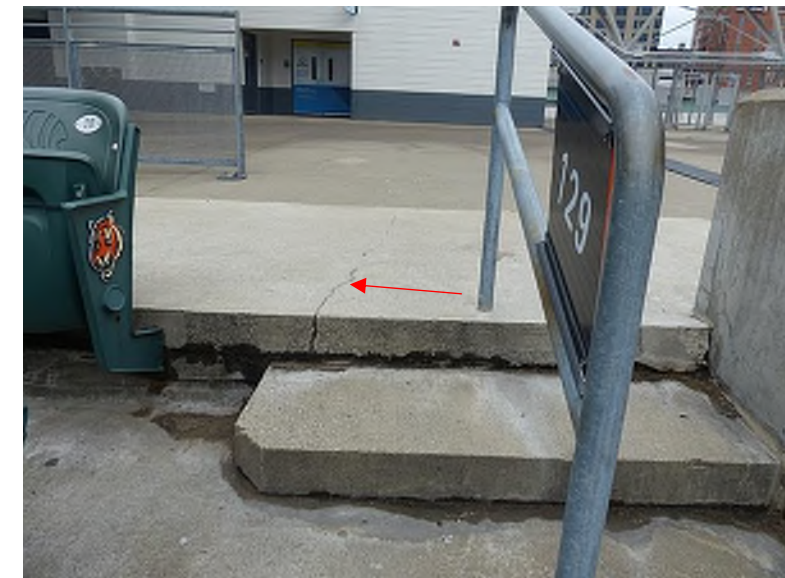
Crack in topping slab extending through the slab edge (Plaza Level and Lower Bowl, Section 129)

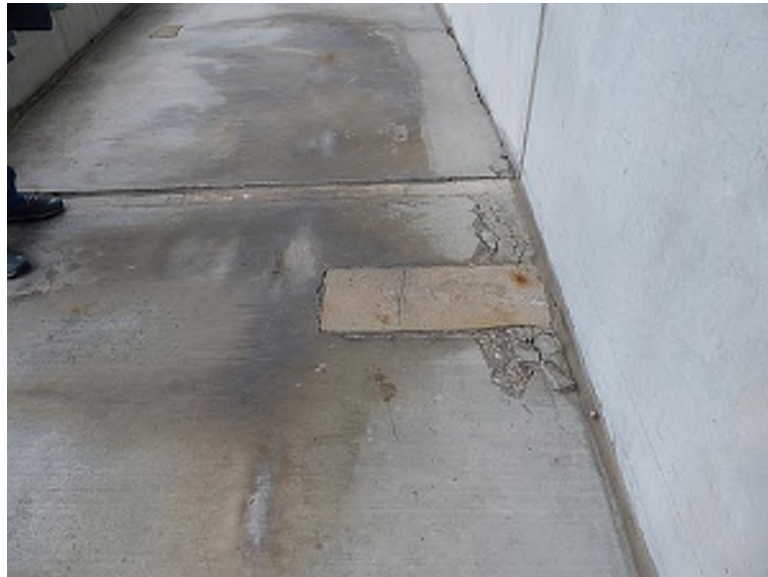
Spalling adjacent to a previous repair in the topping slab along plaza level suites (Plaza Level, Section 140)

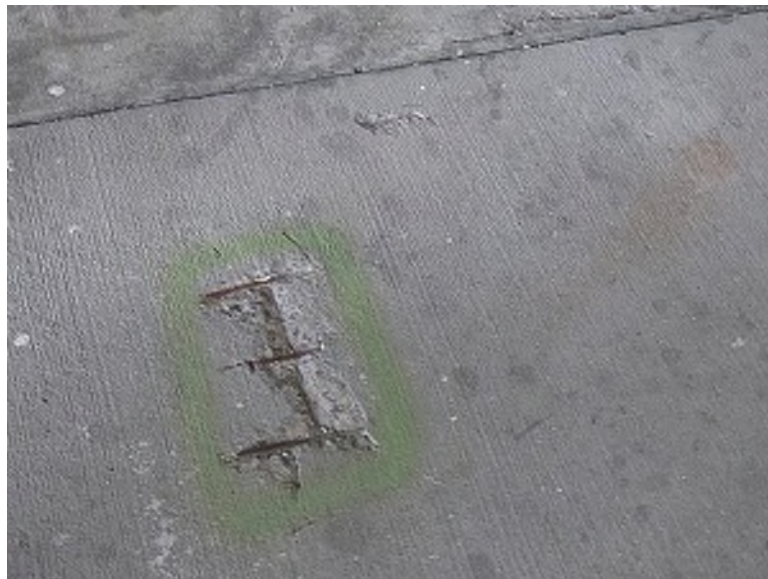
Exposed wire mesh in architectural and structural topping slab may be the results of poor concrete consolidation and localized impact damage.

Exposed mesh in architectural topping slab at the plaza level (Upper Level Suites, west at south end)

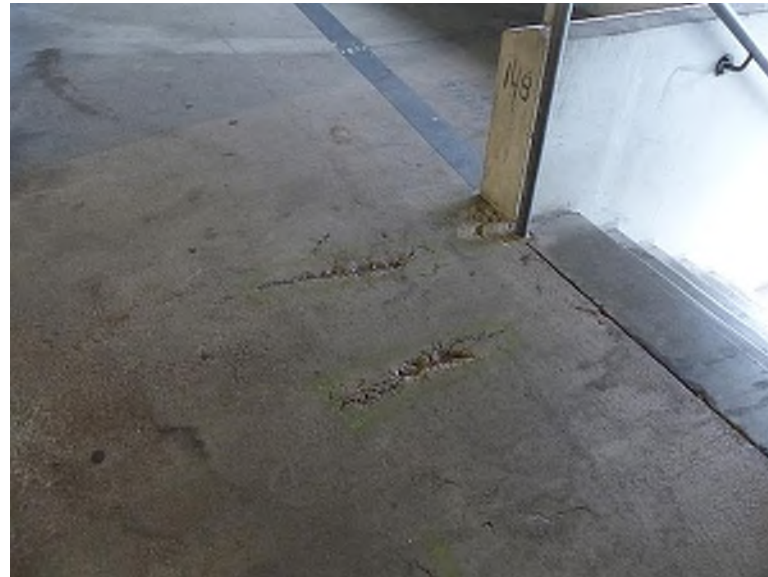
Exposed mesh in structural topping slab at the plaza level (Plaza Level, Section 148)

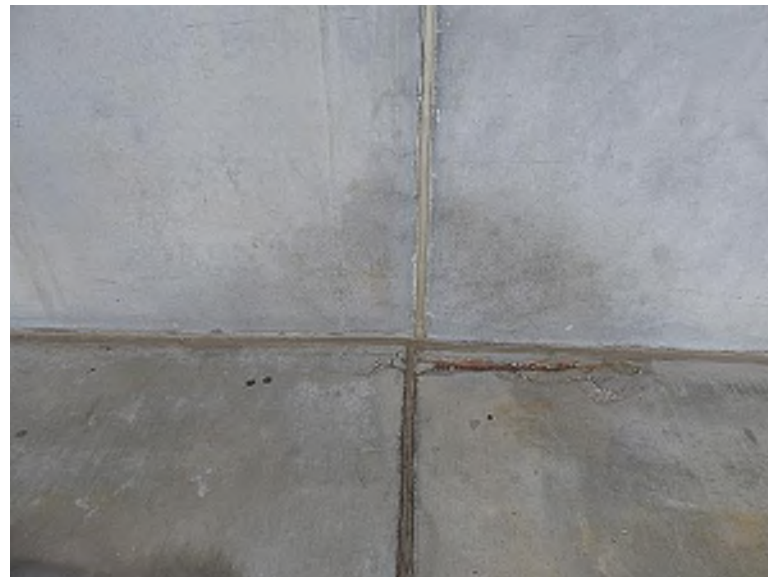
Exposed mesh in precast slab adjacent to plaza suites (Plaza Level, Section 136)

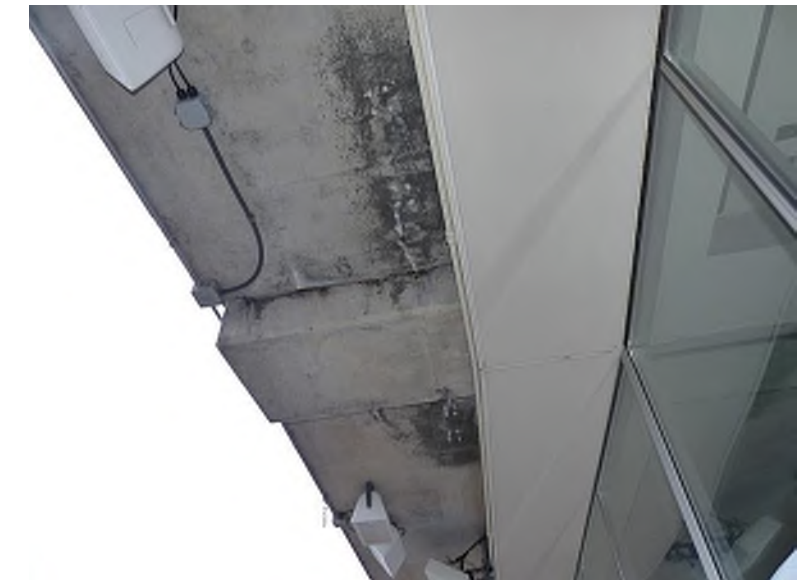
Leaching was visible along various precast riser beams, particularly along the underside of the risers. Efflorescence is induced by moist conditions and unsealed concrete is particularly susceptible. The efflorescence observed appears to follow the length of reinforcing bars within the precast risers. This often is an indication that the rebar beneath the concrete surface has begun to corrode. This needs to be further investigated / repaired as required.

Leaching along the underside of the bottom tier of the precast concrete riser (as seen from Plaza Level, Section 140)

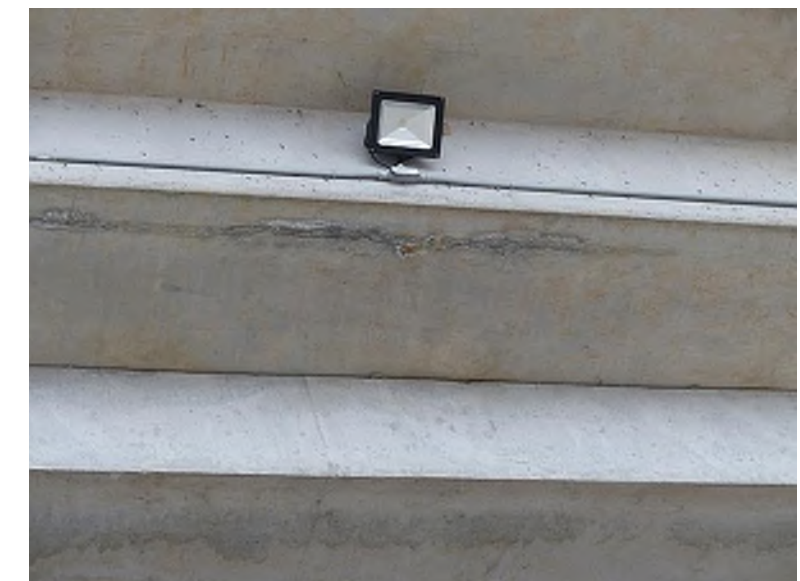
Leaching along the underside of the bottom tier of the precast concrete riser (Upper Concourse, east)

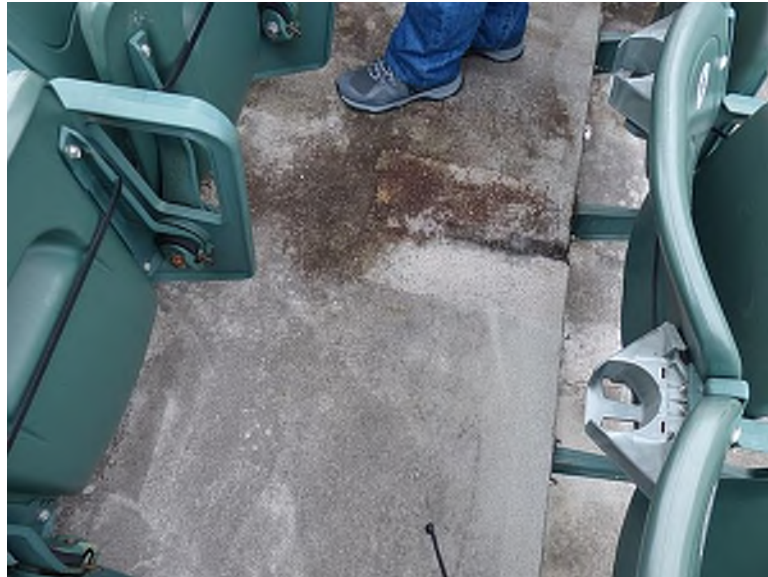
Traffic coating throughout the stadium appeared to be at the end of its lifespan and has further deteriorated due to standing water and de-icing salts.

Deteriorated traffic coating along expansion joint (South Seating Bowl, Section 158)

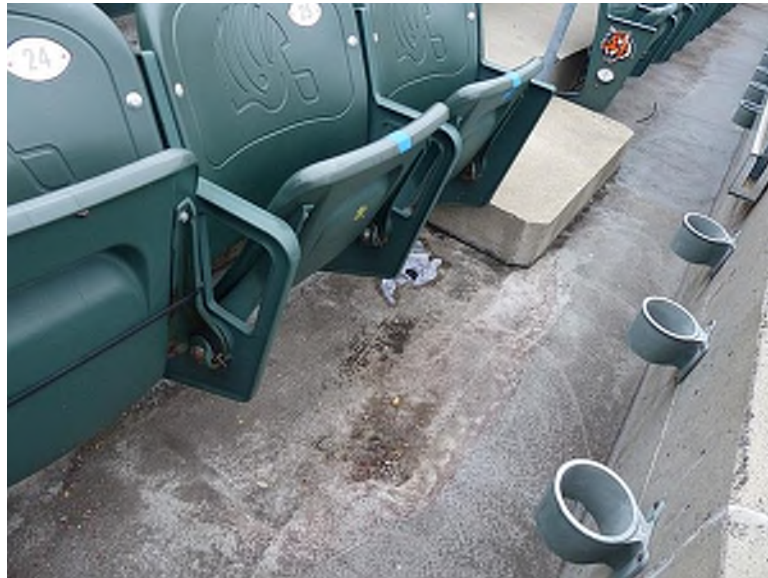
Deteriorated traffic coating on precast riser surface (North Seating Bowl, Section 126 Row 1)

16. Recoat areas with deteriorated traffic coating in seating bowls, along concourse surfaces, and on pedestrian ramps.
17. Inspect corroded steel angles along the pedestrian ramps and seating bowls for the severity of deterioration. Replace angles if necessary.

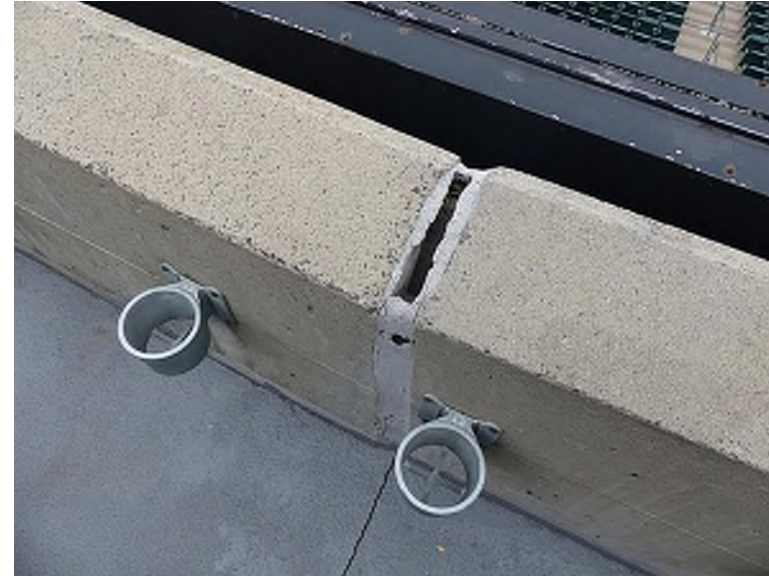
Deteriorated sealants were located along precast riser beams, vomitory walls, and precast walls. The missing sealant is consistent throughout all vertical precast joints at all levels of the stadium.

Sealant missing along the top portion of the railing wall (North Seating Bowl, Section 226), and is consistent throughout all vertical precast joints at all levels

18. Apply approved sealant along gaps in pin caps and upstand plates of the boomerang columns.
19. Remove and replace all failed and deteriorated sealants. Install or replace backer rods where appropriate.
20. Wire brush corroded material from seating bowl railing fasteners or replace. Replace all missing nuts and bolts.
21. Wire brush corroded material from raker beam edge metal or replace.
22. Replace sheets of corroded secondary roofing.
23. Remove and replace sections of delaminated fireproofing.
24. In elevated parking lots, seal cracks in the topping slab per ICRI guidelines.
25. Intermediate concrete step risers should be fully sealed and not partially sealed to keep water from freezing and expanding (freeze / thaw) under the riser, to prevent separation from the precast seating risers.

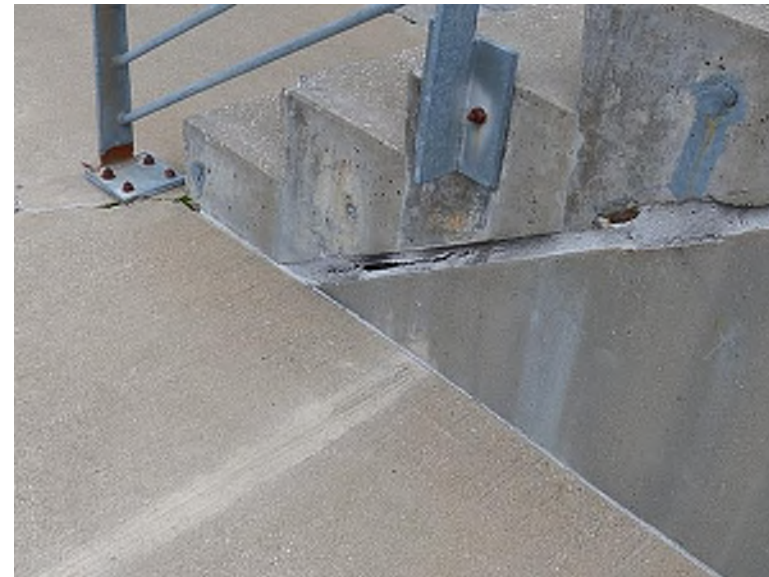
Deteriorated sealant between the precast vomitory walls and steps (North Seating Bowl, Section 226)

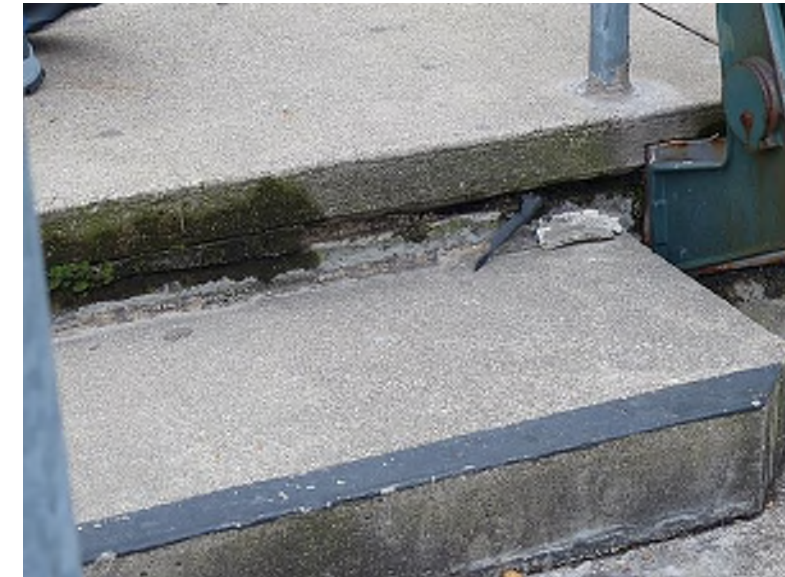
Deteriorated and missing sealant between the top precast riser beam and topping slab (South Seating Bowl, Section 158)

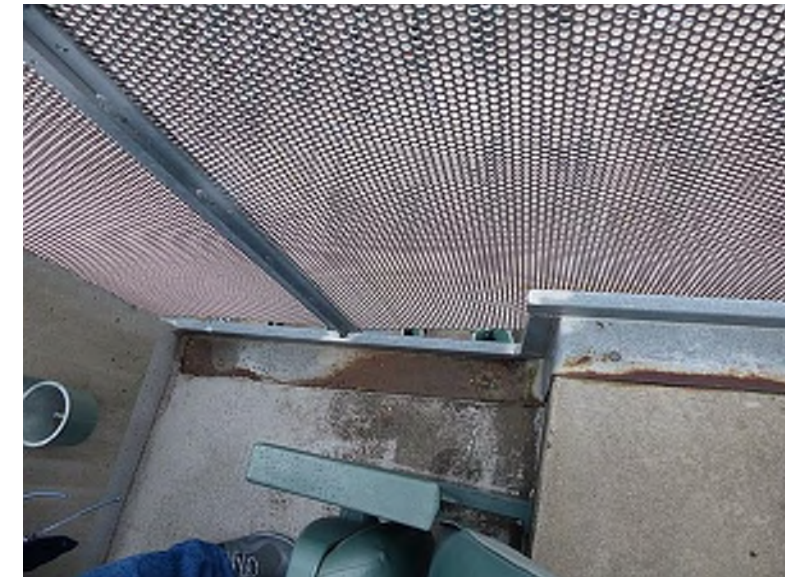
Corroded edge metal along end raker beam (Club Level)

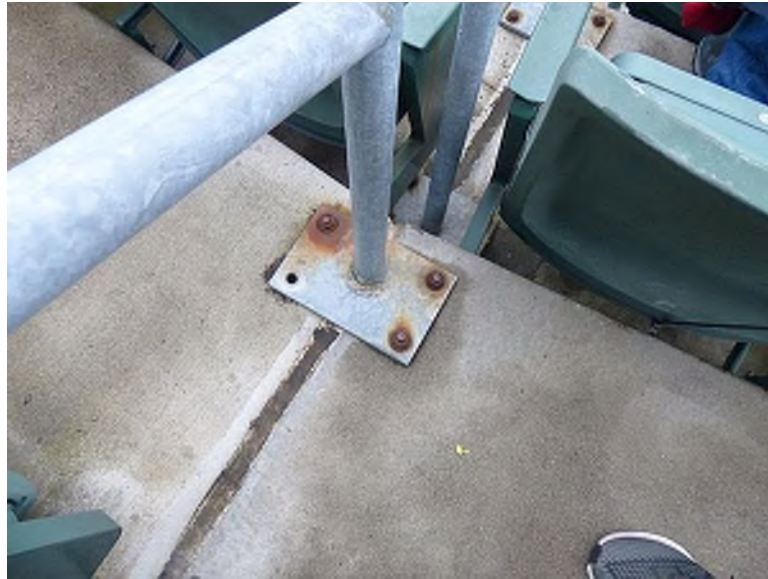
Railings along precast seating risers often had corroded fasteners at the base plate, in addition to missing bolts in some locations.

Corroded railing fasteners with one bolt missing (Club Level, Section 202)

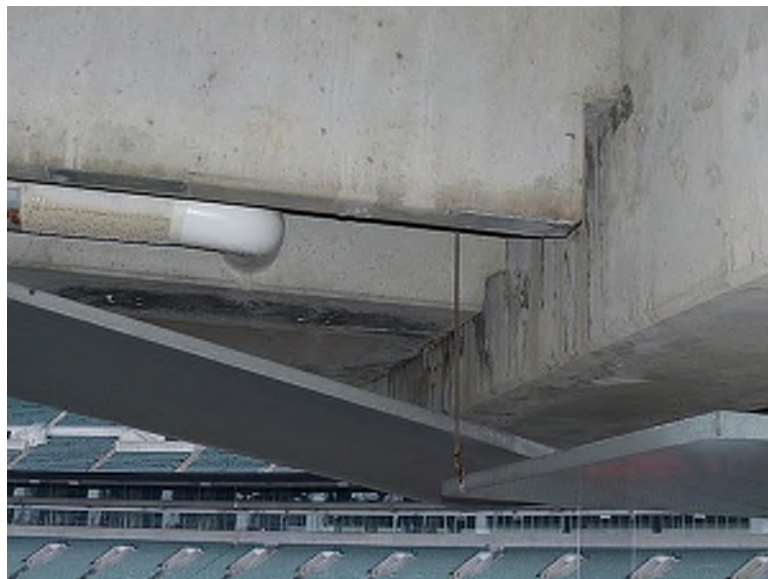
At the Plaza Level, metal pans were placed along the bottom of the precast seating units above throughout the entire length of the Club Level bowl in order to catch leaking water from above. Concrete efflorescence and corroded metal decking were visible in areas where water leaking was evident.

Staining and efflorescence on precast concrete members in the location of water leak locations above metal pans used to collect the leaking water (Plaza Level, north end of east concourse)

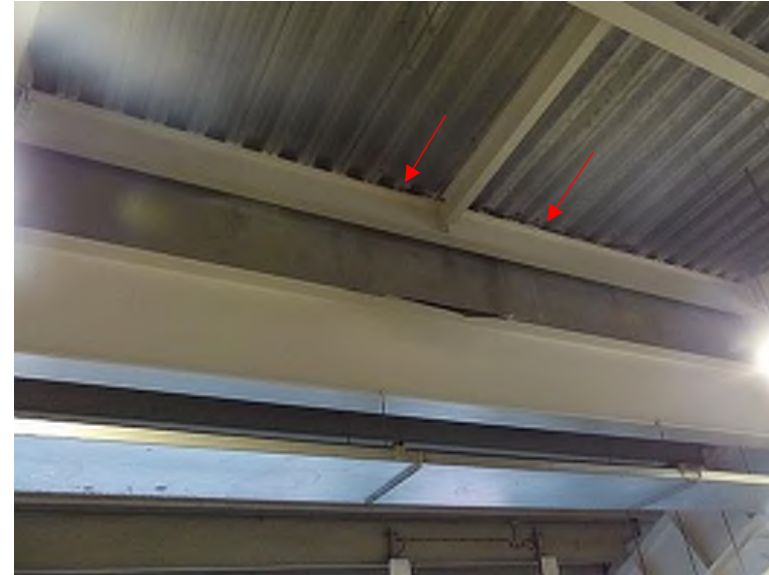
Corroded metal decking and staining on metal framing above metal pans used to collect leaking water (Plaza Level, north end of east concourse). Note that owner has begun metal decking replacement at stairs and ramps during 2021.

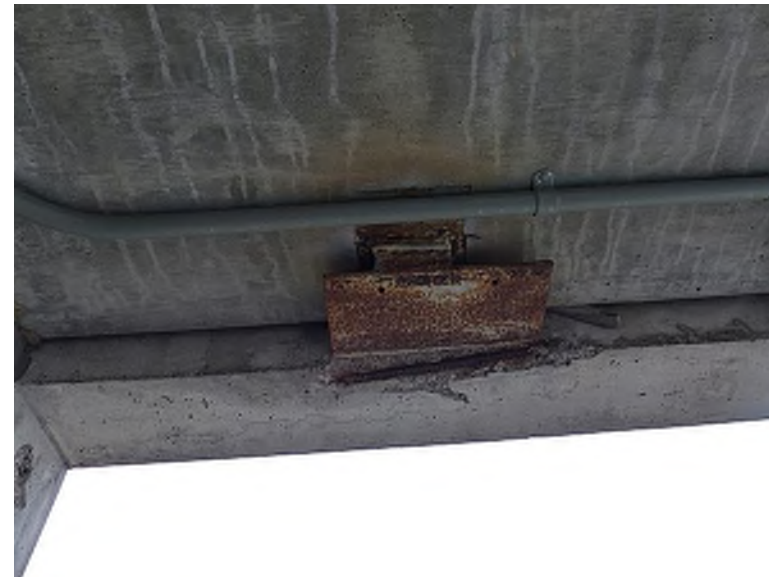
Several clip angles anchoring a precast slab to the concrete superstructure exhibited corrosion. The steel angles require a high-performance paint or sealant.

Corroded clip angle between precast slab and concrete beam (Upper Concourse)

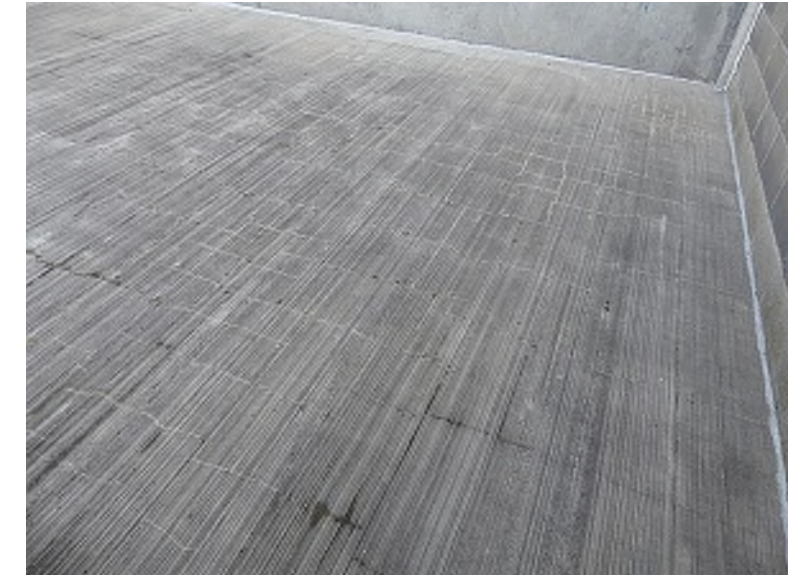
Cracked and deteriorated traffic coating at the upper concourse level

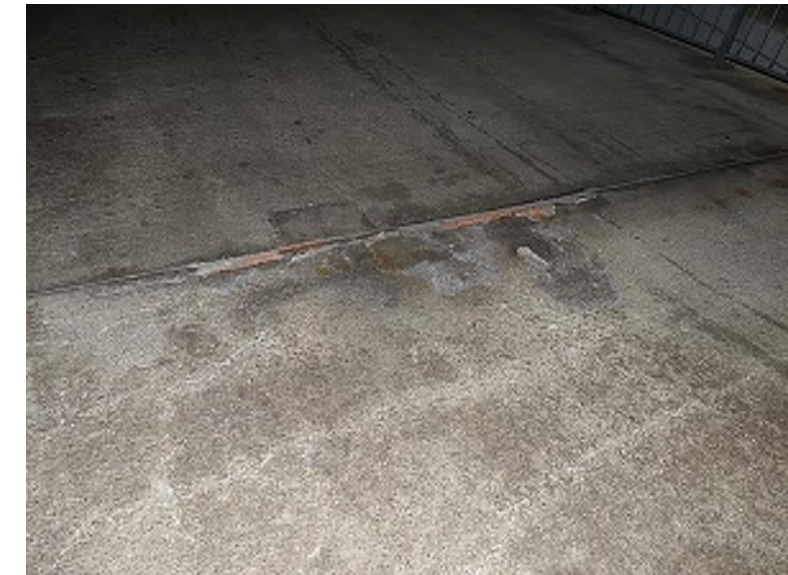
Cracked and deteriorated traffic coating at the plaza concourse level

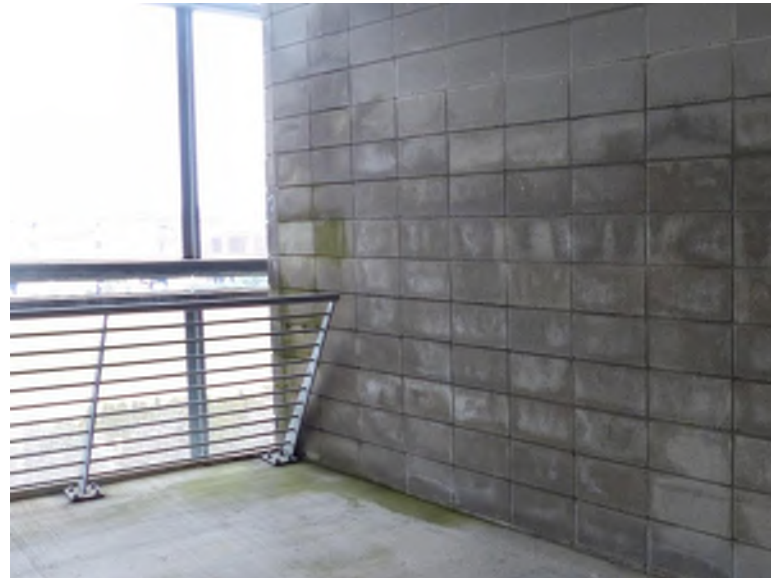
Biological growth was present on some areas of the pedestrian ramp and along a CMU wall that is adjacent to an enclosed space. Presence of biological growth is due to sustained moisture on a surface. The surface of the ramp may be slightly sloped towards the edge, allowing water to collect along railings, causing the concrete to be constantly damp. Cracks in the surface of the concrete would also allow water to collect, causing the concrete to stay wet.

Biological growth located on the CMU wall along the landing on the ramp (northwest ramp)

2. Pressure wash concrete surfaces with biological growth present and inspect for any concrete degradation once cleaned.
3. Repair delamination concrete by removing any loose concrete and install approved repair material following per International Concrete Repair Institute (ICRI) guidelines.

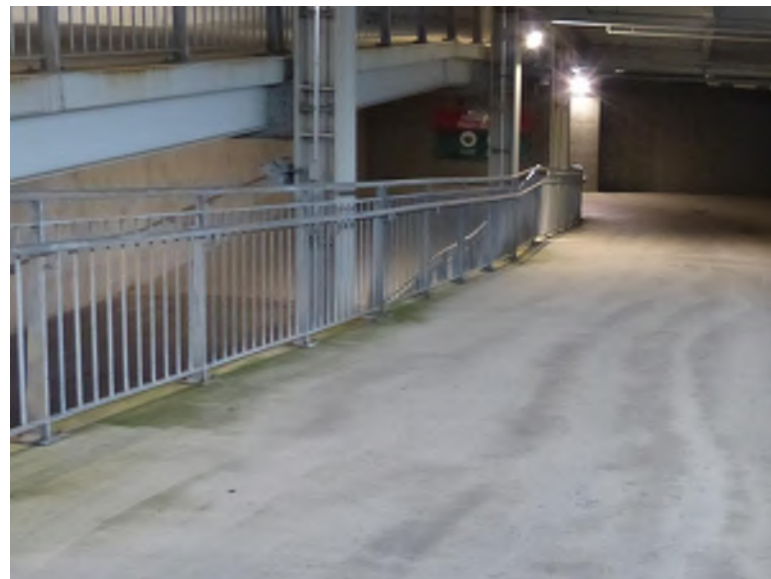
Biological growth along the edge of the pedestrian ramp (southeast ramp)
