OVERVIEW & EXECUTIVE SUMMARY

Venue Solutions Group (VSG)[®] was engaged by Gensler Sports on behalf of Hamilton County and the Cincinnati Bengals to provide a comprehensive facility condition assessment of Paul Brown Stadium that benchmarks the current condition of the facility. As part of the assessment, VSG, in partnership with their consultant team, has developed a 20-year capital expense matrix to assist the owner in establishing priorities for major repairs, potential upgrades and maintaining the facility in a professional manner. The ability to plan and maintain the stadium as it transitions from years 18 to 30 is crucial in extending the life of the facility as well as its relevance in the competitive and ever evolving regional and national marketplace. In addition to the facility assessment, VSG has also provided information related to the practice field, bowl cleaning and event-day trash removal.

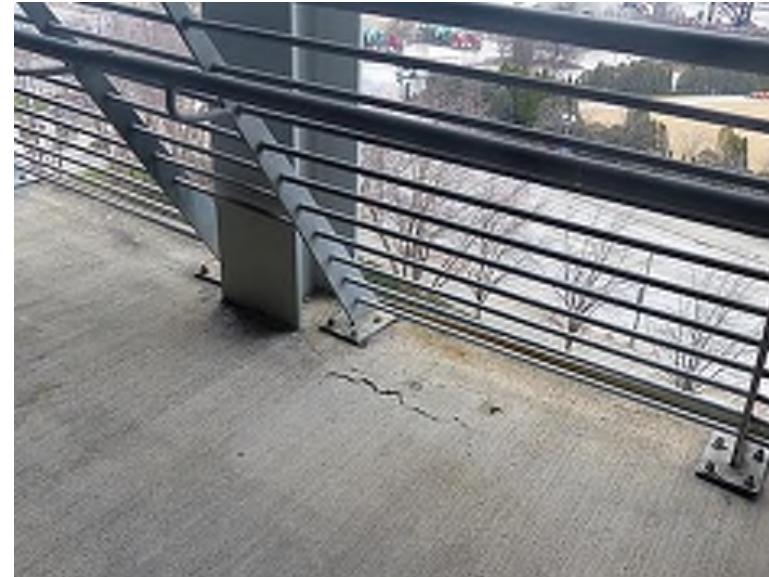
Delaminated concrete was present on a few areas along the surface of the concrete ramps. Delamination is likely due to poorly consolidated concrete or thin concrete cover.

Delaminated concrete adjacent to the railing anchorage (northwest ramp)

2. Pressure wash concrete surfaces with biological growth present and inspect for any concrete degradation once cleaned.
3. Repair delamination concrete by removing any loose concrete and install approved repair material following per International Concrete Repair Institute (ICRI) guidelines.

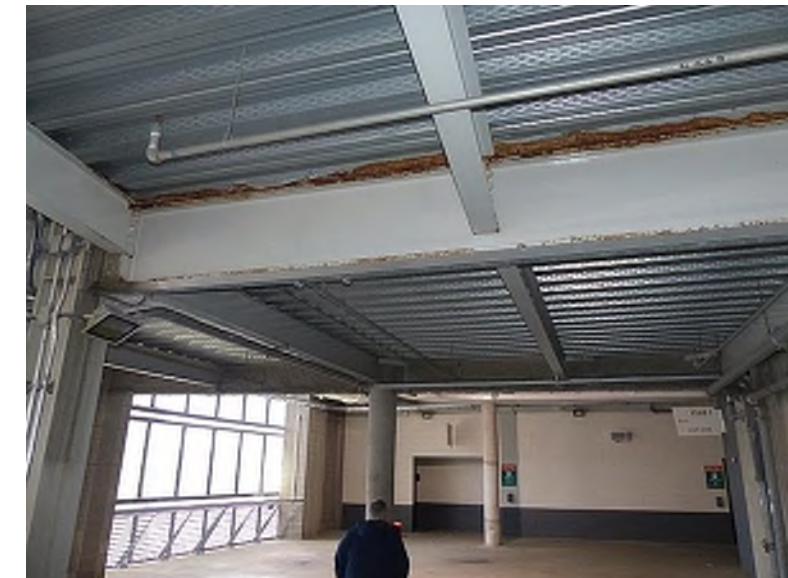
Corroded metal decking along the supporting steel beam of the pedestrian ramp (southeast ramp)

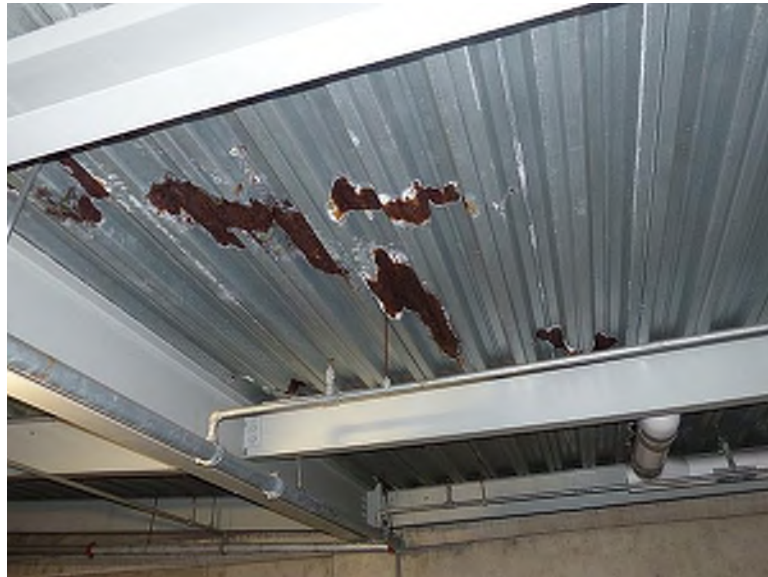
Corroded metal decking was prevalent throughout all pedestrian ramps. Steel elements in some areas also experienced corrosion. Corrosion of metal decking is likely caused by water infiltrating through cracks in the concrete slab due to lack of a protective coating, allowing for water to be trapped between the concrete and metal decking. Corrosion on structural steel elements, such as angles, is due to sustained moisture from water flowing down the edge of the ramps. Additional investigation will be required in order to mitigate water flow over the edge of ramps. Decking replacement and repair is an ongoing capital project at PBS.

Corroded metal decking on the underside of the pedestrian ramp (near Field Level West)

10. Remove all corrosive materials along all exterior stairs and ramps, prepare with a corrosion inhibitor, and recoat with a high-performance coating.

11. Areas of extensive corrosion along composite decking of the exterior stairs and ramps may require replacements or supplemental structural framing members to divide, shorten and re-support the existing concrete slab spans. See Appendix D for diagram of this process.

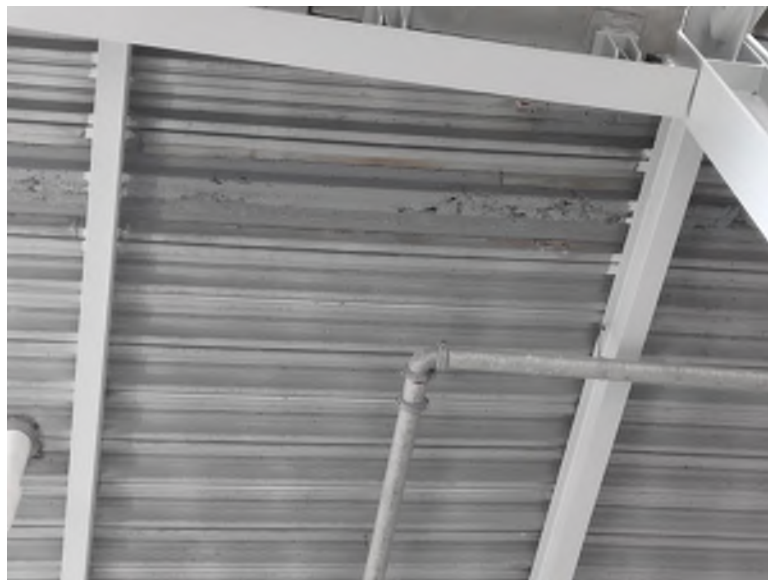
Metal deck after replacement

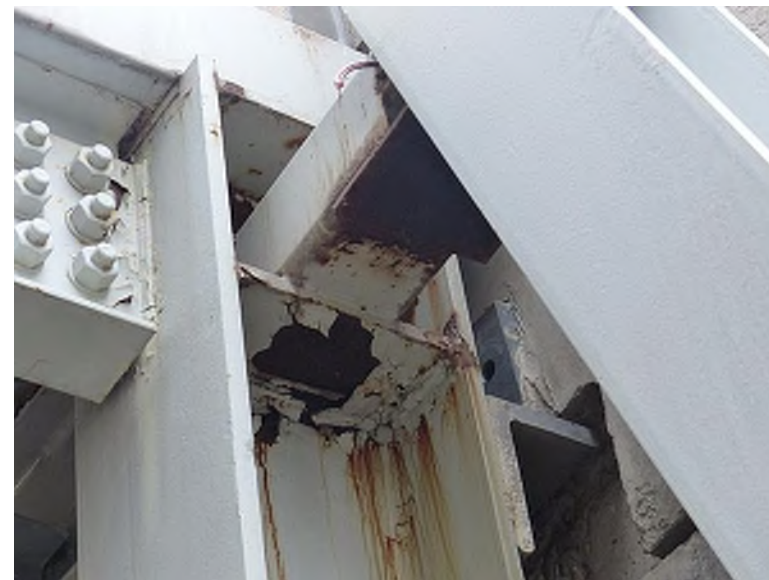
Paint had chipped off or deteriorated on some of the ramp structural steel elements, allowing for the steel beneath to corrode. Deterioration of the protective paint is likely due to sustained moisture on the steel elements.

Corroded ramp structural steel (southeast ramp); steel correction and re-coating is an ongoing, yearly capital project at PBS

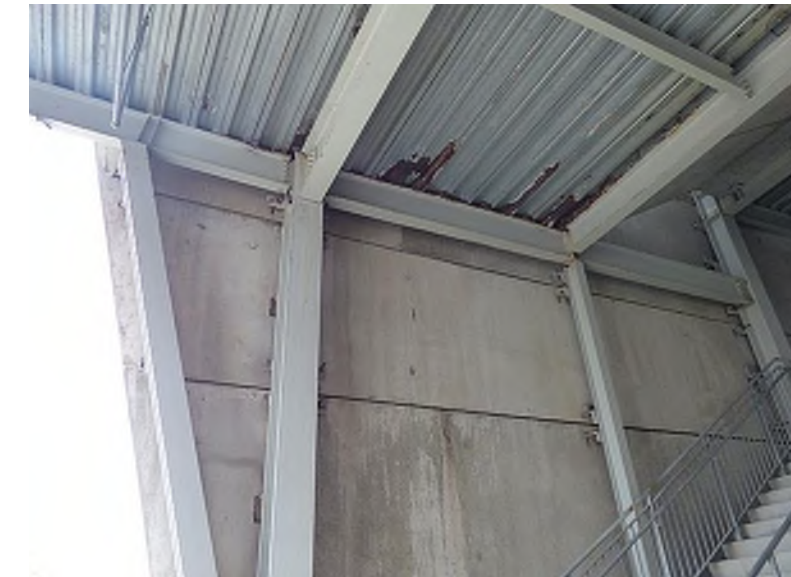
Corroded metal decking located beneath a stair landing above the plaza concourse (Club Level, southwest stairs); steel correction and re-coating is an ongoing, yearly capital project at PBS

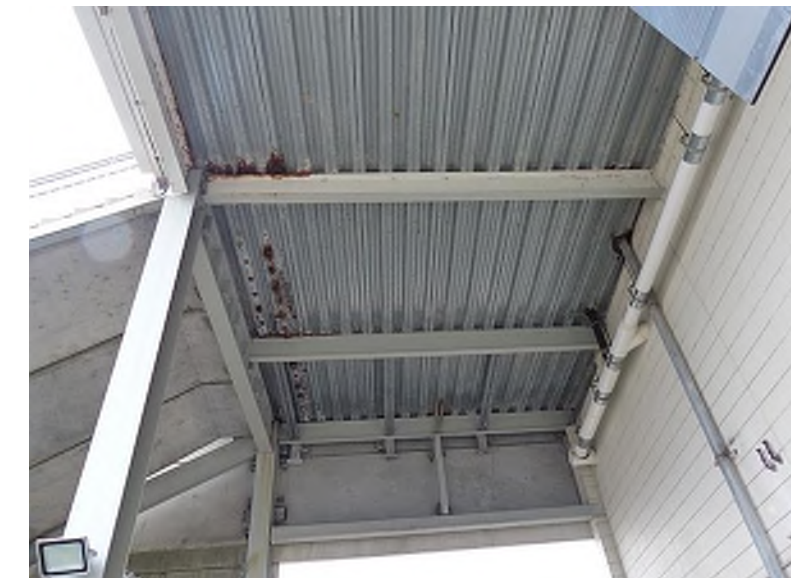
Corroded metal decking located on the underside of the upper concourse stair landing (southwest stairs, looking towards Upper Concourse); steel correction and re-coating is an ongoing, yearly capital project at PBS

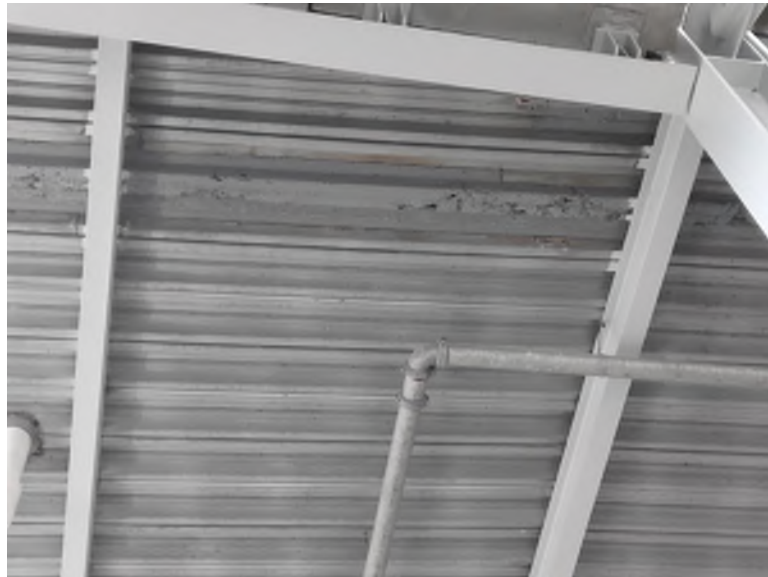
Metal deck after replacement

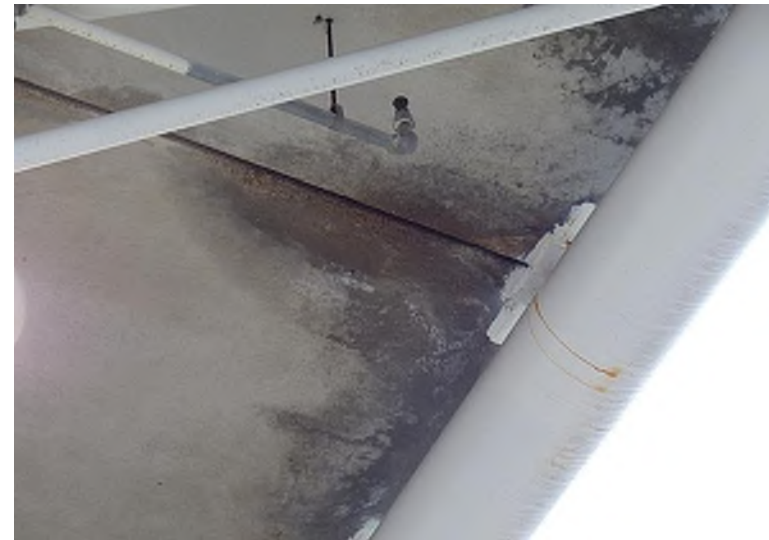
Leaching was located on the underside of the precast planks of the pedestrian bridges. Efflorescence is induced by moist conditions and it is likely that water is able to flow over the edges of the bridge in addition to water penetrating through spalled concrete at the locations of the railing anchorage.

Efflorescence on the underside of the pedestrian bridge precast concrete plants

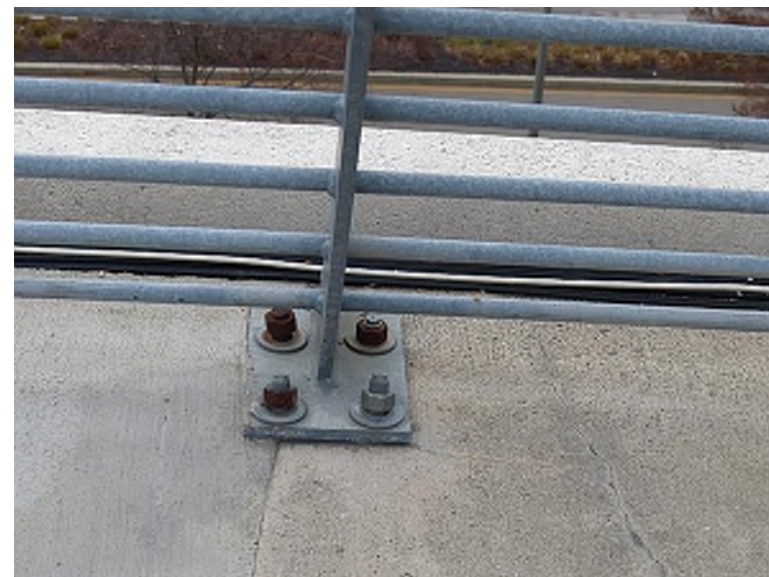
Bent and corroded railing fasteners were visible at some locations of railing anchorage.

Bent threaded rods and rusted rods and nuts at the handrail attachment for the pedestrian bridge leading to the party deck

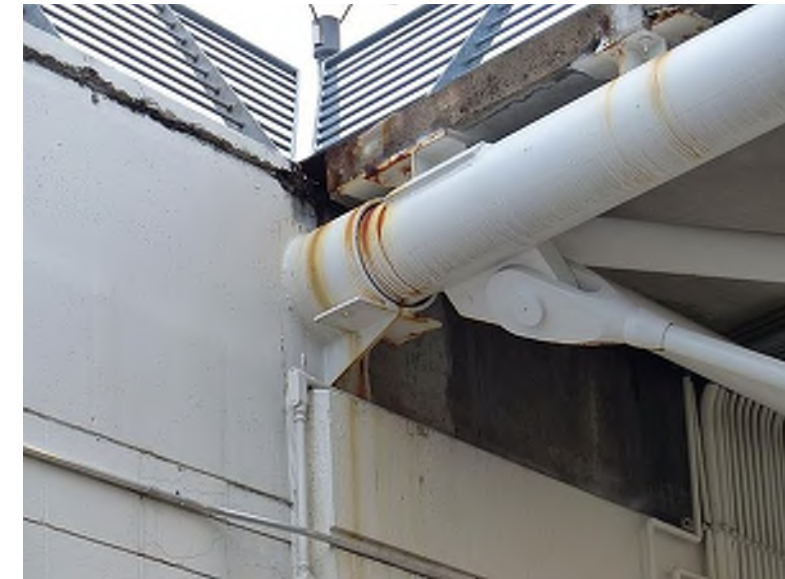
Deteriorated concrete and rusted steel where the bridge terminates

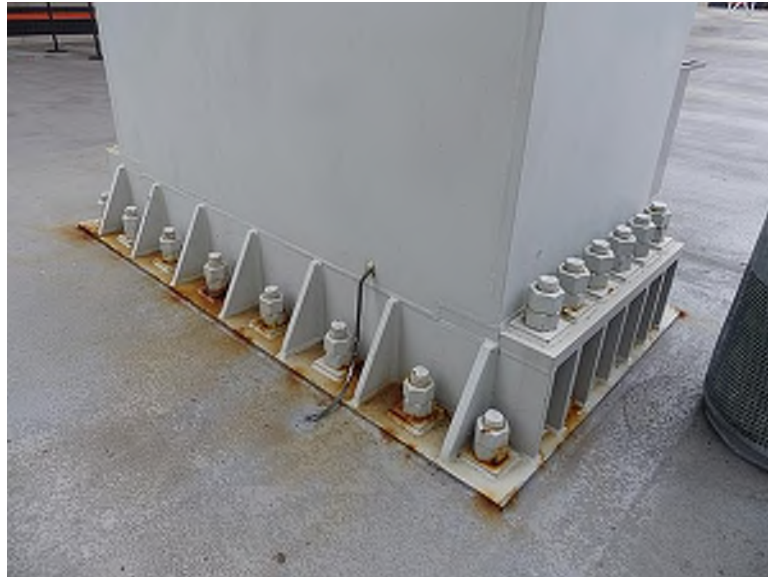
Corrosion was present along the baseplate of the scoreboard support columns. The steel was said to have been painted sometime in 2020. It is likely that sustained moisture along the baseplate has deteriorated the protective coating

Corrosion along the baseplate of the south scoreboard support column

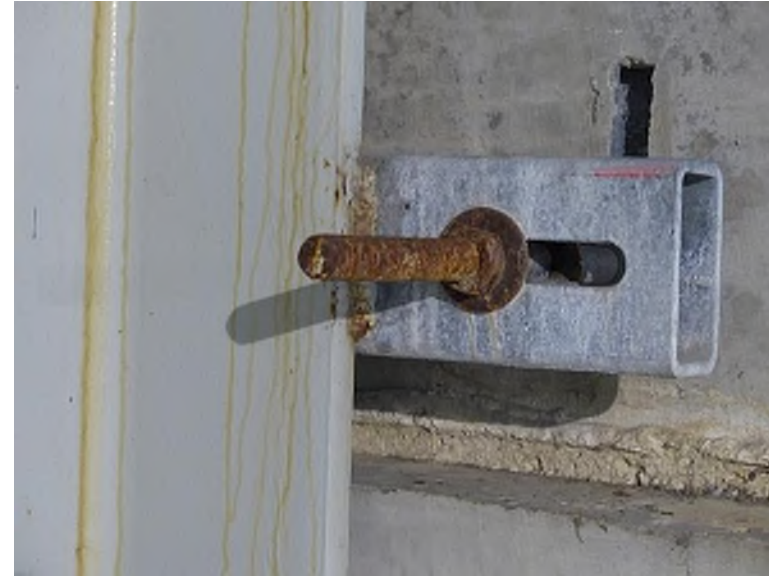
Corroded precast façade panel fasteners are due to water leaking down from corroded ramp or stair composite decking.

Corroded bolt, nut, and washer at the connection between the precast faced panel and steel support structure (Southeast Ramp)

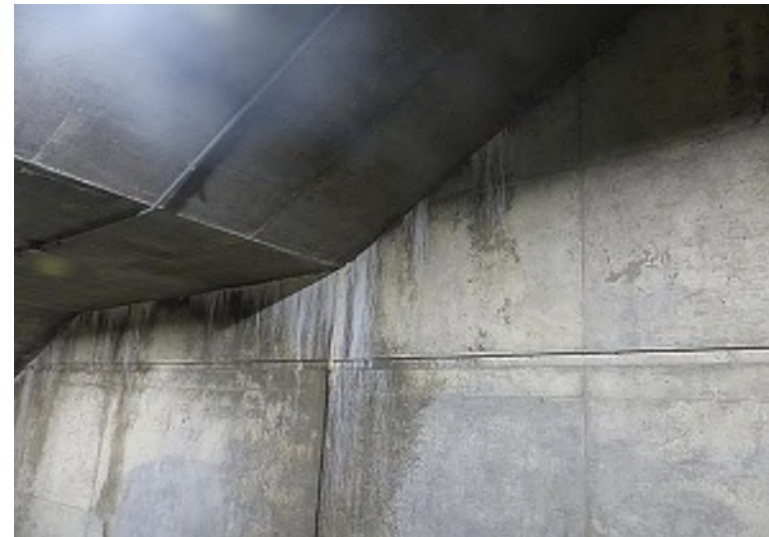
Concrete leaching was located along exterior concrete surfaces. It is likely water is entering the concrete structure through cracks or deteriorated sealant. Leaching can occur due to moist conditions, especially since the concrete is exposed to the elements and likely unsealed.

Concrete leaching below the exterior stairs that lead to parking on the east side of the stadium

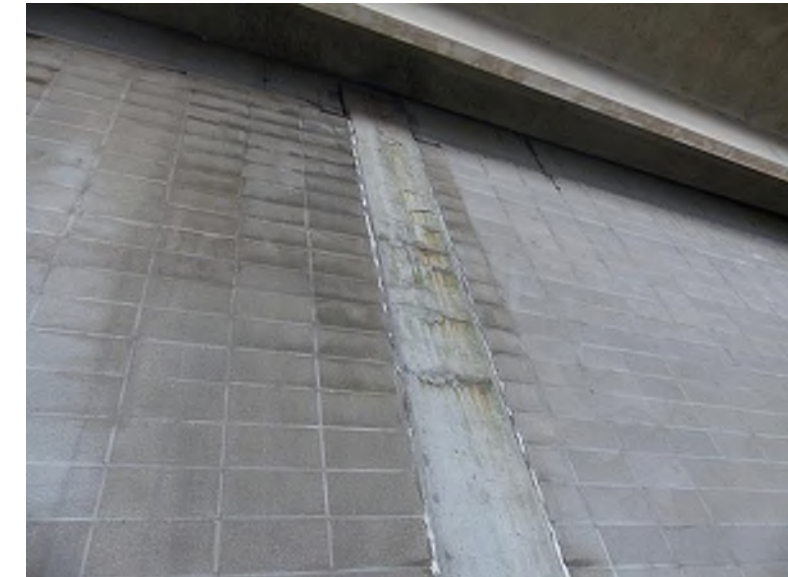
Delaminated concrete on column along exterior concrete masonry wall at service level

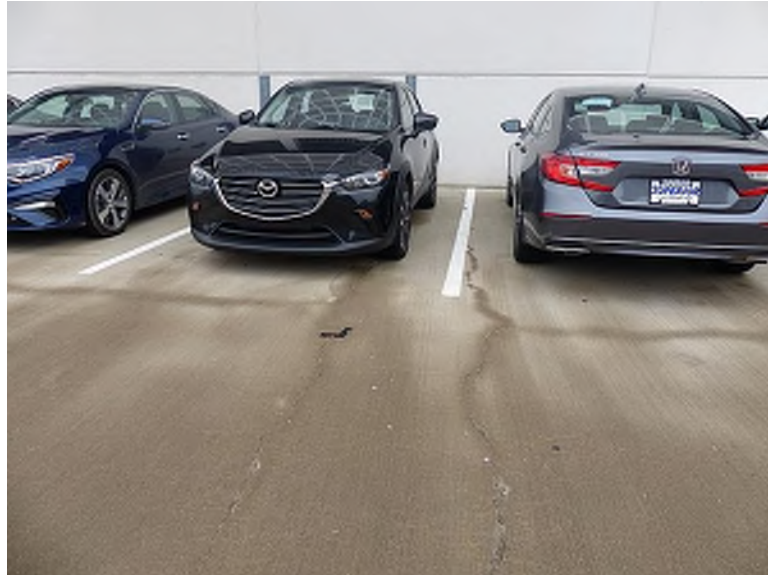
Cracks were present in the topping slab of the elevated parking level surrounding the north and east sides of the stadium. The cracks were primarily occurred at the locations of the concrete beams and girders below. Cracking is likely due to the slab located over the beams having more stiffness and the adjacent area of slab having more flexibility, so cracking gradually occurs as cars drive over the surface.

Cracking in parking lot topping slab that follows edge of concrete beam below

13. Repair minor cracks in non-structural topping slab with application of traffic coating over the affected surface. Cracks and divots shall be properly prepped prior to the traffic coating being applied and any fills or caulking used shall be compatible with the traffic coating.

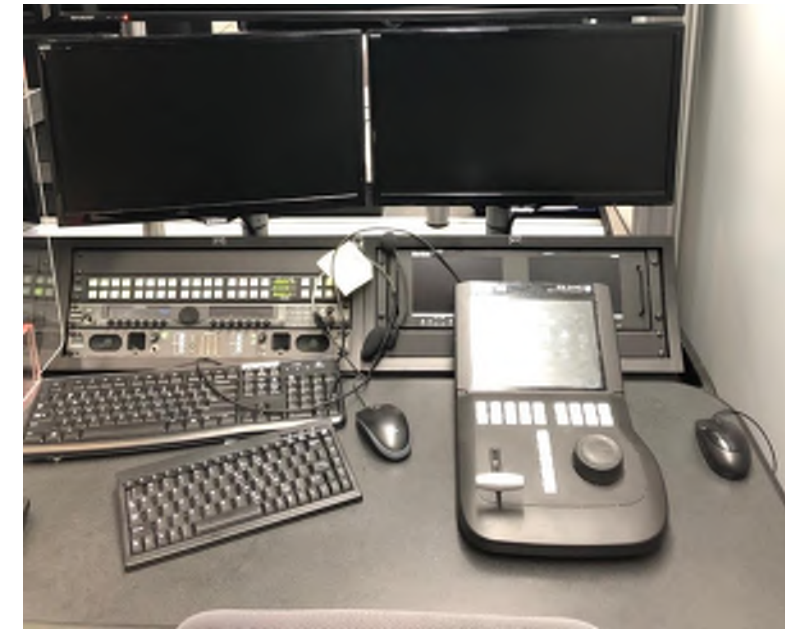
Legacy slow motion system

The slow-motion replay system is based off the now-discontinued Grass Valley DYNO replay system. There are ten inputs and four outputs. For the existing system this is sufficient, but the technology used is aging and no longer supported. A new replay system that should be considered should be almost doubled in the number of inputs to support multi-phase high frame rate recording. Additional features such as automated clip tagging, collaborative replay, real-time slo-mo editing and export to a master media asset system are all features not currently had on the existing systems that all modern NFL teams are able

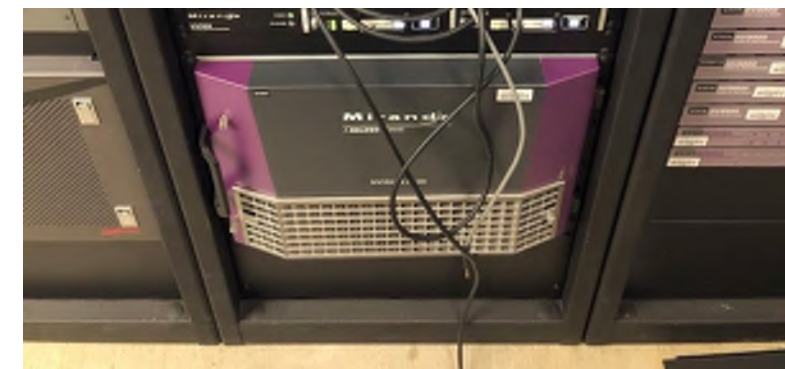
Legacy core video router

The video production system core is based around a Grass Valley NVision routing system with Evertz, Ross & Grass Valley distribution equipment. While this equipment is suitable for baseband production, the future of video production has moved away from large scale central RF video routers and components. Updated IP SMPTE 2110 systems rely on high performance network switches for core routing and reprogrammable FPGA software-based processing to accomplish what used to require dedicated specialized hardware. Additionally, this routing platform has been discontinued by the supplier and while reliable, is beginning to show its age. As these products no longer receive software updates/patches and as computer technology progresses, they become more difficult to control and run the risk of no longer being able to be accessed by their control systems due to the software not being executable. Additionally, should a failure occur, replacement cards will from the manufacturer will no longer be available after 2021.

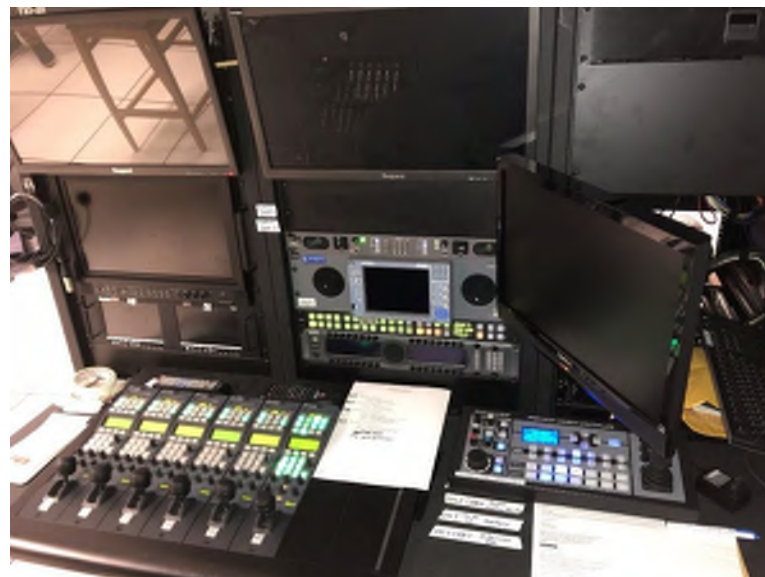
Camera control station supports (6) manned cameras

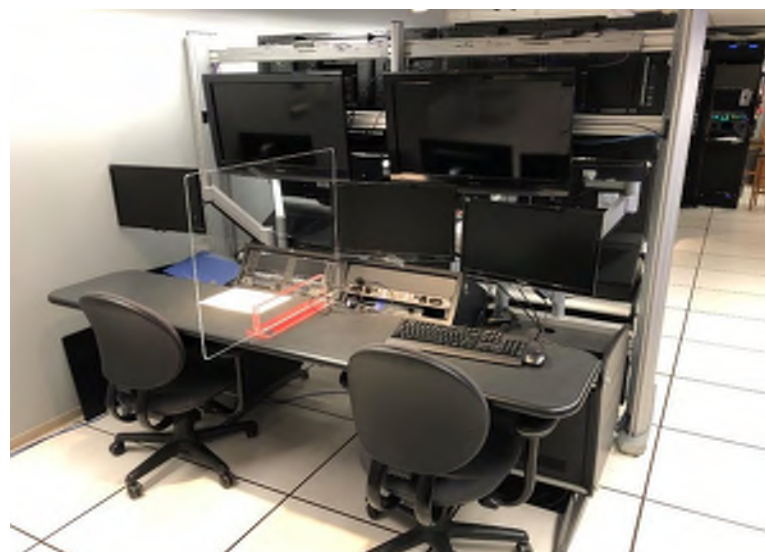
The video production room at Paul Brown stadium has both adequate operator and equipment rack space, but will need modifications to the layout of the room to solve several of the challenges in upgrading the production system as seen in newer NFL facilities. The chief complaint of the current room is not enough dedicated operational positions and multi-viewer monitor systems to expand. This could easily be remedied with minor spatial modifications to remove the production islands and replace with long rows of operators. With additional cameras and high frame rate cameras, more operators will be required to support those technical systems.

Production islands not optimizing space

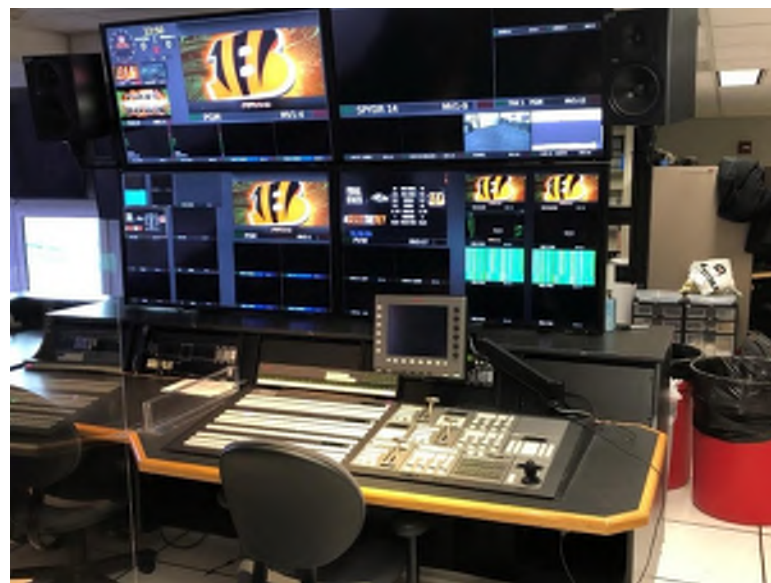
The video production switcher is a 4M/E Ross Ultrix Acuity switcher sized with 80 inputs and 80 outputs, installed prior to the 2021 season.

Ross Vision switcher

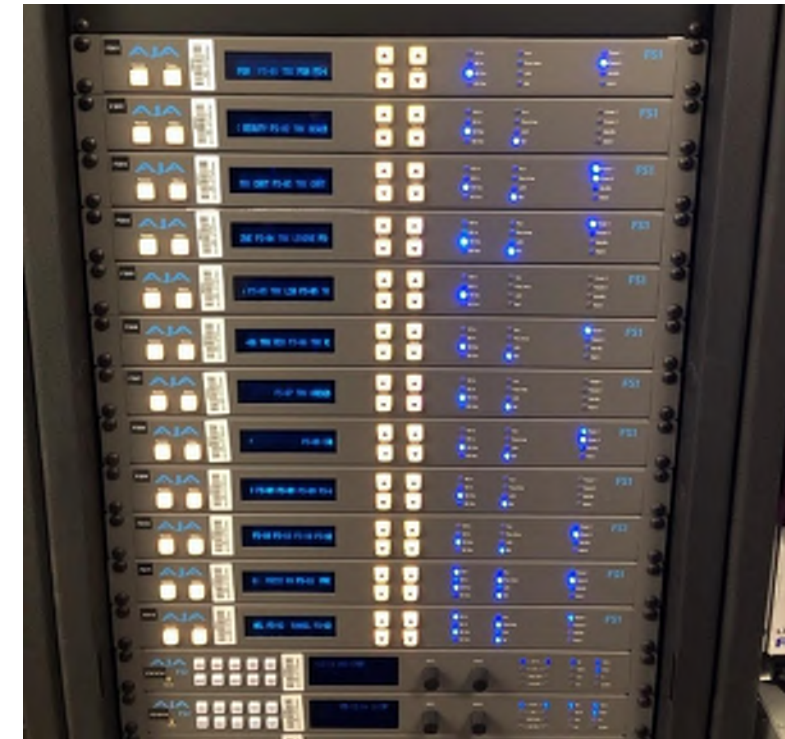
A sizeable amount of Rackspace and power is currently being utilized by AJA FS1 frame synchronizers. Not only have these devices been upgraded over time, they have also become more dense to allow more processing per RU. Upgrades to these systems to newer hardware will result in a decrease in power and cooling consumption.

Frame synchronizer rack

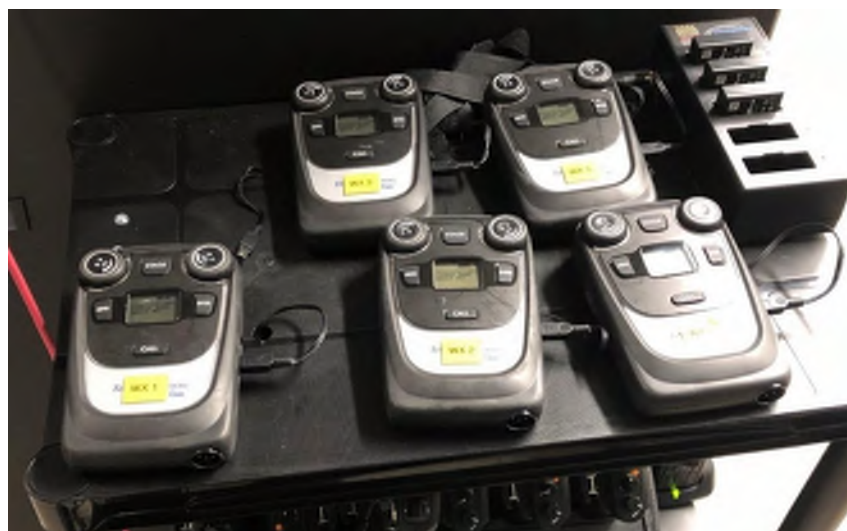
The production intercom system is based around the RTS Adam platform with wireless being provided by Clear Com tempest. While the matrix intercom solution is efficient and still in production, the technology is showing its age. Modern matrix intercom systems utilize AES 67 across network switches for communication. The current system is currently operating over analog four-wire technology with serial control to each panel. Over time and as the cabling degrades more noise will be noticeable on each of the channels and point-to-point cross points within the system. A modernization of the system to a comparable RTS Odin or Riedel Artist is recommended. Additionally, the Clear Com Tempest system has been discontinued for a number of years now and will soon be almost inoperable. As cellular networks have evolved and FCC frequencies adapted to allow for a larger amount of spectrum to be used for wireless services, this has made the tempest system almost unusable. A modern matrix based wireless intercom solution utilizing the DECT bands with multiple access points installed throughout the stadium is required to allow for communication between the control room and production staff elsewhere in the building. A minimum of fifteen belt packs is desired for this production group and a DECT based system allows more to be added in the future.

Discontinued wireless intercom system

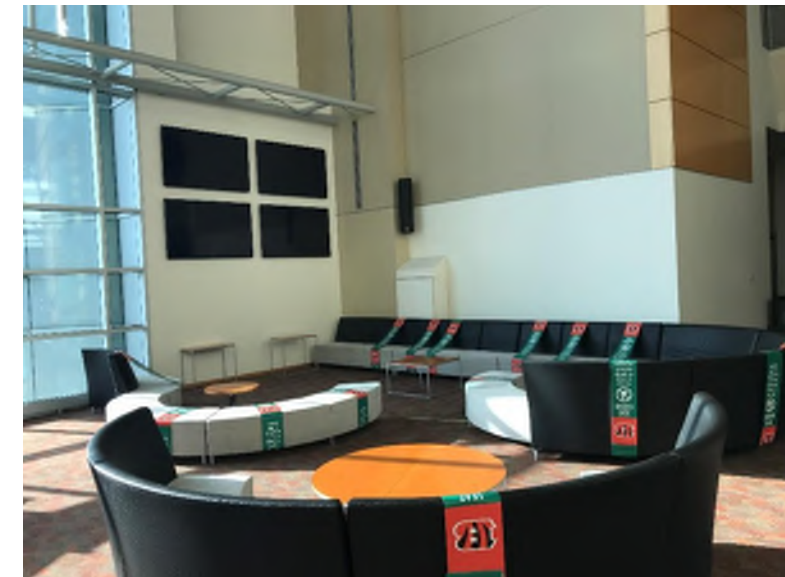
There are only a few locations within the east and west clubs to insert an audio or video signal into the in-house cable television system, and once added there are further limitations on which televisions in the clubs as to where those signals can be displayed. There are clusters of four televisions that have very large gaps between them so they could not, if the necessary electronics were available, be used as video walls.

Four display TV cluster

During prime-time television slots in a premium sports venue space, one would expect to be able to see the Bengals game, away games or major events, fantasy stats and RedZone, so a higher display count narrow bezel video wall or large segmented LED display would be better suited to draw and keep fans in these areas.

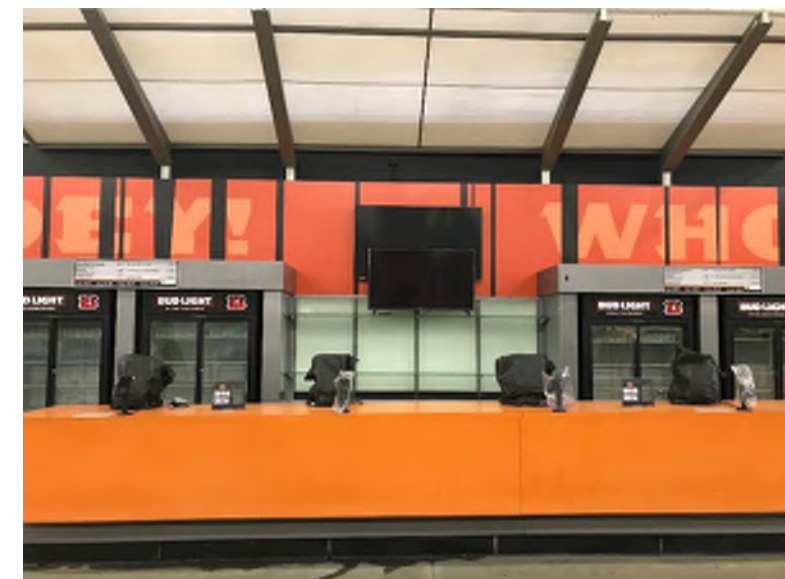
Concourse concession displays

This concession would benefit from a refresh of AV technology tied to the larger stadium system to benefit from dynamic messaging. Cisco, TriplePlay and VITEC have digital menu

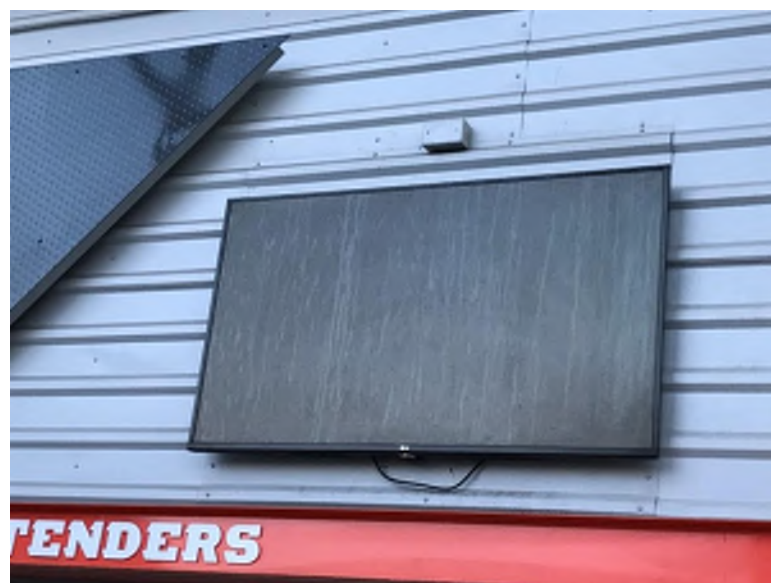
Fully exposed non-outdoor rated television

The television displays throughout the stadium are functional, but with so many different makes and models there are no standards for image quality, any type of remote management and no common metrics for latency or channel setting. In order for operations to turn on all displays they must carry at least five different remote controls from various manufacturers/types.

A plan should be developed to replace these displays in the next 12-16 months as failure rates will begin to increase after the current winter season, especially for the displays near concession stands and exterior concourses. That said, the majority of displays still look reasonably good, so complacency in planning this step must be avoided.

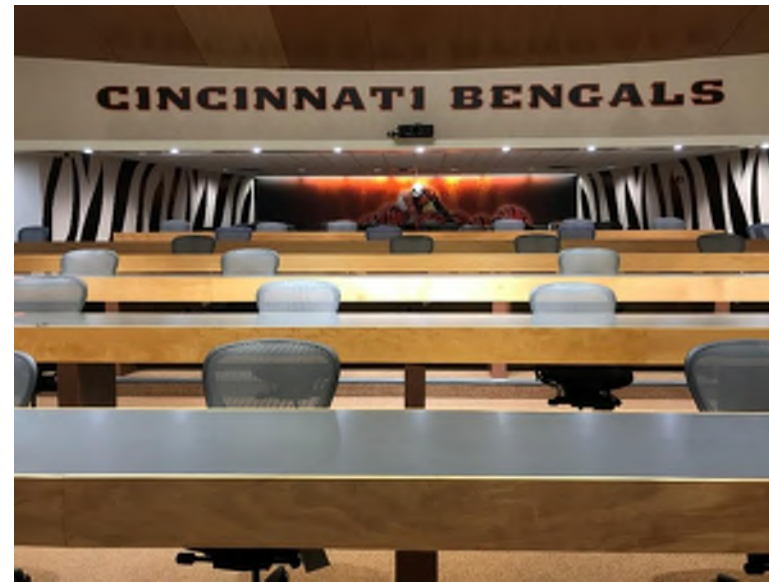
Offense Team Theatre

While the computers have been kept current, the projector cable infrastructure is from original construction. The existing projectors are commercial grade rated at 6000 ANSI lumens for larger venue use but this relatively bright environment needs a projector rated closer to or greater than 15,000 ANSI lumens to not be washed out by overhead lights.

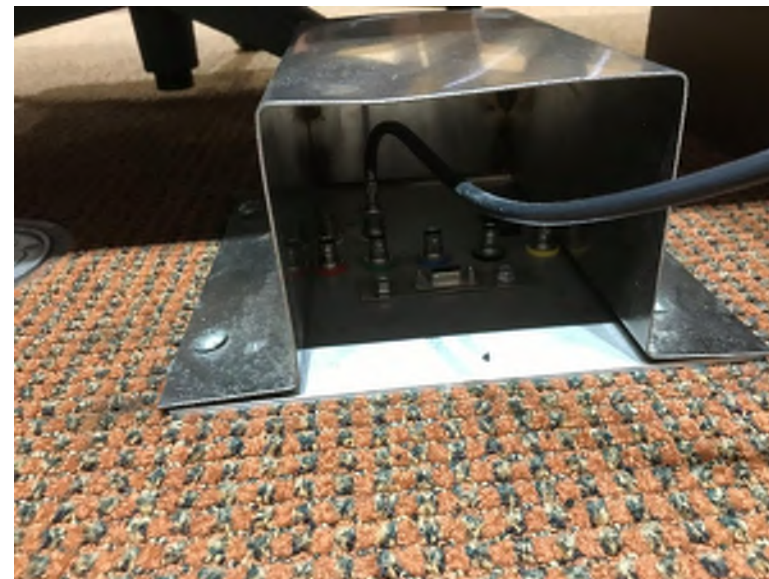
Theater projector input plate

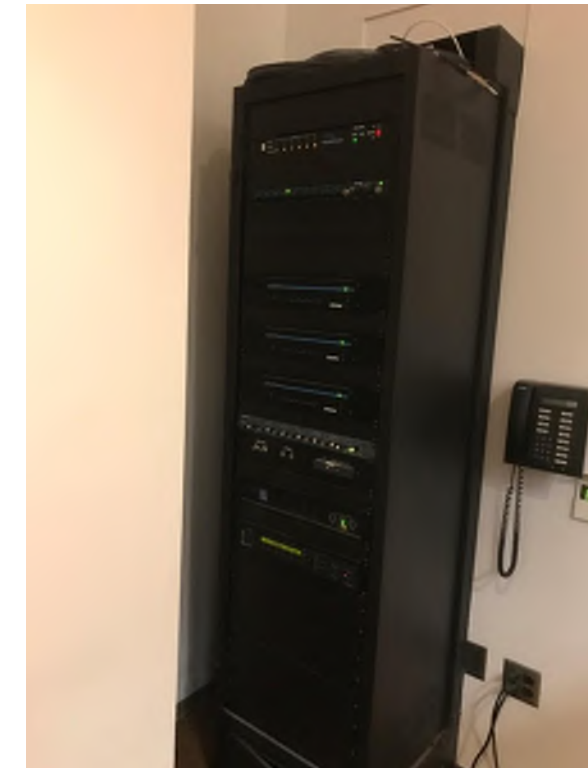
The theatre wireless microphone base stations, processors and amplifiers for the sound systems are housed in equipment racks at the front of the room. These systems are at end of life and should be replaced.

Team theatre equipment rack

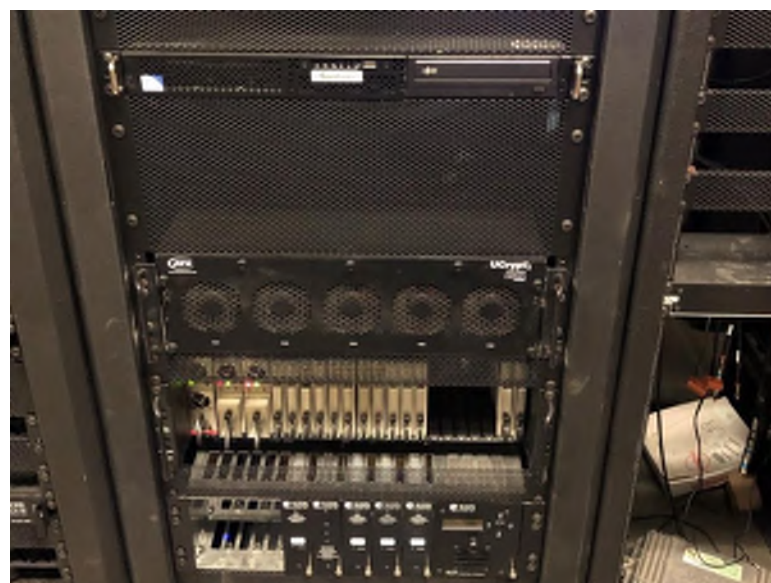
The head end is located adjacent to the MDF on the Service Level near main security. The distributed TV system at Paul Brown Stadium is based on an RF-QAM hardline distribution system with the primary system launch from the headend. The system was upgraded in 2014 with a new UCrypt for management of the cable feeds being provided by Charter Spectrum with an ATX UCrypt device.

Cable TV provider demark

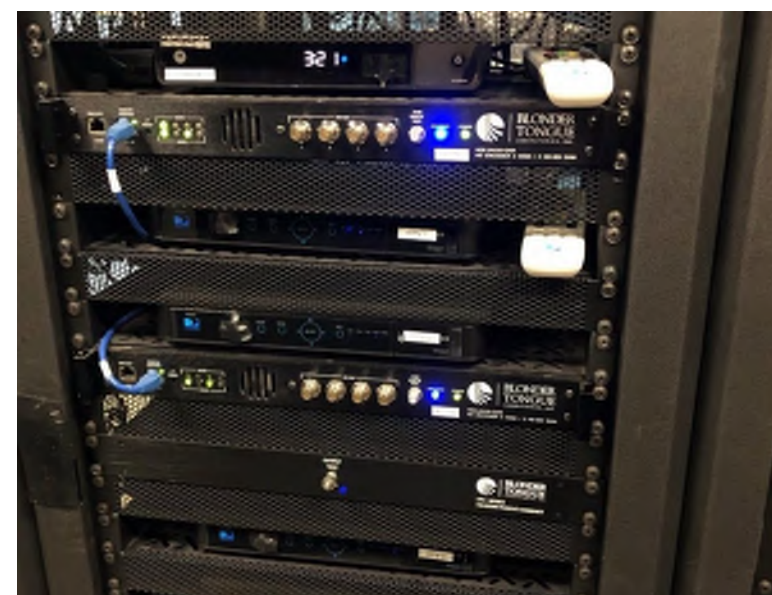
Additional sources in the cable plant are several DirecTV receivers attached to QAM modulators as well as four (4) feeds that originate from the in-house video production system. The average latency on the in-house feeds is around 2-4 seconds. This amount of latency, while somewhat of a distraction if in the sightline of the live event, has come to be appreciated by those not in view of the field as a way to quickly review an exciting play based on crowd noise.

Satellite receivers & in-house feed encoders

Upon observation of the DTV head end equipment racks it is clearly noticeable that the system has been upgraded several times within the life span of the facility. There are numerous abandoned pieces of equipment, cables, etc. that are no longer in operation and should be removed and recycled. The environmental control system in the space does not appear to be properly filtering air as the majority of the equipment was extremely dusty. RF equipment does not need to be in a perfect clean room, but standard care of electronics equipment does apply, and the equipment should be cleaned regularly. This will allow additional lifespan and optimal operational standards. Overall, the room would benefit from a deep cleaning, removal of all decommissioned equipment and cable management inside the racks and onto the walls.

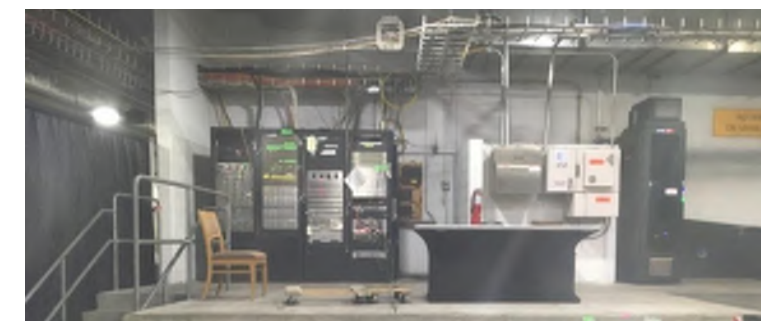
Existing network racks, AT&T (common carrier), and NFL Technology racks

As can be seen from the photo above, the existing network racks (4 racks on the left) are installed on the loading dock platform. The right single rack is the NFL Technology rack. As part of a 2021 capital project, Paul Brown Stadium will be performing upgrades to the TV truck dock and selected field junction boxes. Upon completion, the network broadcasters should be consulted to identify additional areas that may benefit from future upgrades.

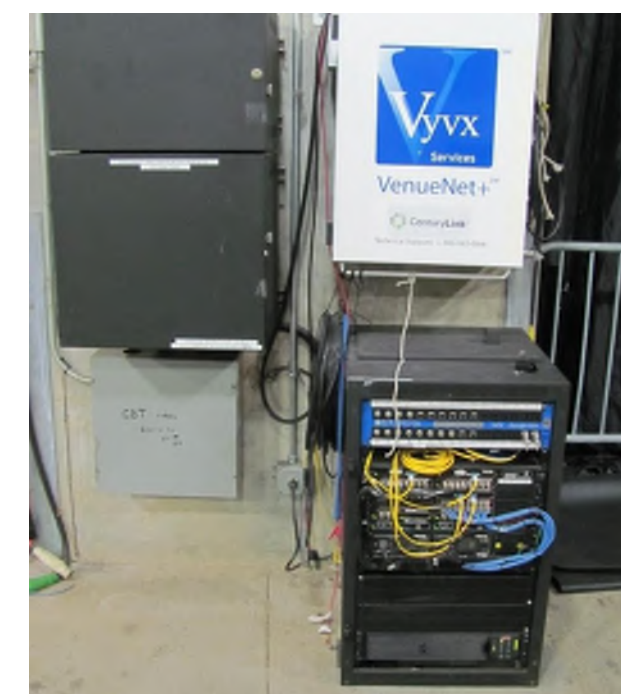
CenturyLink and The Switch (Common Carriers)

The fiber optic back haul carrier’s equipment has been added. These companies take signals from the TV trucks and leagues and send them over high-speed fiber optic networks to league replay systems and broadcast network home studios. The photo below shows the cable termination rack compliment at SoFi stadium for comparison with a brand-new stadium installation

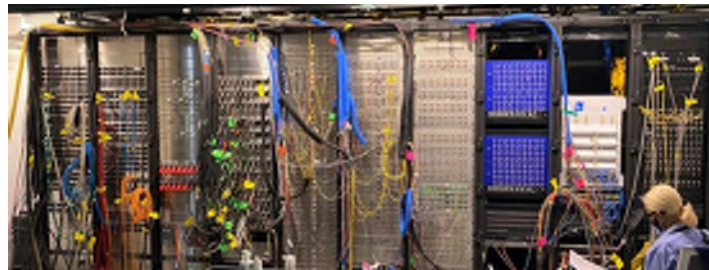
Cable termination room at SoFi stadium, for comparison of NFL Standards. Sliver panels are network installed, black/blue are in-house and common carrier I/O panels

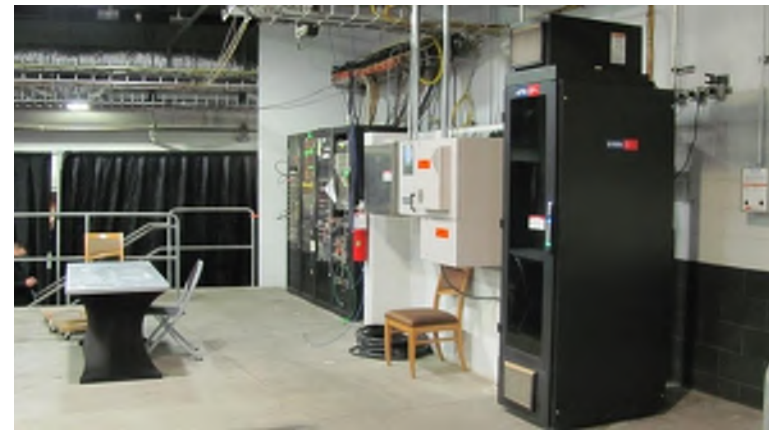
The current NFL technology equipment rack is located on the loading dock as shown in the photo below. In new construction projects, the NFL has additional equipment racks and is requesting a dedicated room or a fenced/secure space within a shared room. Starting with the 2021 season it is anticipated that the NFL will switch to the Hawkeye review system which may require additional cabling to the Hawkeye camera locations and additional rack space required for servers.

NFL Technology rack at truck dock (nearest rack)

The NFL instant replay cabling has been continuously upgraded as the league has evolved the system over the years. This will continue. Other than the overall NFL technology equipment space requirements, the existing pathways are sufficient to accommodate future (known) changes. The NFL technology cabling needs to be identified to keep it from being removed. We recommend contacting John Cave or Chris Vassallo with the NFL to see if any changes can be coordinated with the broadcast cabling update.

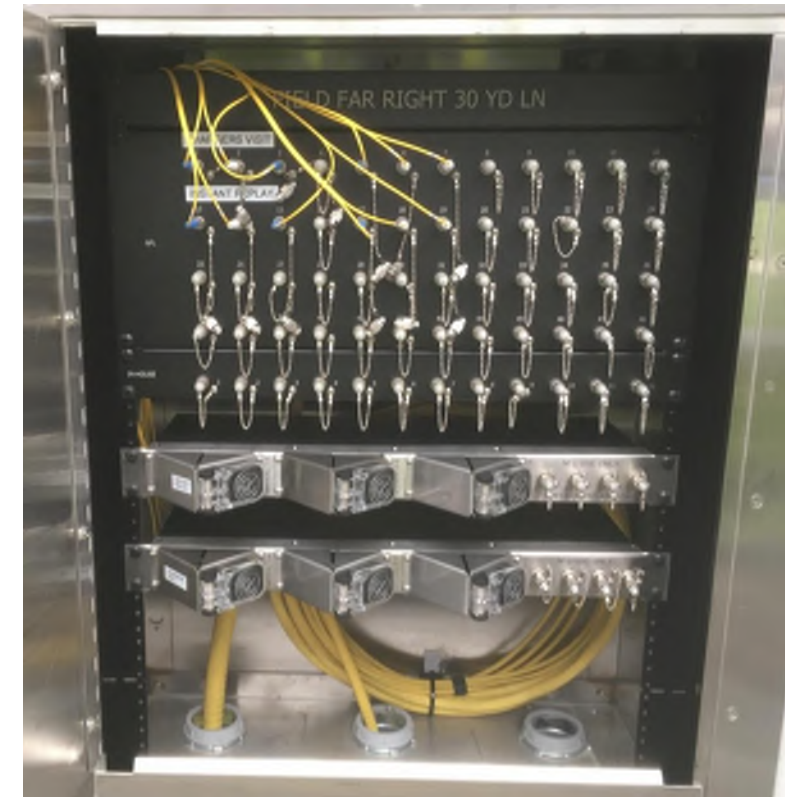
The images below illustrate the additional cabling now being installed by the NFL for the sideline instant replay junction box. The newer stadiums have more single mode fiber to support future NFL technology changes.

SoFi Stadium sideline NFL box

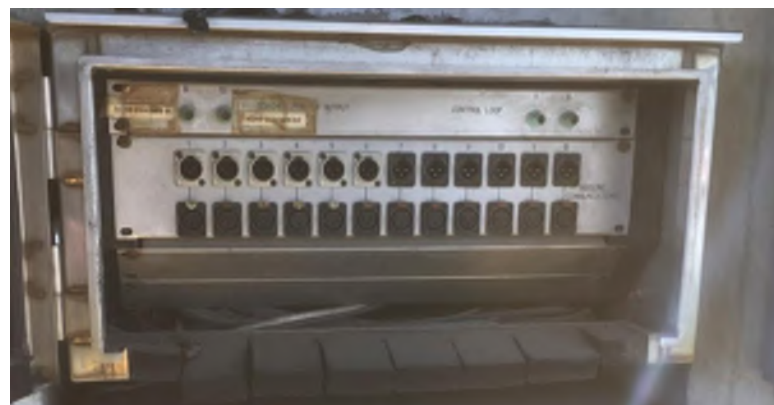
Like the other systems above, the coaching intercom system has been updated over many seasons by NFL-hired installers. The new NFL technology fiber appears to have been re-located to the old ENG field wall boxes. The following picture shows the old analog cabling panels. The old cabling and panels can be removed, and the boxes potentially re-allocated for something else.

Old analog coaching cabling at visitor field sideline

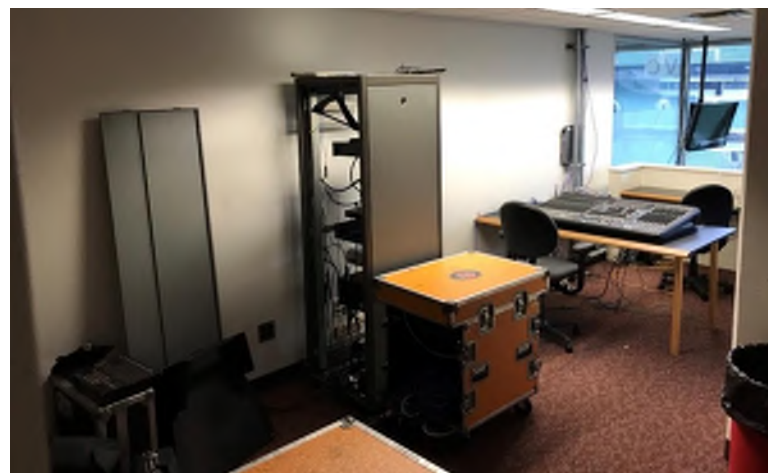
Bengals Radio. A new sound board and rack will be installed for iHeart radio for the 2021 season.

Radio cabling is not part of the network broadcast cabling update. It is recommended that 6 SFMO and 4 audio lines be run from the TV network racks to home, visitor, and national radio booths.

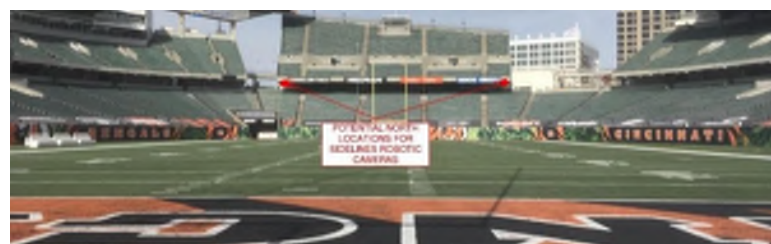
South end zone side-line camera locations

A south end sideline camera position can be accommodated on the existing coaching camera platform but will require the addition of a coiling/rollup door. The north end can be accommodated on the existing top of scoreboard and bridge positions. Each location only needs to accommodate a single camera.

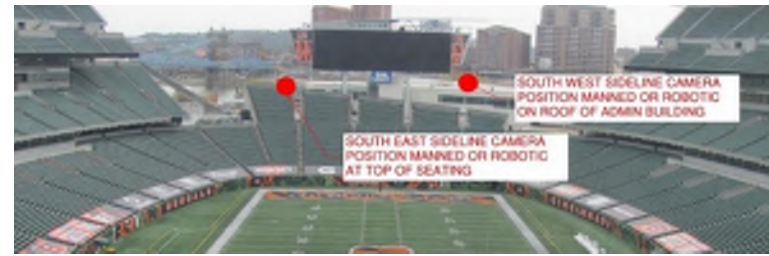
South end zone potential sideline camera positions

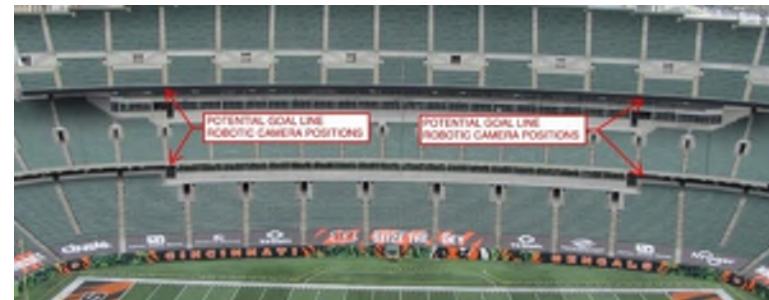
The goal line cameras are typically robotic cameras. We envision that broadcasters wanting to locate under one of the seating decks on the east and west sides.

Typical goal line broadcast camera locations for robotic or manned (East Side)

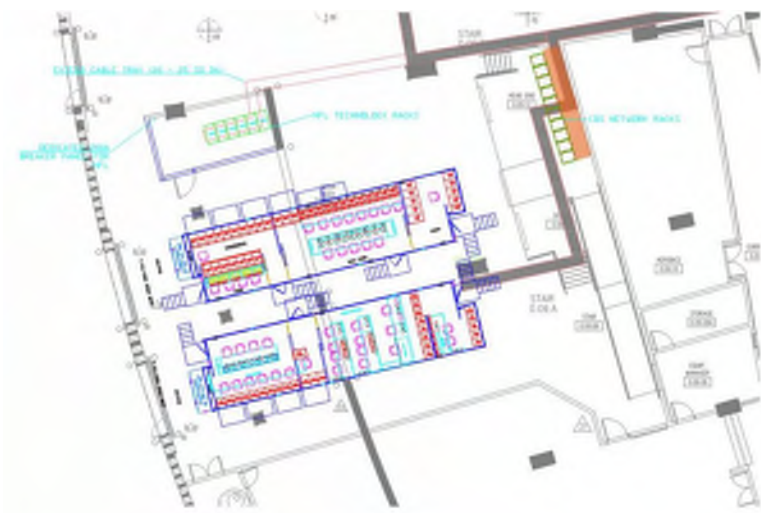
Option 2 – TV Truck Dock

1. Remove CMU bump out wall on loading dock platform, fill in floor to utilize space for racks.
2. Convert the existing network rack area for up to 10 network racks.
3. Move the NFL Technology racks down to the loading dock floor level and build new room to house the racks.
4. NFL Technology requests a 200A breaker panel in their NFL Technology room.
5. New CBS network racks will require 16 to 20 20Amp circuits.
