OVERVIEW & EXECUTIVE SUMMARY

Venue Solutions Group (VSG)[®] was engaged by Gensler Sports on behalf of Hamilton County and the Cincinnati Bengals to provide a comprehensive facility condition assessment of Paul Brown Stadium that benchmarks the current condition of the facility. As part of the assessment, VSG, in partnership with their consultant team, has developed a 20-year capital expense matrix to assist the owner in establishing priorities for major repairs, potential upgrades and maintaining the facility in a professional manner. The ability to plan and maintain the stadium as it transitions from years 18 to 30 is crucial in extending the life of the facility as well as its relevance in the competitive and ever evolving regional and national marketplace. In addition to the facility assessment, VSG has also provided information related to the practice field, bowl cleaning and event-day trash removal.

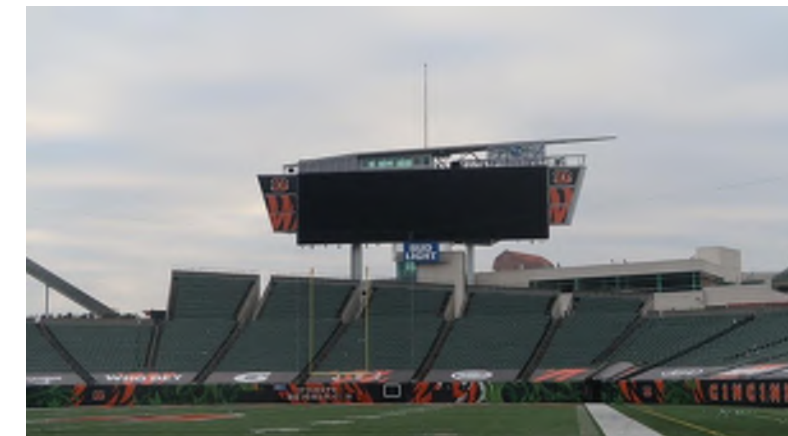
End Zone LED Display

The two main displays were installed in 2014 and are both 36' tall by 130' wide Daktronics HD13 virtual pixel pitch systems configurable as two side by side 16:9 images, 16:9 image centered with game in progress and advertising on either side or center cut of camera video filling the entire display. There are separate game and play clocks so portions of the displays do not have to be given up for those functions. In terms of size, the displays are currently 24th out of thirty NFL stadiums and, regionally, although similar product and square footage to the Pittsburgh Steelers, their displays are closer to the fans reducing viewing distances and configured by width and height to have a larger 16:9 image capability. The Cleveland Browns main display is lower resolution but approximately one third larger in square footage.

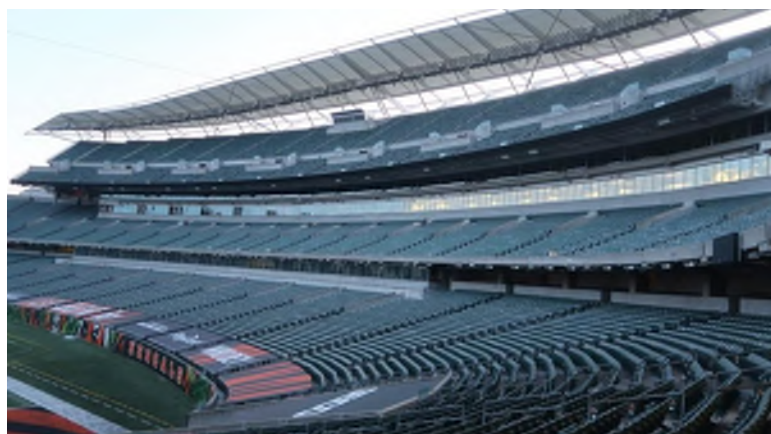
Upper fascia ribbon board display

The 558' wide by 3' tall east and west fascia ribbon displays were also installed in 2014 and are lower resolution than the main displays with Daktronics HD15 virtual 15mm product. The displays are currently functioning as intended but their control system, like the main bowl displays, is also within the five-to-seven-year window for replacement.

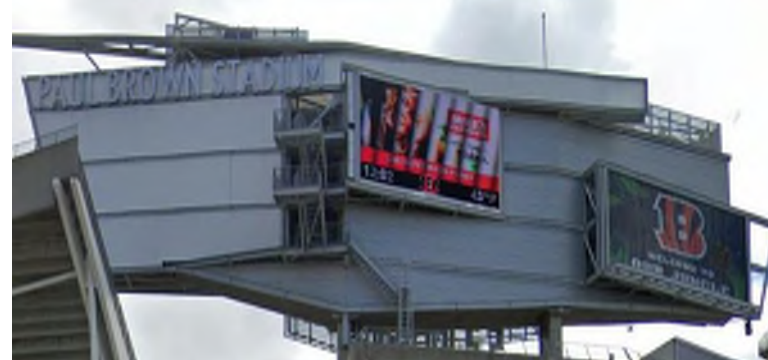
The existing exterior marquee display is beyond end of life and the system is being replaced in the fourth quarter of 2021. The adjacent rotating advertising sign will be decommissioned.

Marquee and Rotating Sign

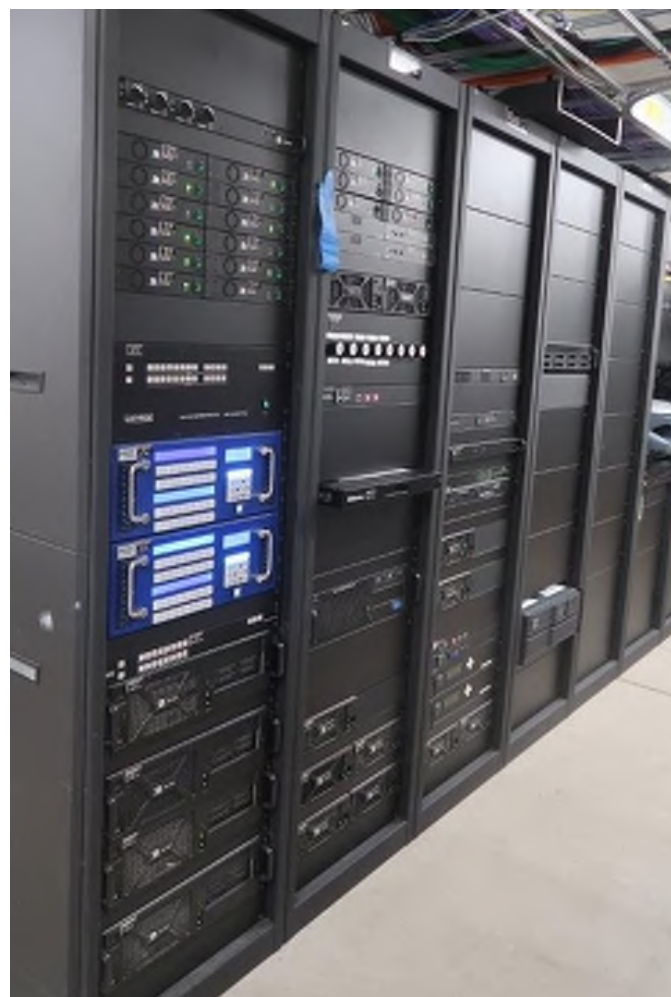
LED display control system

The main LED display control systems are currently fully functional but are in the five-to-seven-year window of consideration for replacement of computer/server-based systems. At minimum their power supplies and any other components deemed critical by service should be replaced and full assessment performed by Daktronics to minimize the possibility of failure during the football season. Coordination of replacement must be done with video production systems since LED control systems have become more integrated with them. The control systems is scheduled for replacement in 2021 pending equipment availability.

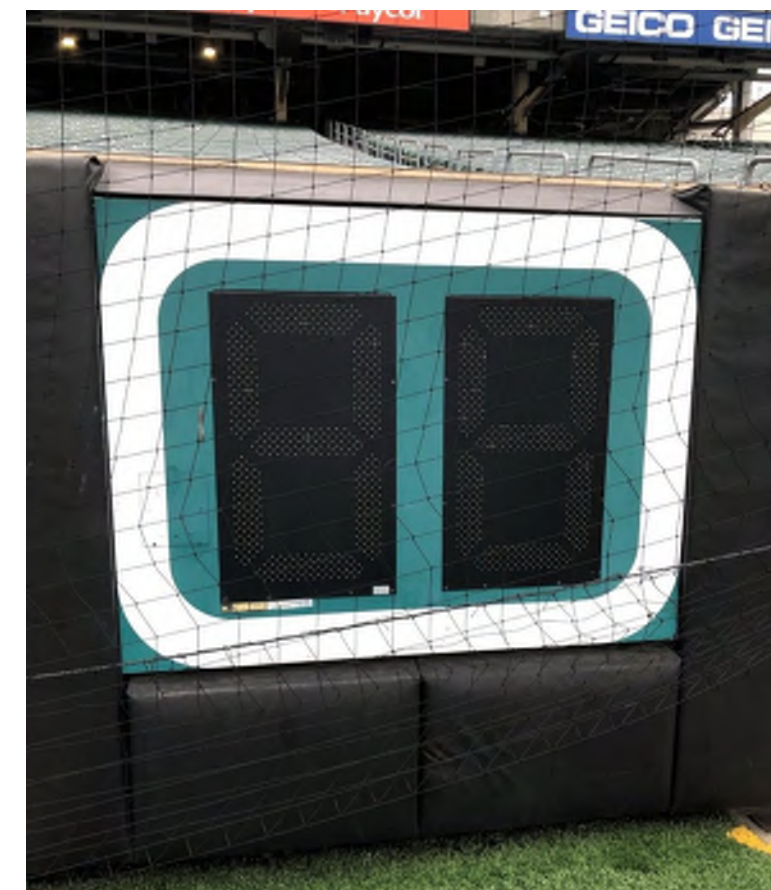
The Daktronics All Sport 5000 system located in the press box provides game scoring data to game and play clocks, video control room equipment, TV trucks and back of house clocks. There were some possible communication issues reported and technicians were on site troubleshooting. The equipment appears to be working properly so it is possible that signal cable may need to be replaced.

Daktronics play clock

Except for firmware, including sport related template revisions, the scoring system and its displays should align with future replacement of the bowl LED displays.

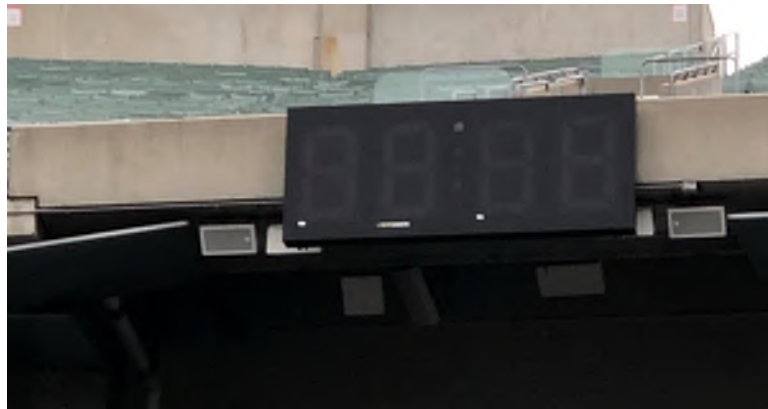
Daktronics game clock

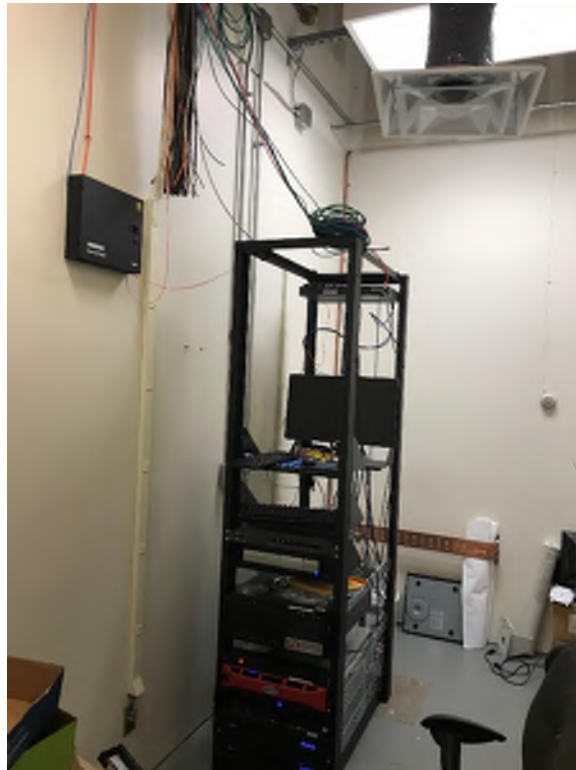
The security systems servers are in an equipment rack room in the security office and are on UPS which has capacity to transition to emergency power but have no redundancy built in. This is problematic because should a server fail in proximity to a football game, it would be challenging to get systems back online and fully functional in time for the game. When the surveillance system was upgraded, all of the old infrastructure appears to have been abandoned in place and although this could have provided a cost savings at the time, future removal may be more costly.

Security systems equipment rack and abandoned analog security camera cables

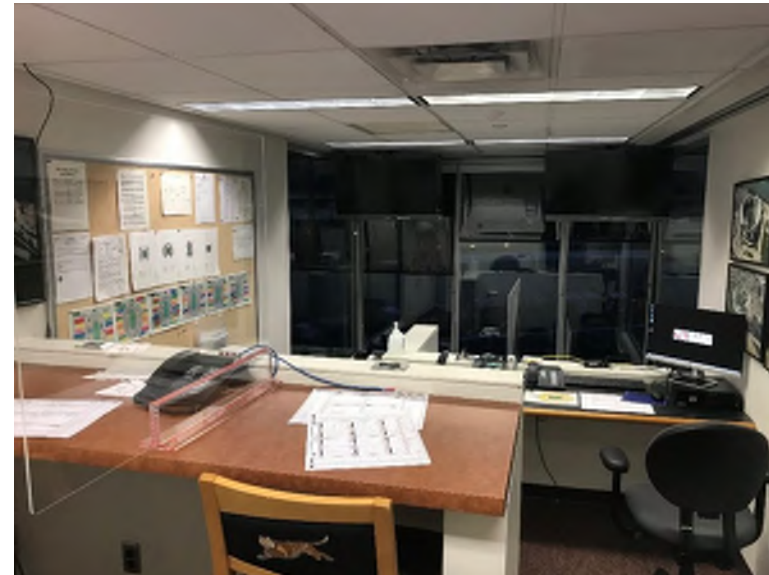
The existing bowl-facing Command Center is very small but is scheduled to be enlarged this off season to seat twenty-four to twenty-six which will be in line with the current number observed in other NFL facilities. The new space should be capable of supporting eight to nine workstations as well as a security camera workstation connected to multiple monitors in the rear second tier to share important views with the group.

Command Center

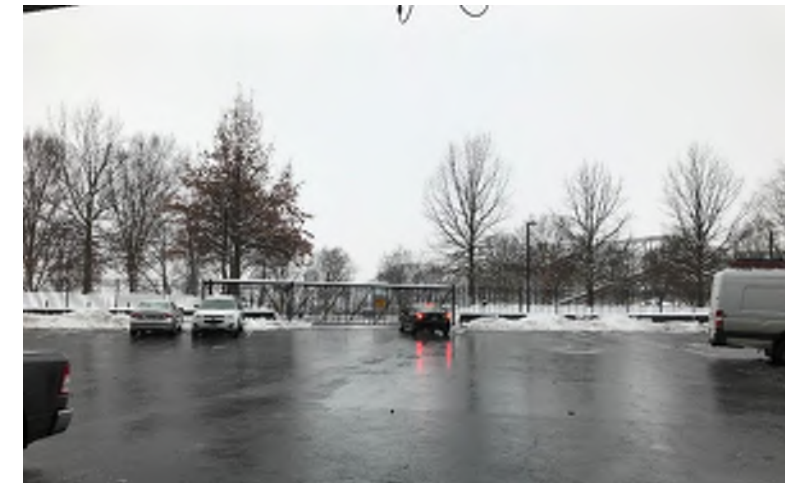
South security gate

A portable vehicle barrier is deployed at the south entry gate where there is a PIN pad, card reader and intercom on the exterior and a free exit loop on the interior. An additional scheme may need to be deployed to address vehicle piggybacking on entry. A pedestrian gate with card access is also available adjacent to the south parking gate.

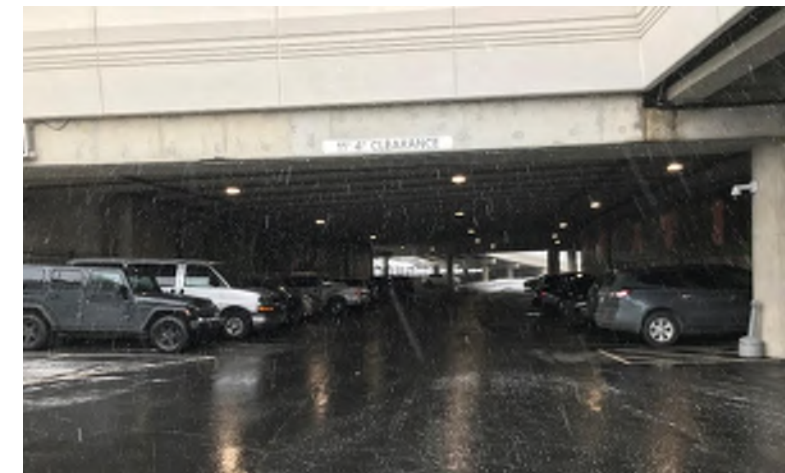
South entry player parking

There are cameras located on either end of the player parking areas that can monitor the space. Other cameras monitor the south vehicle and pedestrian gate.

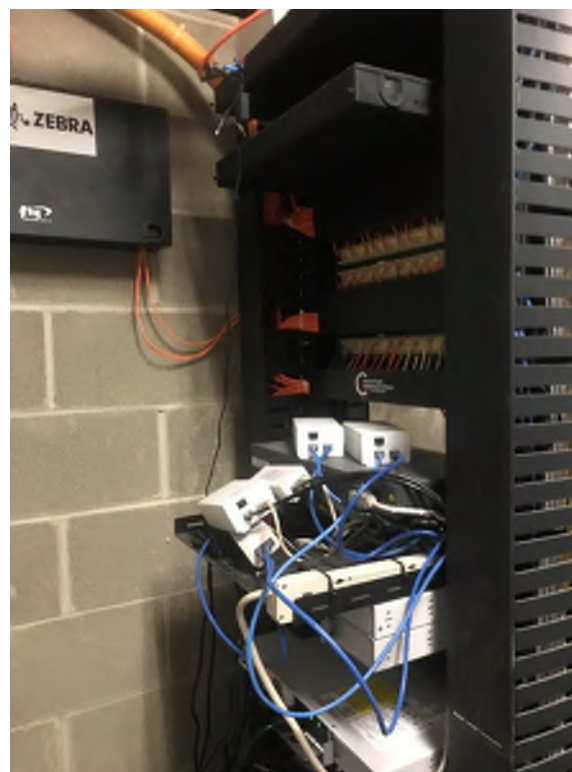
Security camera power injectors

4. Add approximately sixty-five to ninety additional video surveillance cameras to provide surveillance of forty to sixty pixels on target for every seat in the seating bowl.
5. Add redundancy to the control systems for cameras and access control.
6. Replace POE injectors with switches that can support POE.

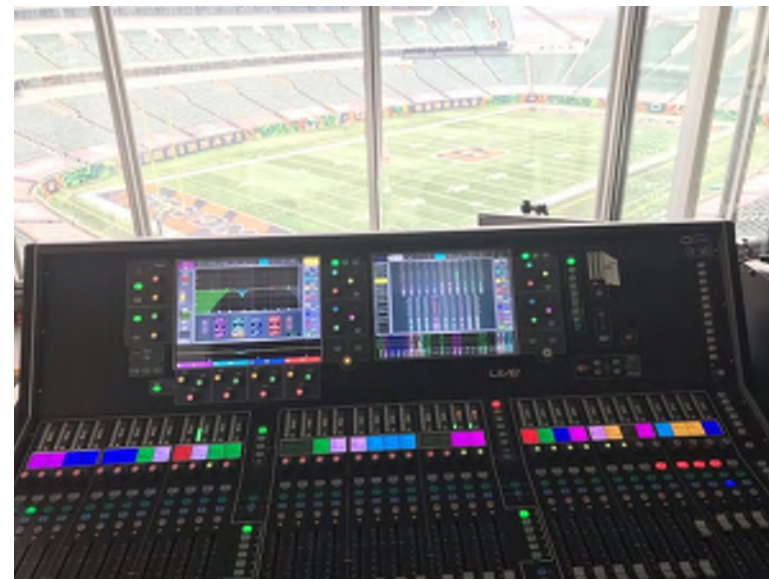
The audio equipment in the control room has been appropriately updated. Older wireless microphone systems have been replaced with current professional grade systems for both the referees and the in-game entertainment microphones. The mixing console has been upgraded to an Allen & Heath digital model and there is also a rack mounted backup mixer.

Control Room sound system console

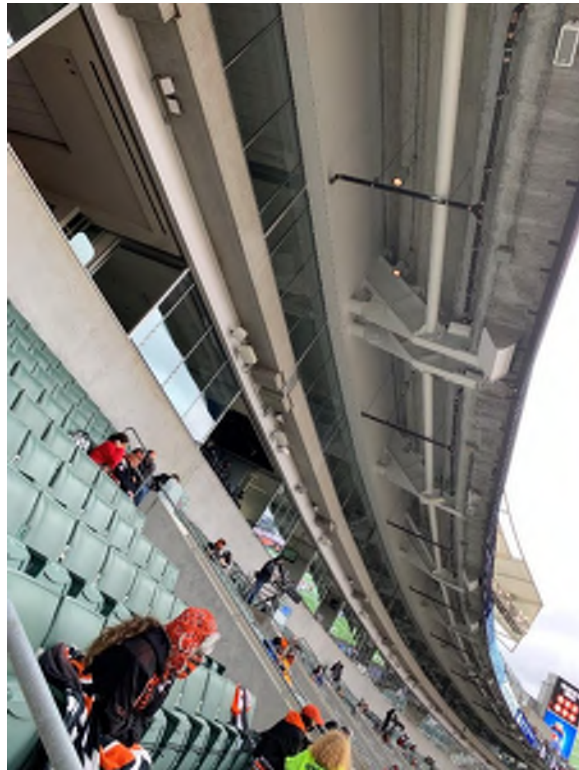
Loudspeaker located under the upper bowl precast overhang serve the lower deck.

Most of the stadium bowl speakers are installed in such a manner that they are protected from direct exposure to the elements which promotes functional longevity barring improper operation. The internal components of the speaker cabinets and speaker cones are made of paper and rubber, the voice coils are copper which are all materials that deteriorate and change properties over time. Typical speaker failure maintenance includes replacing the drivers to restore original performance. Repairing the stadium speakers is not easy or inexpensive as the devices are difficult to reach and must be brought down from locations high in the stadium for inspection and/or service. Good maintenance practice is for the seating bowl loudspeakers to be inspected and serviced on regular intervals to ensure they are working for ticketed events and reduce the chance of outright failure during use. It is recommended that the speakers be thoroughly tested prior to each NFL season. Any components that are found to be non-functional or out of compliance should be repaired or replaced.

Loudspeaker service should be recorded each season and charted to identify trends that help plan for system wide renovations. While the aging components in the speakers may still provide sound, they should be tested and adjusted to be sure they continue to provide clear intelligible voice announcements and music programs.

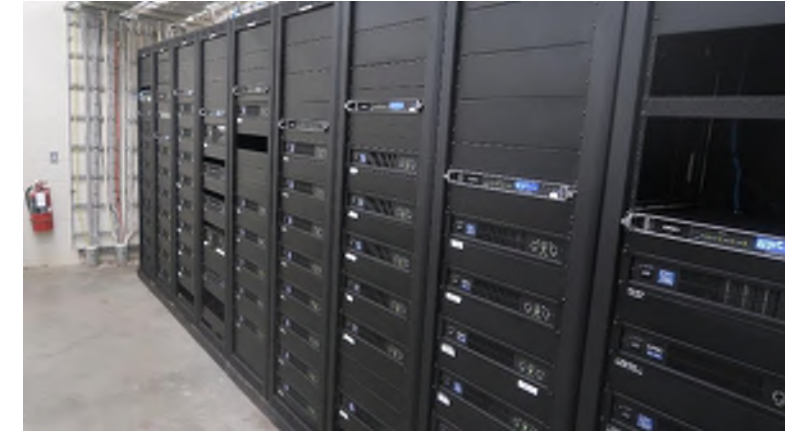
Amplifier Room

The amplifiers driving seating bowl loudspeakers are in a dedicated conditioned equipment room and monitored. The amplifiers and amplifier interfaces are refurbished products and were not replaced which puts them out of sequence with the predicted life cycle of new equipment. The dedicated equipment room provides a very good environment for the devices and effectively extended the useful life of the system.

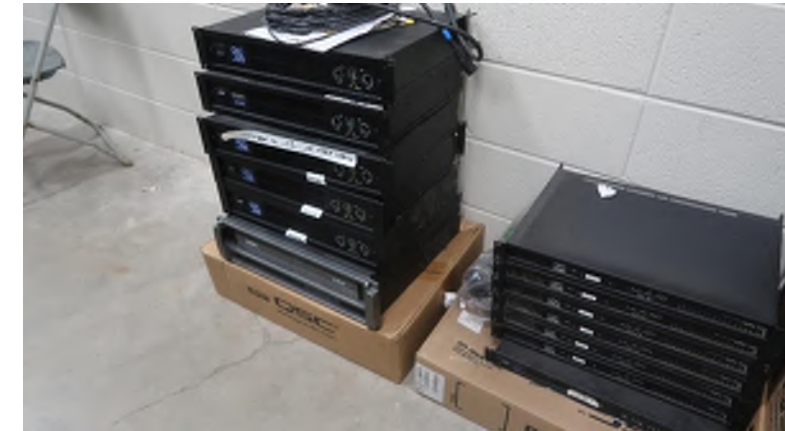
Original QSC CX series audio amplifiers still in use

Although refurbishing has extended the life of the system, an amplifier replacement project could take advantage of current technologies to provide more power with less wasted heat and control the amplifiers over the same network used for the DSP equipment.

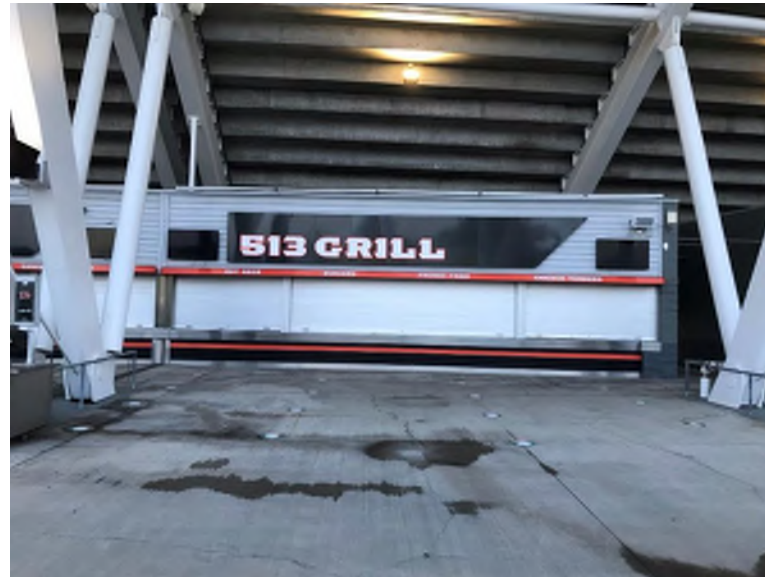
Concession stands typically have local speakers in addition to audio from televisions in some locations. The current loudspeaker strategy employs a significant distance between devices. If the distance between speakers is reduced, more uniform coverage would be achieved.

Concession speakers

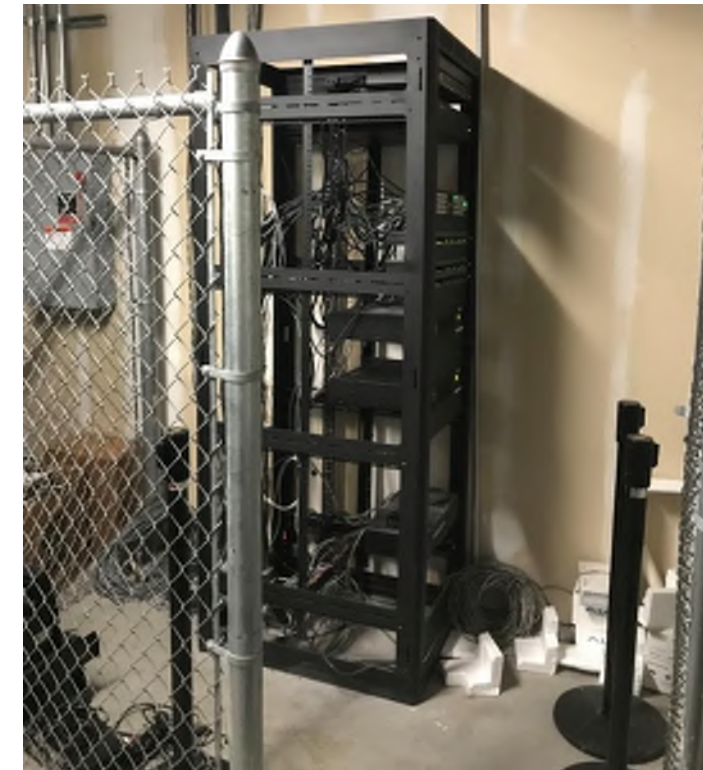
There are two identical clubs on either side of the stadium, and each has a sound system that includes overhead speakers, and a wall mounted input plate to support microphones, DJ equipment, or a small mixer. The TV distribution systems allow for local video sources to be plugged in and shown on some of the local TV's. These areas also serve as rental spaces for non-game day use. Each space has a local equipment rack with a mixer connected to an input plate on the wall with tie lines from the PA control room. The input plate is located near the head of the room near a quad TV wall while the local equipment rack is behind the bar which requires cable to be run across the floor to set up equipment at the front of the room for some private events.

Club sound system rack in local Amp room

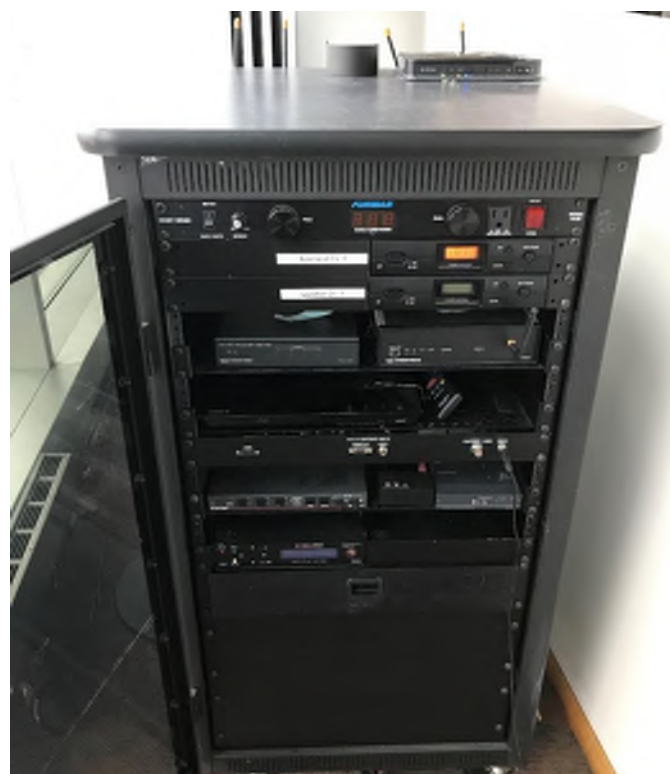
Local source input rack behind the bar

There are very limited presentation resources currently built into the club and premium spaces which makes them very difficult to set up or promote for non-game day events. With the equipment rack by the main bar and input plate across the club, cables must be run across the floor to accommodate any seating scheme that does not align with the source input plate. Content inserted on to the TV system locally cannot be distributed to all the displays because the systems are not integrated.

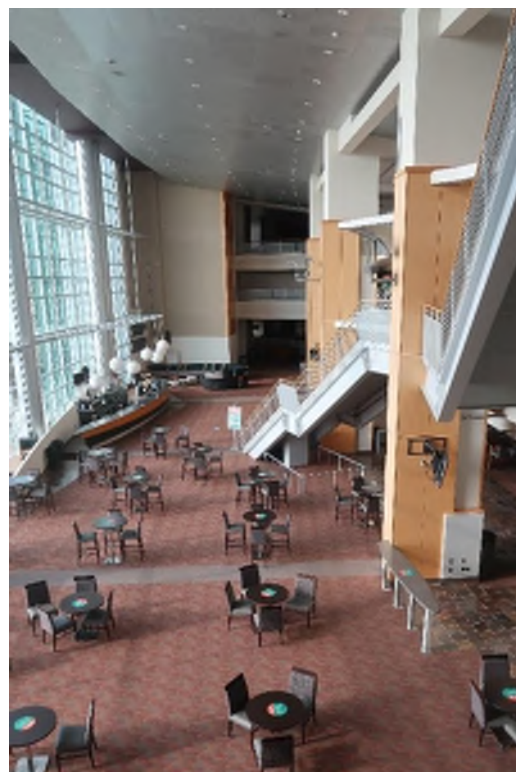
The combination of high and low ceilings requires the use of local wall column and ceiling mounted speakers to provide adequate coverage. Sound is provided by overhead speakers and controlled by Crestron touch panels. The overhead speakers provide background music and game day sound but are mounted too high and away from the audience to perform well as support for a person speaking to a group or a small band/music act. Portable sound speaker systems are brought in to support most club events.

Club high ceiling area

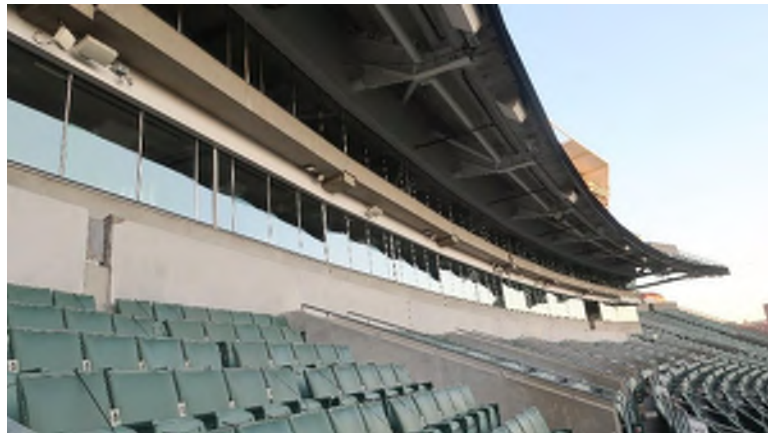
No speaker systems are provided inside the luxury suites and audio program is only on the TV set speakers. When the windows are open, sound from the bowl distributed speakers and fans wash into the space for an inclusive experience.

Bowl fill speakers covering the suites when the windows are open

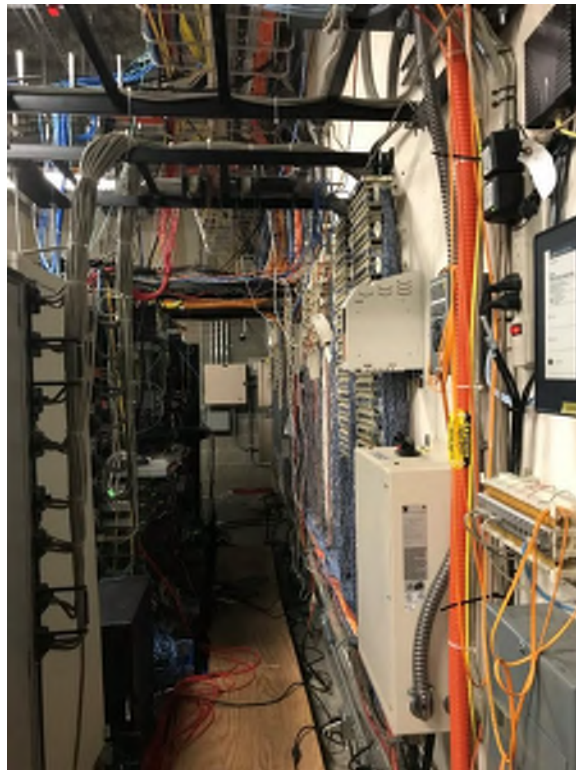
There is a lot of old equipment stored in the room with no organization. Due to the building critical nature of systems located in this space, an effort should be made to dispose of equipment no longer needed and relocate other devices to appropriate storage. Future projects should standardize equipment rack manufacturer, models and their infrastructure management systems. Redundant scalable internet services/products are available to both team and building operations delivered by Cincinnati Bell.

Wall mounted building copper infrastructure for the 700 building phone drops

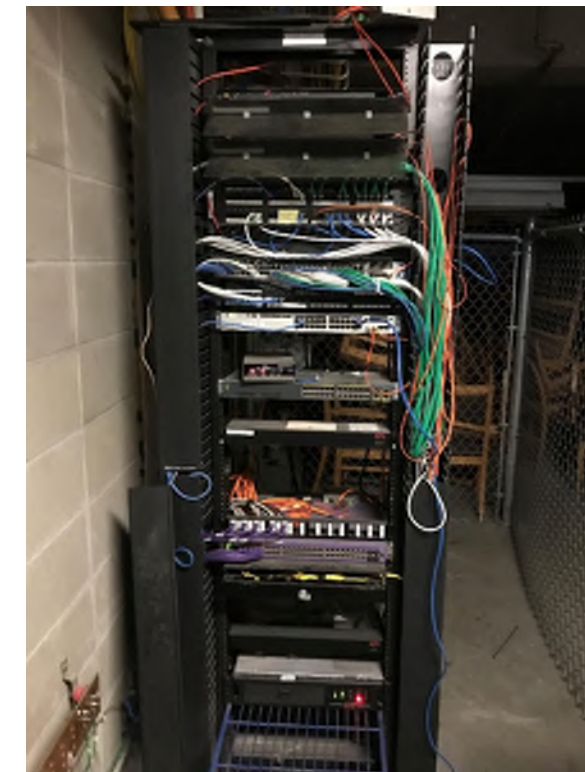
Typical IDF

IDF equipment racks observed had uninterrupted power supplies in alarm state and legacy network equipment abandoned in place. Although fenced off from the larger space, the equipment is still relatively easily accessible by anyone capable of climbing over the fence. There is a lot of dust buildup in the room which, if it gets into the equipment, can at minimum reduce the life expectancy of the electronics.

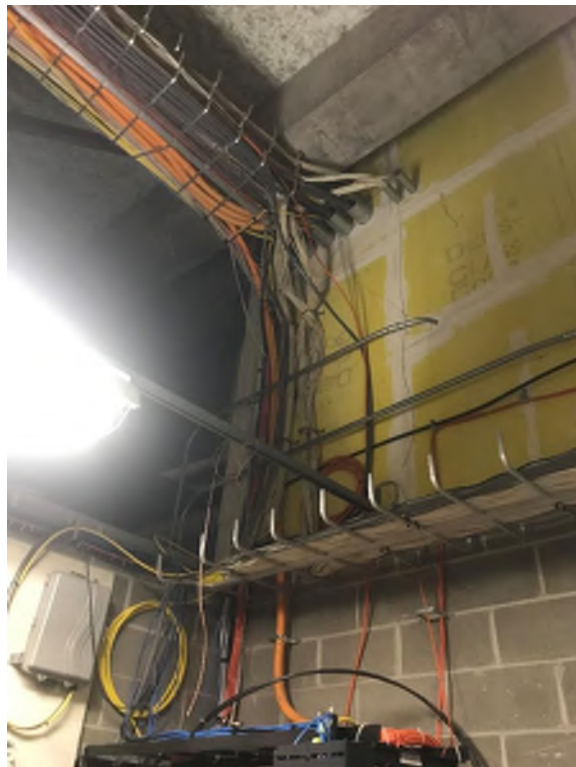
Although there are IDFs in each quad on each level, they do not stack so vertical cable conveyance must take several ninety degree turns between floors. The existing vertical conduits are completely full of cable with no room to accommodate forecasted upgrades. Solutions would include adding new vertical chases or auditing and removing any cable abandoned in place, each option having their unique and significant challenges.

Upper cable tray and conduits in the IDF are full

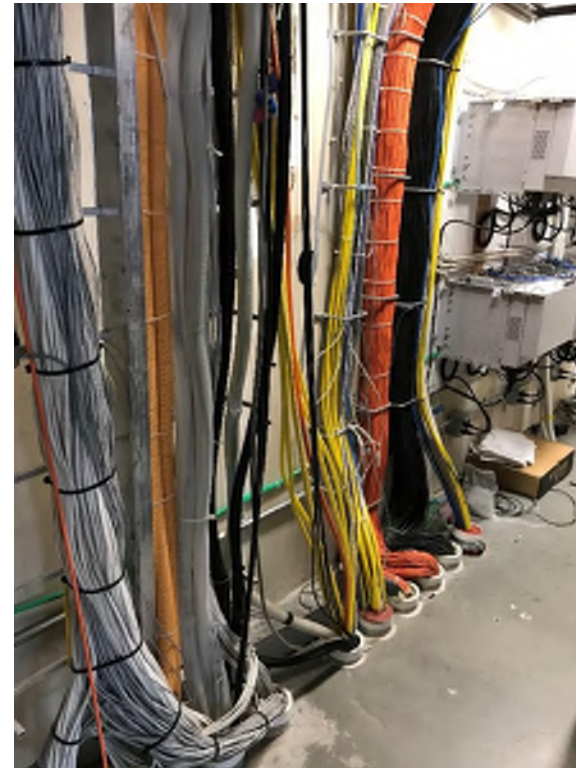
Press level IDF floor penetrations all full beyond industry recommended capacity

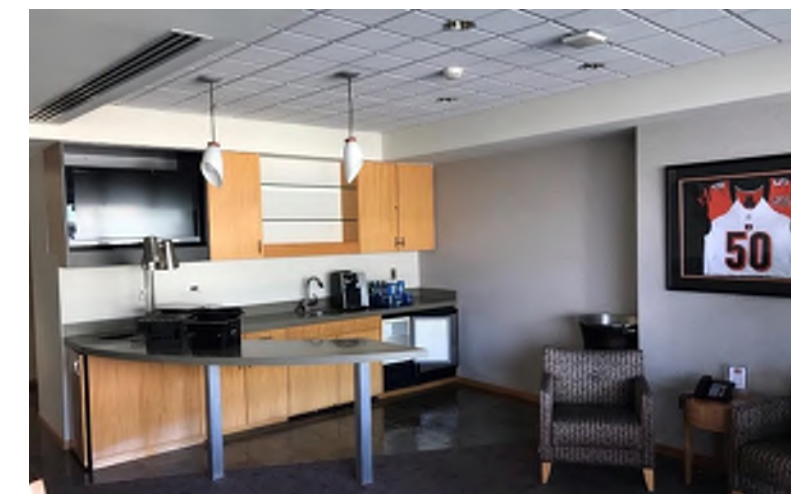
The Extreme Networks wireless solution is deployed to provide coverage throughout the stadium and appears to broadcast consistent signal strength based on random tests during the site walk. Wireless access points were observed at regular intervals in most spaces. The seating bowl coverage strategy for wireless access points is placement on walls and overhead structure which currently satisfies the needs for upper seating sections, but the lower bowl is confirmed to have coverage issues due to the long distances from access points to the targeted area of coverage. As Wi-Fi 6 technology is adopted higher density of wireless access points near fans will be required, current deployment strategies in similar venues place the access point under seat or in the handrail or a combination of both.

Access point on the suite ceiling grid

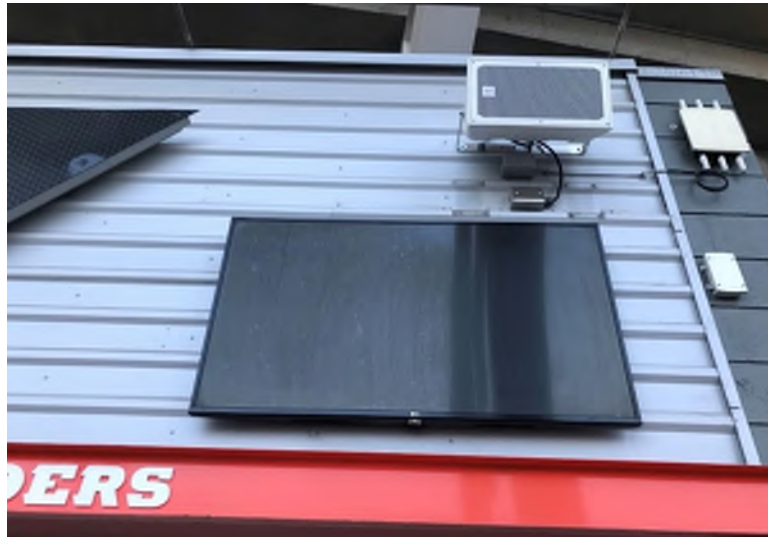
Access point next to speaker on concession stand fascia

Access points are provided near concession queues to allow fans use of their cellphones to keep them engaged, browse the web, or use their favorite apps while waiting to purchase food.

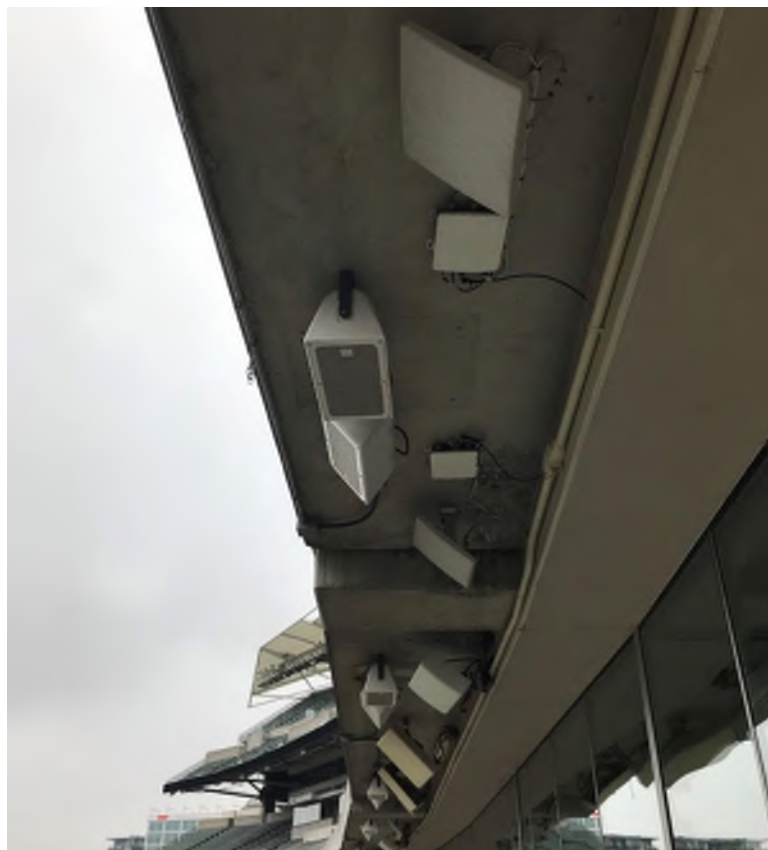
Access points and panel antennas on the bowl fascia precast

A significant number of antennas on the precast are aimed at specific bowl seating sections to maintain uniform coverage across the area.

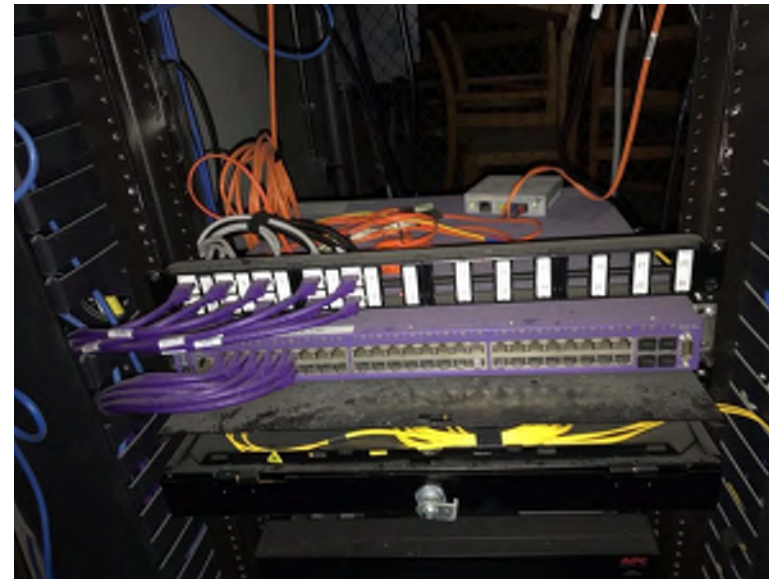
Extreme Networks switch connecting access points

Single mode fiber backbone with Category 5e data cables was installed in 2014 for the Wi-Fi system. An upgrade of the Wi-Fi system can reuse the single mode fiber backbone. The Category 5e data cables may limit the Wi-Fi solution to support 2.5 Ghz. If higher backhaul bandwidth is required, the cable will need to be replaced Category 6 or 6A meeting the Wi-Fi access point solution requirements.

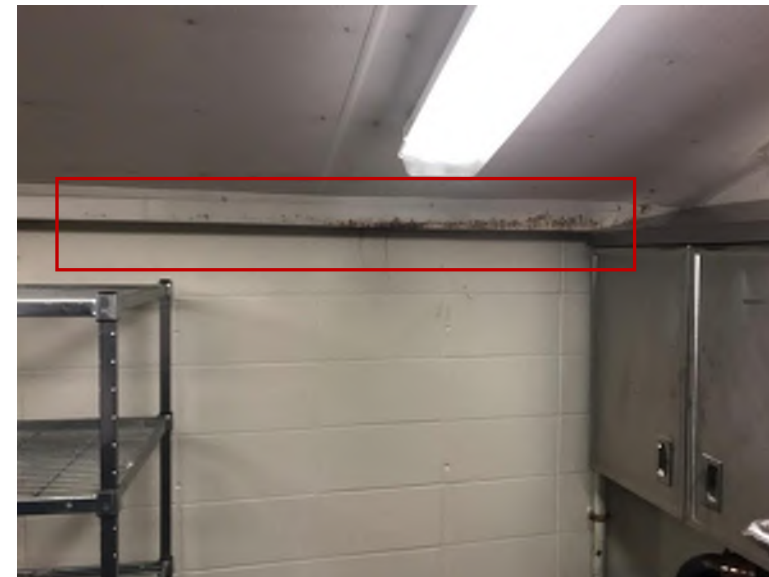
Water Leaks

Currently, water leaks into the gutters in the upper concourse and flows into the back of house in several upper concourse concessions. Annual water infiltration (structural and sealant) repairs need to be incorporated to remedy these areas.

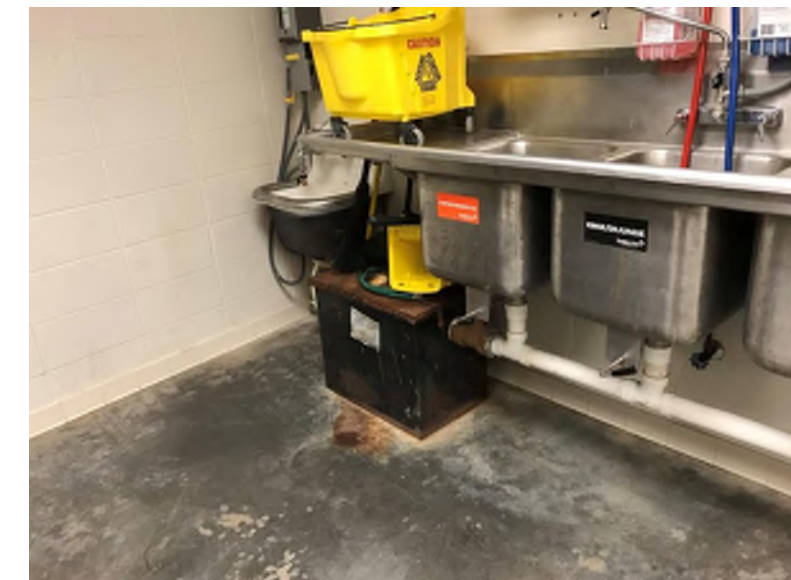
Grease Traps

Grease traps are original to the building construction. Many are rusting causing rust stains on the floors. There has been an effort to replace them, however not all have been replaced. This has created another maintenance cost. Although grease traps not part of the food service scope the rusting units does affect the aesthetics of foodservice spaces.

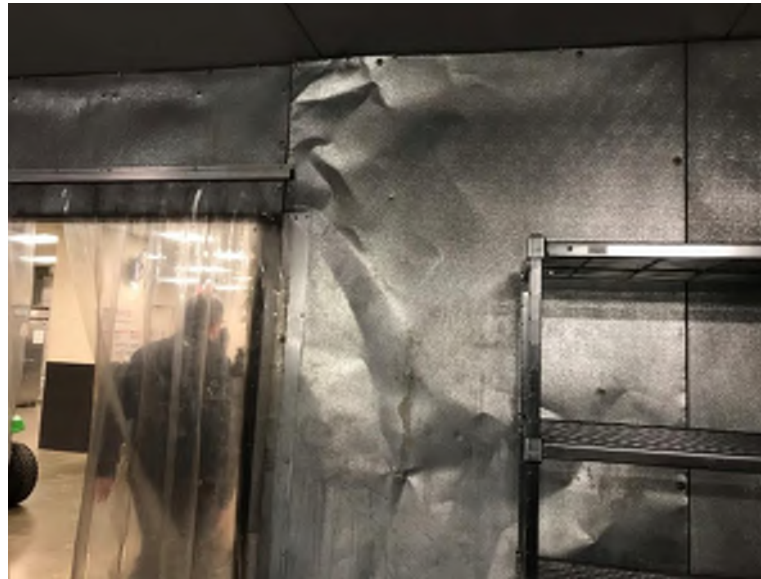
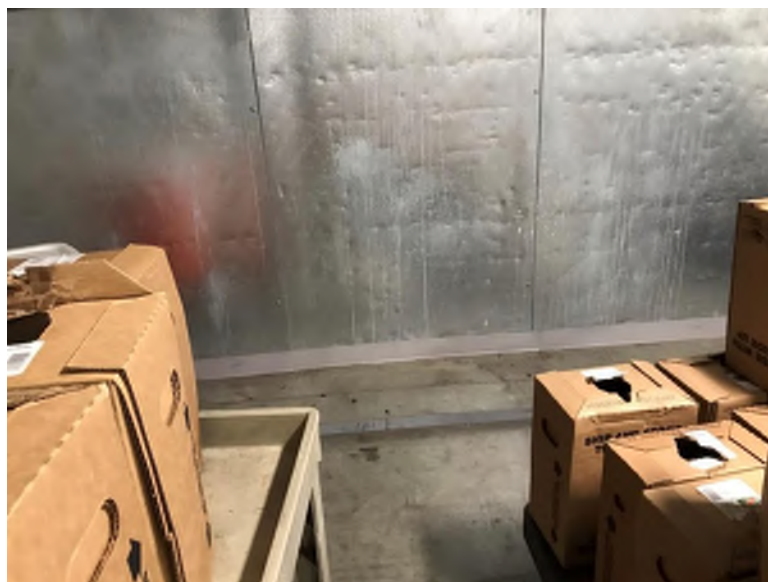
The original main kitchen walk-ins are slab on grade with insulated floors at the freezers. The walls are damaged from

being struck with pallet jacks and carts. Floor guard rails have been installed in the issue cooler to protect the walls from further damage. Additionally, this walk-in “sweats” and leaks at the floor. Sliding doors are in poor condition; some have damaged tracks which has caused the doors to be difficult to close.

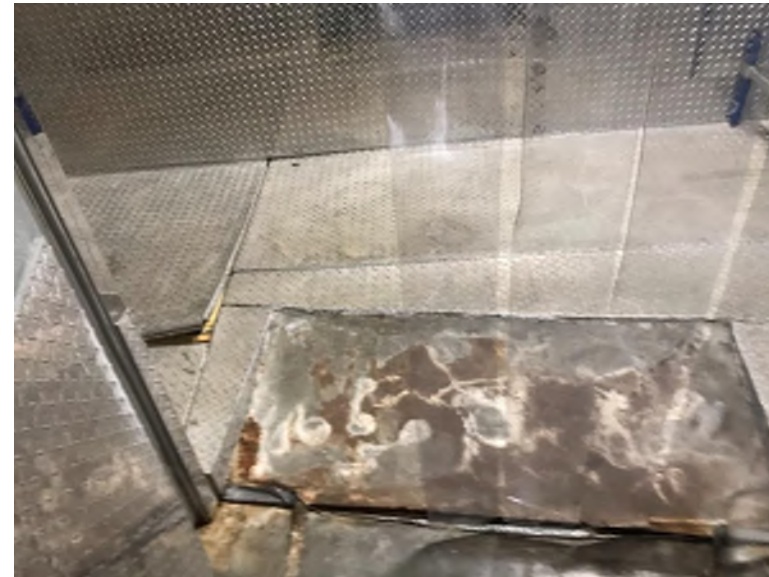
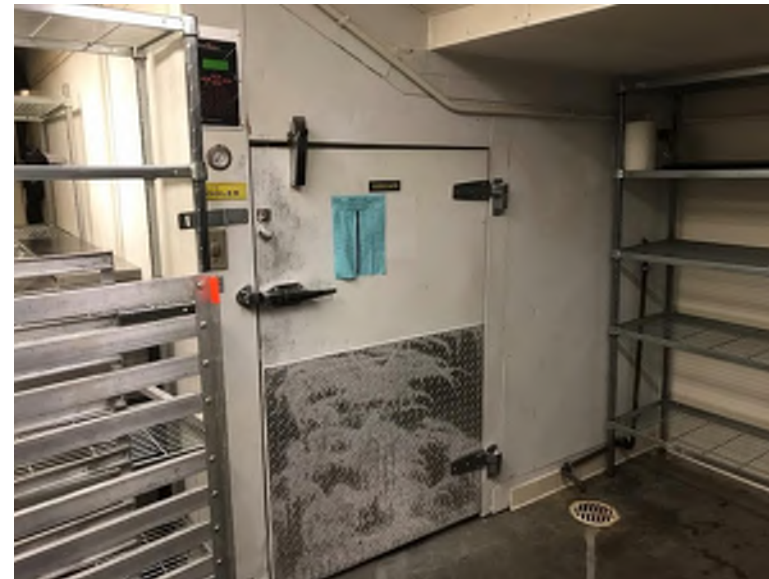
All walk-ins located in concession stands include an insulated floor. The walk-ins’ walls and ceilings are in very poor condition. Ramps are spongy and raised at the doors which poses a tripping hazard, as do the floors where the diamond tread is curled up at the corners.

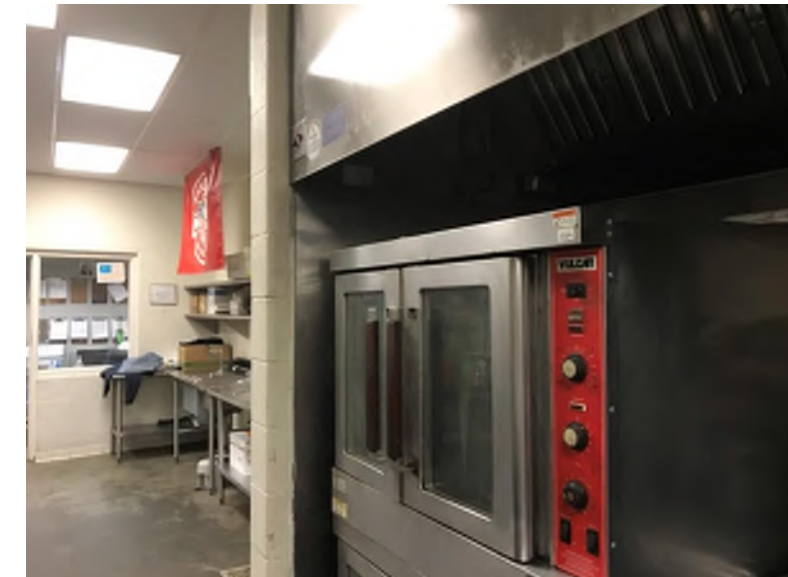
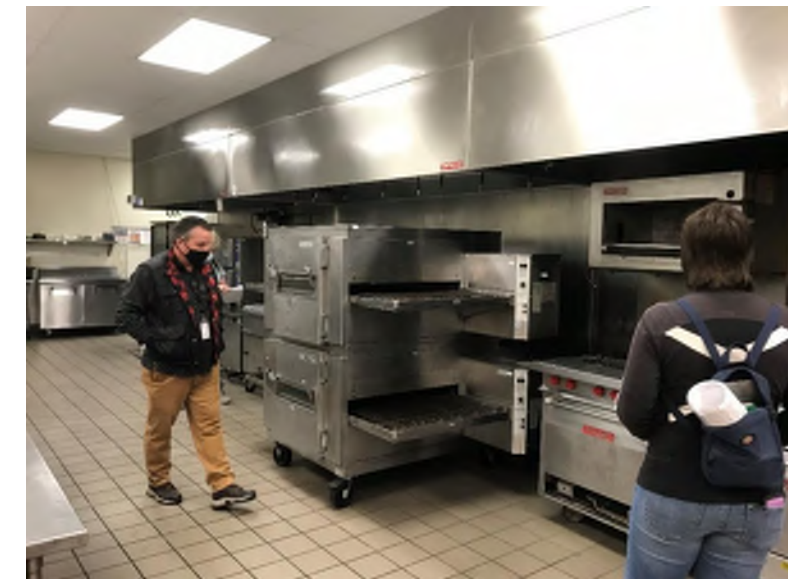
The main kitchen includes three (3) Type 1 exhaust hoods. Overall, the hoods are in good condition, however, newer hoods are being designed with additional front overhang to increase capture and containment of grease laden vapors. Minimally, 6” front overhang is required, but 12”-18” front overhang is recommended.

The kitchen hoods range from 48” deep to 66” deep. The 66” deep section is over a 6’ charbroiler. The 48” deep hoods cover

the remaining 33’ of cooking line. At 48” deep there is limited flexibility in the equipment that can be installed under the hood. Typically, the average hood depth starts at 60” deep. The limited depth is currently creating a code issue on overhang at the double stack convection oven. This is also the case with a large triple stack conveyor oven in one of the suite kitchens.

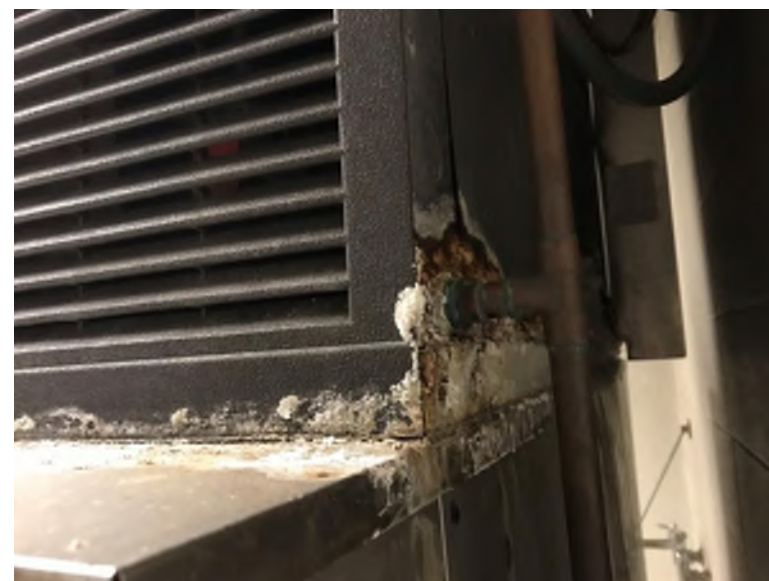
The age of the ice makers is an issue. Many have been replaced in the last ten years, however 90% of the icemakers show signs of rust on the back vents. Some rust is so bad the venting material is completely gone. All ice bins are original and should be replaced.

Aramark expressed they change the water filters annually and clean the ice makers and bins after every season. Due to the age of the filters, replacement cartridges are difficult to obtain. New filters should be considered as proper water filtration greatly extends the ice machines life.

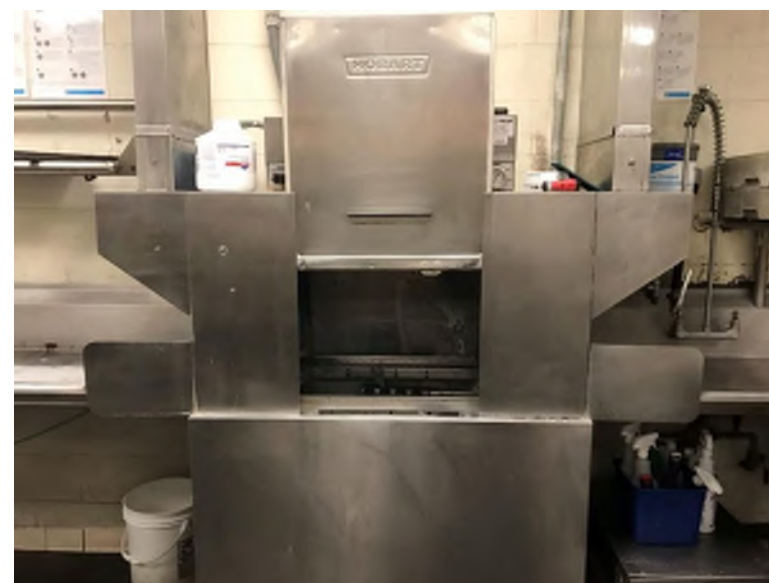
All three kitchens include a 63” conveyor warewasher. All warewashers are original to the building and have had multiple repairs but are currently functioning. They are sized correctly for the operations. The main challenge is the equipment age and costly repairs; all require replacement.

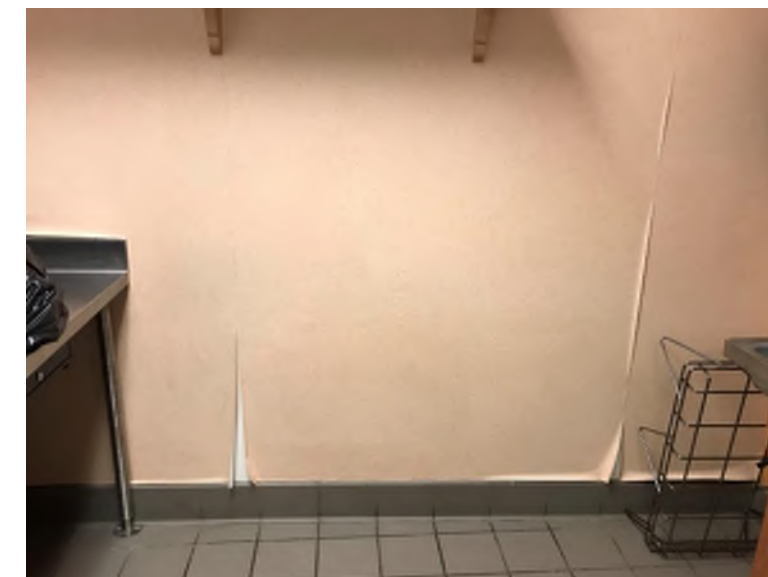
Walls are epoxy painted CMU. Overall, the condition of the walls is pitted and gouged and requires repainting. There are multiple stands where wallpaper is in the front of the house. Unfortunately, it is peeling and in view of guests. Upon updates we recommend the wallpaper be removed and replaced with epoxy paint.

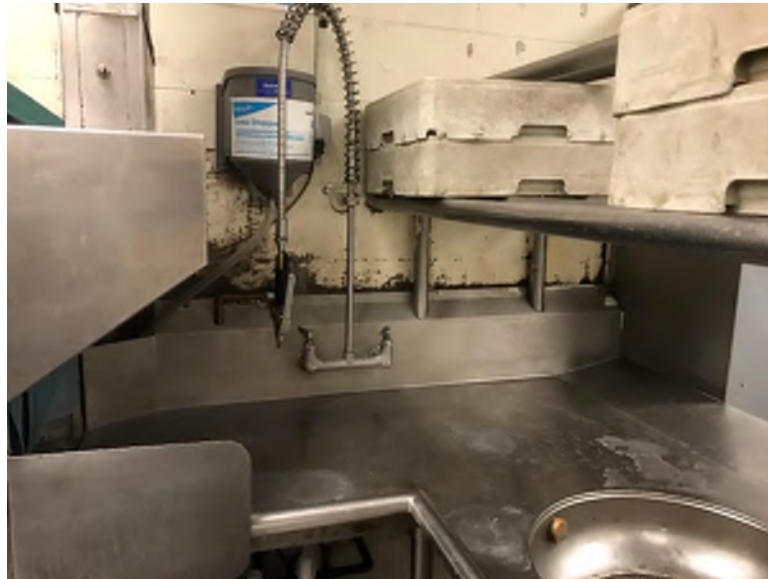
The warewashing area has areas of peeling paint due to water spray.

We recommend adding fiberglass reinforced panels (FRP) at all warewashing areas. The floors are concrete and are generally in good condition when considering their age. We could not determine if the concrete has ever been sealed. Current code requires sealed concrete in foodservice areas. We recommend a thorough scrubbing and sealing the floors.
