OVERVIEW & EXECUTIVE SUMMARY

Venue Solutions Group (VSG)[®] was engaged by Gensler Sports on behalf of Hamilton County and the Cincinnati Bengals to provide a comprehensive facility condition assessment of Paul Brown Stadium that benchmarks the current condition of the facility. As part of the assessment, VSG, in partnership with their consultant team, has developed a 20-year capital expense matrix to assist the owner in establishing priorities for major repairs, potential upgrades and maintaining the facility in a professional manner. The ability to plan and maintain the stadium as it transitions from years 18 to 30 is crucial in extending the life of the facility as well as its relevance in the competitive and ever evolving regional and national marketplace. In addition to the facility assessment, VSG has also provided information related to the practice field, bowl cleaning and event-day trash removal.

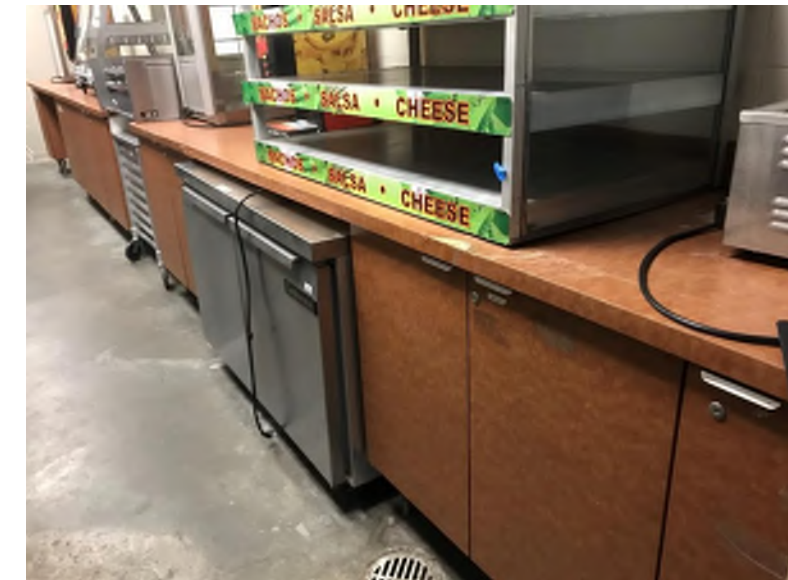
Front counters are stainless steel with vendor-provided soda stations between two POS units. Also on the front counter are two faucet beer towers. The back counters are laminate. Most stands include 1 to 2 hand sinks in the front of house. Some of the larger stands will likely require additional hand sinks to meet code.

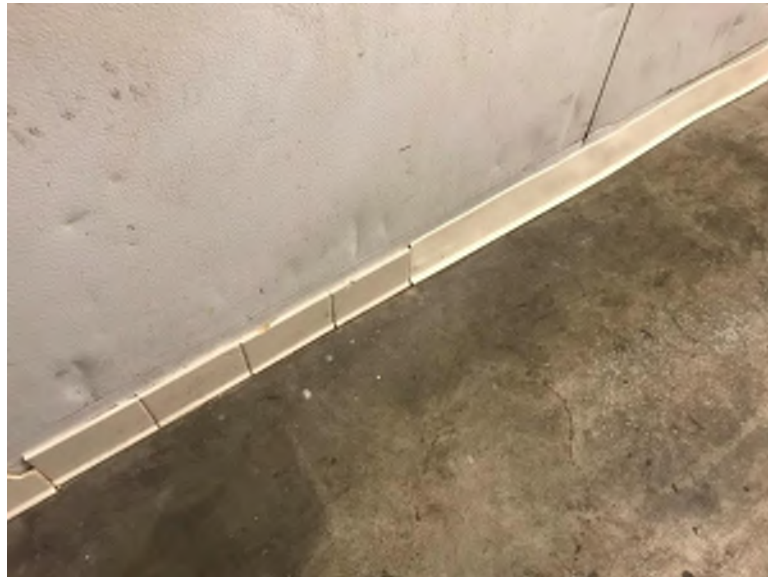
The ceramic cove base is cracked and has been replaced in certain sections with rubber cove base. This results in a patchwork of coved base. We recommend replacing all cove base in all concession stands when the spaces are updated. This can be integral to the floor instead of a separate piece.

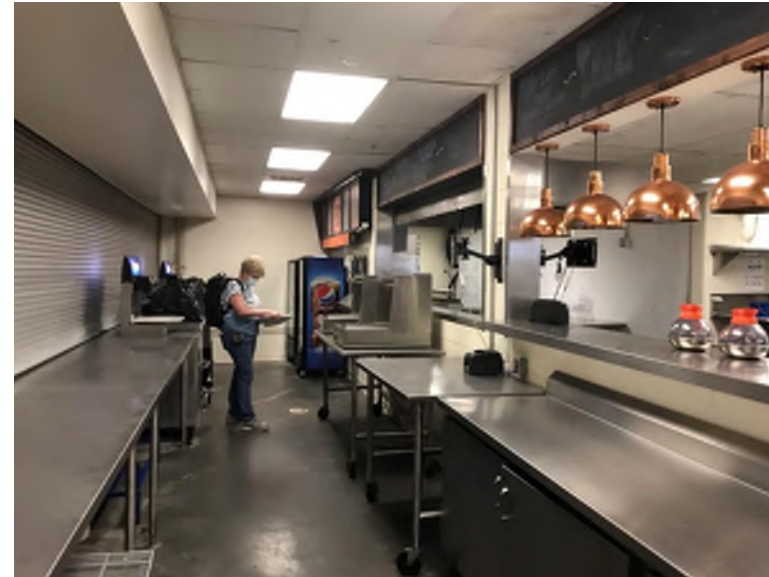
It is our understanding that the existing back wall hoods were relocated and are now used as an island style. These are different types of hoods and are not functionally interchangeable without creating operational issues. The wall hood utilizes the back wall to assist in capture and containment. The island style has a different set of filter banks and pull because there is no back wall. The decision to use wall type hoods without a wall is probably one of the causes for the lack of smoke capture at these hoods. In addition, the fans were not updated to accommodate the additional CFMs required.

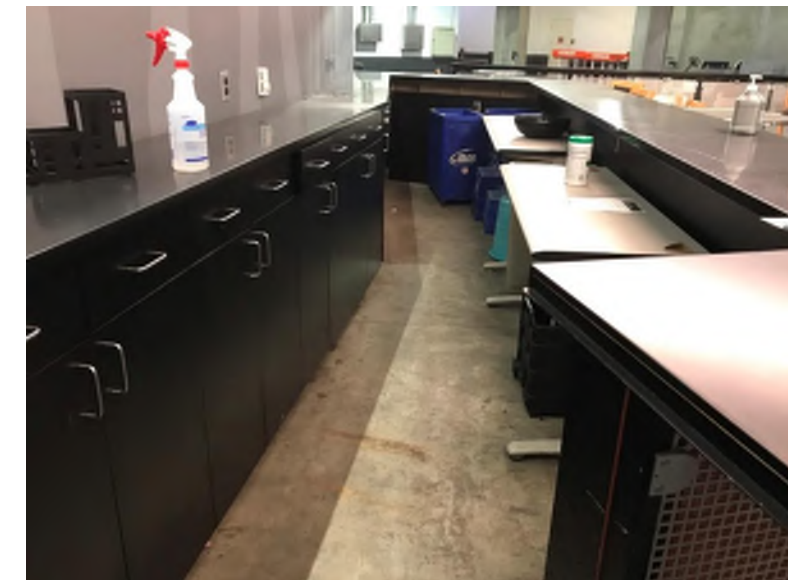
Located just outside the Service Level locker room, the Service Level Premium Patron Space is considered a bar although it lacks bar equipment, electricity, and plumbing. It is a front bar and back laminate cabinet base with folding tables. The bar is not code compliant without a hand sink and other functional pieces of equipment.

The space has potential because fans can watch the players exit the locker room as they run onto the field. We recommend the space be brought up to code with proper underbar (including hand sinks) and back bar equipment. Front and back bar counters should be provided with a non-porous, code compliant surface.

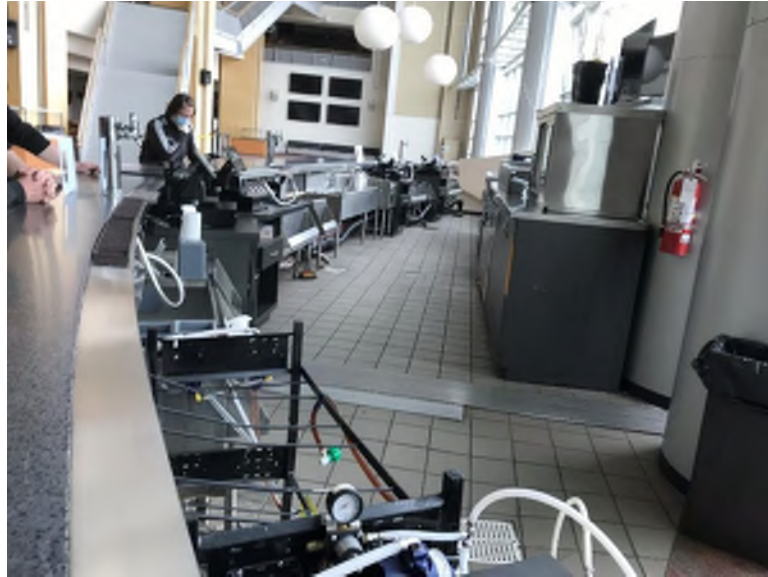
The two main concourse bars have a beer garden feel. They consist of laminate counters with vendor-provided full height coolers in lieu of back counters. Although the addition is a well-used element, we recommend updates to the areas with more permanent finishes.

There are several code issues at the bar, one of which is that some of the back counters and POS stands are laminate which is not code compliant and requires replacement upon any updates.

The underbar equipment is in good condition and appears it could be used in a renovation. The back bar coolers are original to the building, have outlived their life expectancy and require replacement.

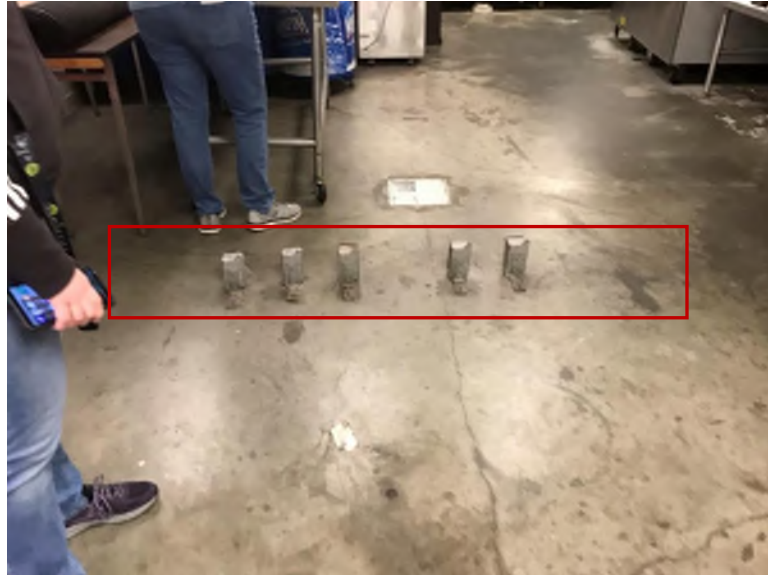
There are 23 vendor commissaries, and all include a walk-in cooler. In addition, some include vendor-provided ice cabinets and/or icemakers. The quantity of vendor spaces adequately supports the operation. The major issue with the spaces is the age of the walk-ins and building. Some of the commissaries include floor mounted receptacles and these did not appear to be functioning and pose a tripping hazard as well.

We recommend that when the spaces are updated, ceiling pendant receptacles be added in place of the floor mounted receptacles.

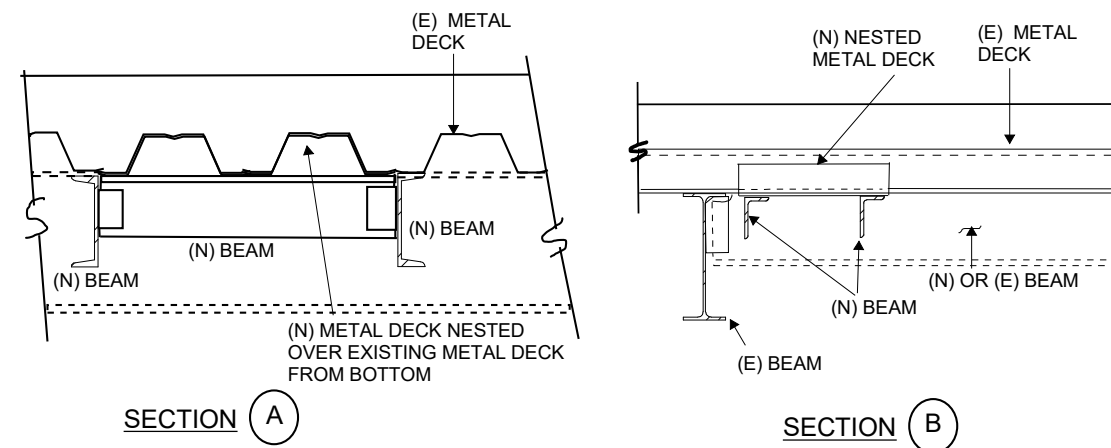
EXAMPLE OF RESUPPORTING CONCRETE TOPPING OVER CORRODED METAL DECK
